Service Bulletin

PRELIMINARY INFORMATION

Subject: Engine Coolant Odor inside Vehicle Passenger Compartment

Models: 2011-2012 Chevrolet Cruze
Equipped with 1.4L Engine (RPO LUJ)

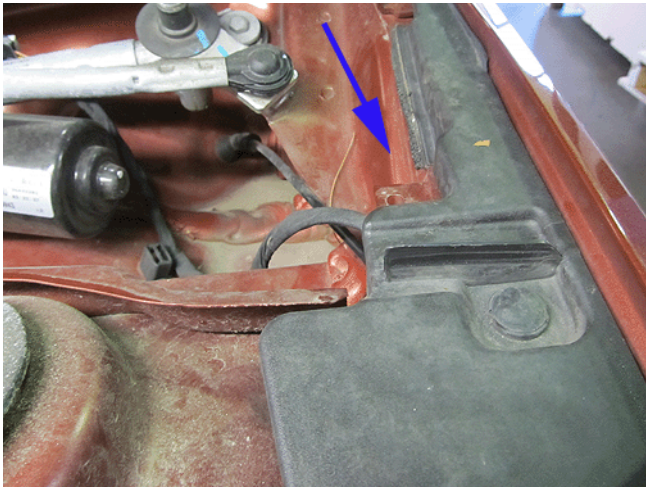
4. Inspect the front of dash seals (particularly around heater core inlet) and inspect the hood to cowl seal for gaps/poor sealing. Repair as required.
5. Install left and right hood seals as follows:
 - 5.1. Remove the air inlet grille. Refer to Air Inlet Grille Panel Replacement in SI.

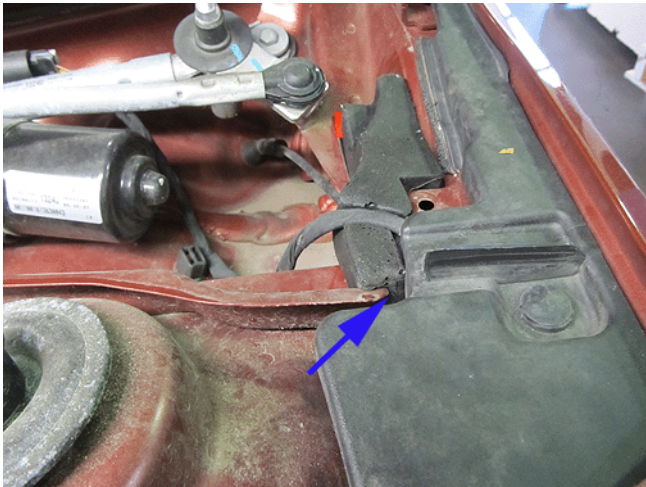
5.3. Install the right side hood seal, P/N 95486182, as shown. Ensure the gap is sealed.

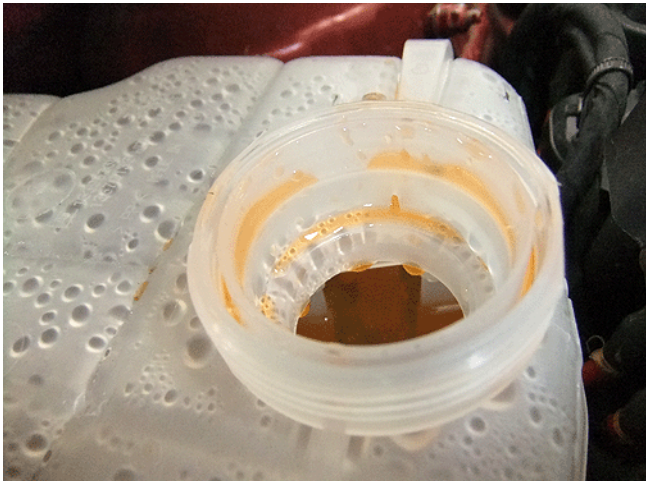
6.1. Remove the coolant reservoir vent cap/cover.

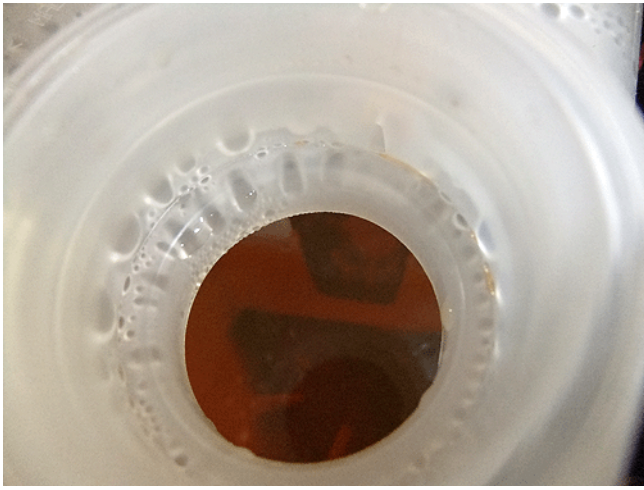
6.2. Clean any coolant residue from the fill neck area of the reservoir.

Ensure all traces of coolant are cleaned from the filler neck.

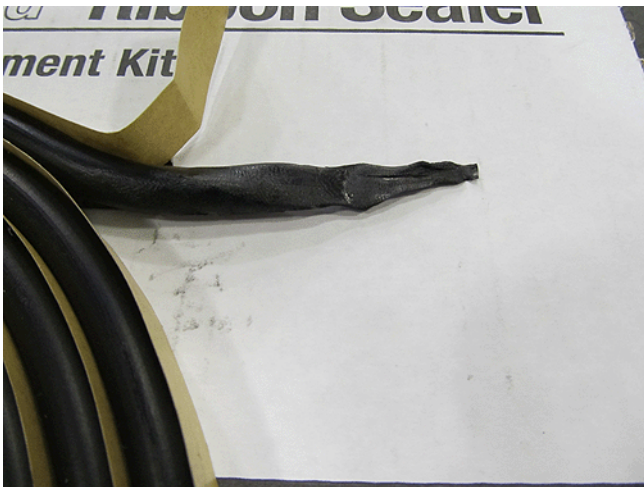
- 6.3. Clean the vent opening and make sure it is dry before moving to the next step.
- 6.4. Prepare a 40 inch long section of locally sourced 0.375 in. OD and 0.167 in. ID drain hose.

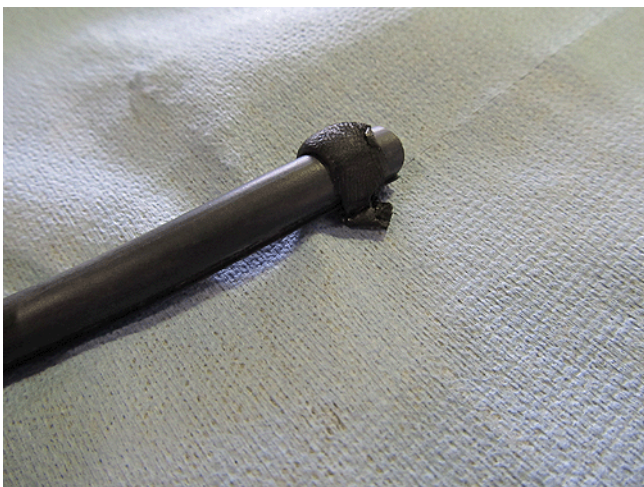
- 6.5. Stretch a small amount of butyl ribbon sealer, such as *3M® Window Weld Ribbon Sealer, Part # 08612 or the equivalent, into a thin ribbon about 25 mm (1.0 in) in length as shown.

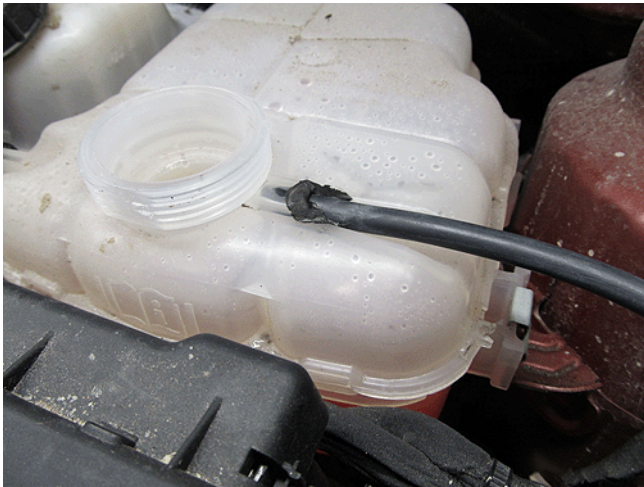
- 6.6. Wrap the butyl around the end of the hose as shown. Use care to not plug the end of the hose.

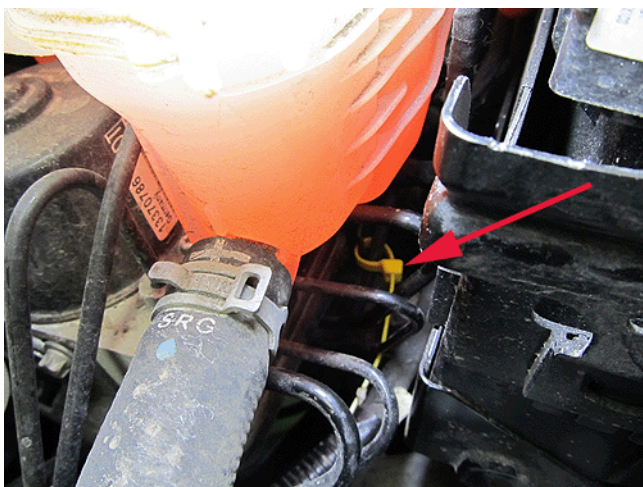
6.8. Using a 40 mm (1.5 in) long section of *3M® Scotch Brand Electrical Moisture Sealer part # 06147 or the equivalent, secure the hose to the top of the reservoir as shown.

6.9. Route the hose down from the reservoir, along the driver side frame rail and between the control arm bracket and the frame rail. Using black wire ties, secure the drain hose as shown.
