Service Bulletin

Bulletin No.: Pl0981

Subject: Decklid is Hard to Open/Close, Will Not Open and/or Trunk Open Message Displayed in DIC

Models: 2014 Chevrolet Impala

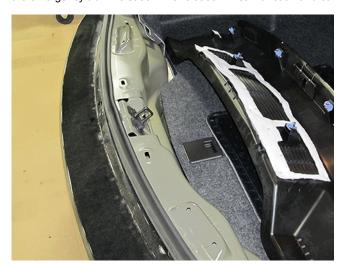
The cause of this condition may be that the decklid latch striker may be positioned too low on the body rear end panel.

1. If the decklid will not open, push down on the lid while pressing the latch release. In some cases, the lid may still not open and it will be necessary to use the emergency trunk release. This release will still function and can be accessed in the trunk through the rear seat.

2. Remove the rear end trim finish panel. Refer to Rear End Trim Finish Panel Replacement in SI.

- 3. Loosen the two bolts retaining the decklid latch striker.
- 4. Raise the striker upward 1.0 mm (0.04 in) and tighten the bolts. Refer to Rear Compartment Lid Latch Striker in SI.
- **5.** To help reduce possibility of a water leak, ensure proper seal contact to the decklid by placing strips of paper around the decklid opening, closing the lid then checking for resistance when the paper is pulled out.
- 6. Once correct position/function of the decklid is verified, reinstall the rear end trim finish panel. Refer to Rear End Trim Finish Panel Replacement in SI.
