No.: 13 TS-11  
March 21, 2013

SUBJECT: **DD Platform Oil Filter Bypass Valve**

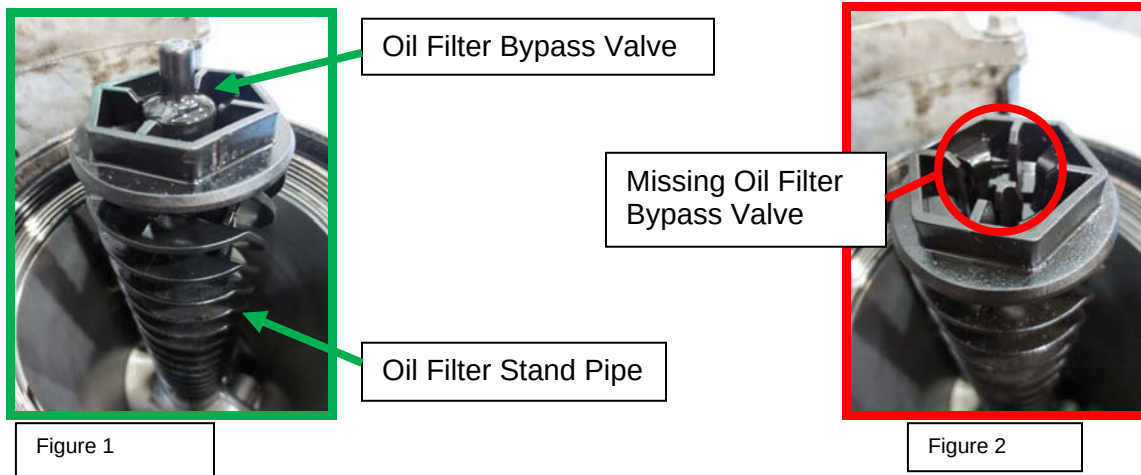
The oil filter bypass valve located on top of the oil filter stand pipe has been found to break off during an oil filter replacement. The bypass valve is a vital component to ensuring the engine oil is being filtered properly.

Visually inspect the Oil Filter Bypass Valve to ensure it is intact. See the figures below:

If the oil filter stand pipe or the oil filter bypass valve is damaged, the oil/coolant filter module must be replaced.
