## Vehicle Owner Notification

**To:** All Dealers  
**From:** Tracy Daniels  
Warranty Department  
**Subject:** VON #82 – Heater/Defroster 2 Fuse Replacement  
**Date:** January 31, 2013

## VEHICLE OWNER NOTIFICATION #82

**MODEL:** SAF-T-LINER MVP-EF  
**SUBJECT:** HEATER / DEFROSTER FUSE REPLACEMENT  
**DATE:** JANUARY 31, 2013  
**ACTIVE PERIOD:** 1/31/2013 – 1/30/2014  
**EXPIRES ON:** 1/31/2014  
**PAGE:** 1 OF 2

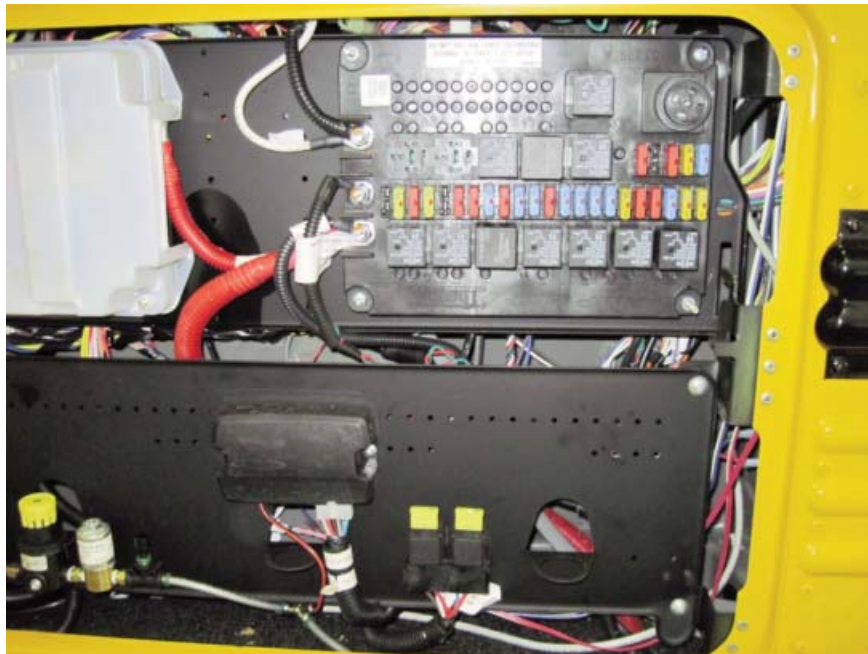
**FIGURE 1**

1. Turn the ignition key to the "Off" position. Chock the tires and disconnect the batteries.
2. Open the exterior electrical panel access door below the driver's window.
3. Remove the PC Board #1 cover, if present. **Figure 1**
