SERVICE BULLETIN

APPLICABILITY: 2010-2013MY Outback
2009-2013MY Forester

NUMBER: 12-153-13

SUBJECT: Tonneau Cover Stopper / Holder Repair

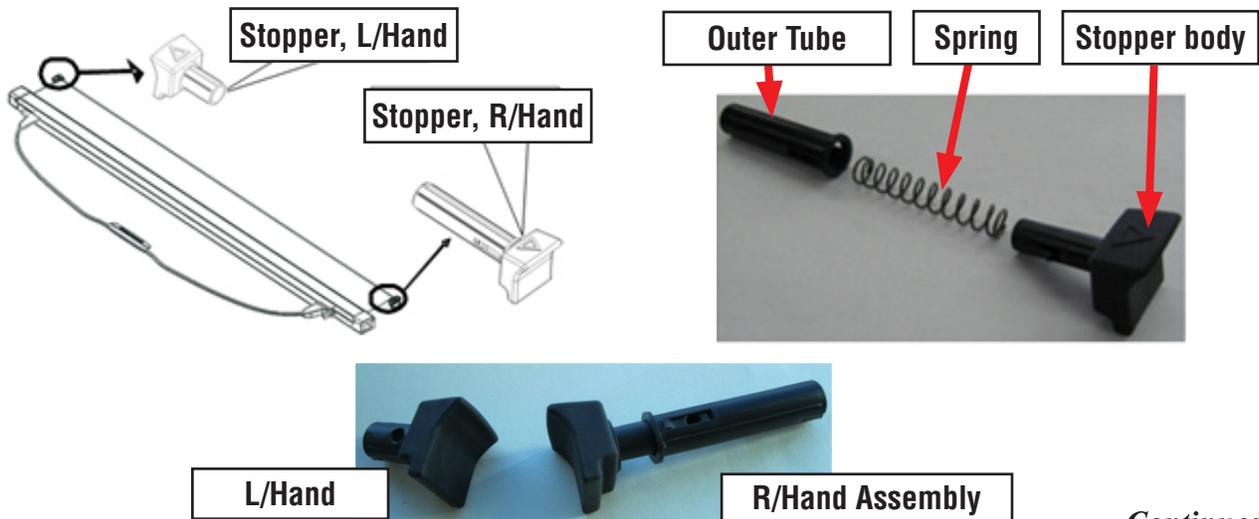
Parts overview: The L/Hand stopper is one-piece while the R/Hand is a 3-piece assembly as shown.

NOTE: Both the Left Hand (L/Hand) and Right Hand (R/Hand) stopper should be ordered together when either replacement is needed as the L/Hand stopper will likely be broken and no longer usable after removing it from the support pipe.

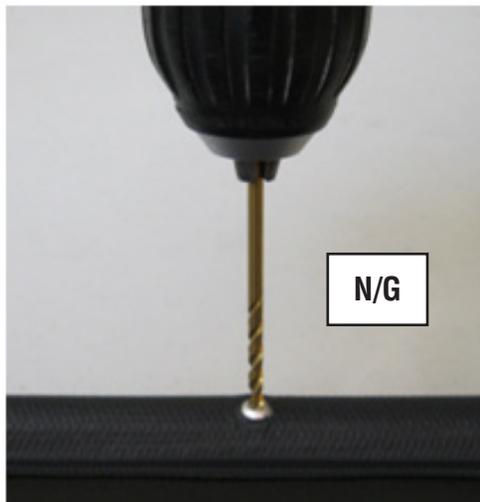
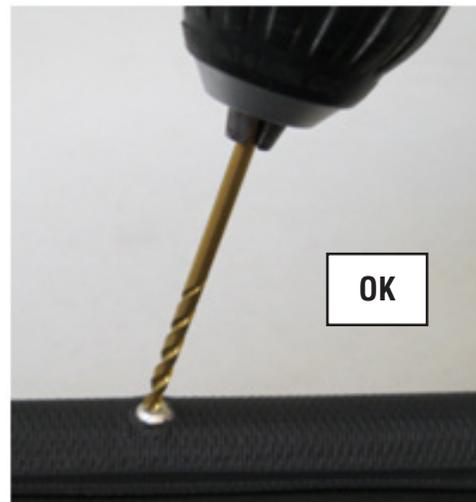
Step 2- Using a sharp 1/8” drill bit, drill out the 2 pop rivets which position the material of the tonneau cover over the support pipe. To minimize any damage to the tonneau cover material from the rivet head spinning while drilling, use minimal pressure and as slow a drill speed as you can while holding the drill at an angle to the support pipe (not perpendicular) as shown in the photos below.

CAUTION: Wear Safety Glasses.

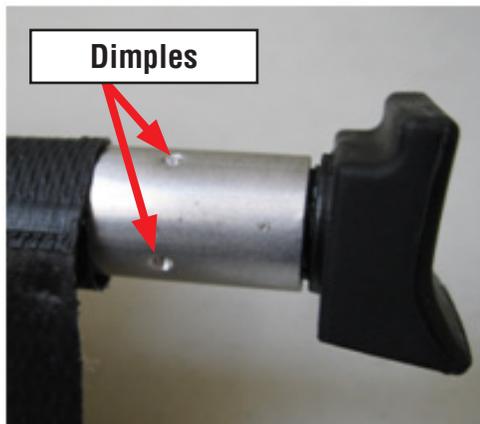
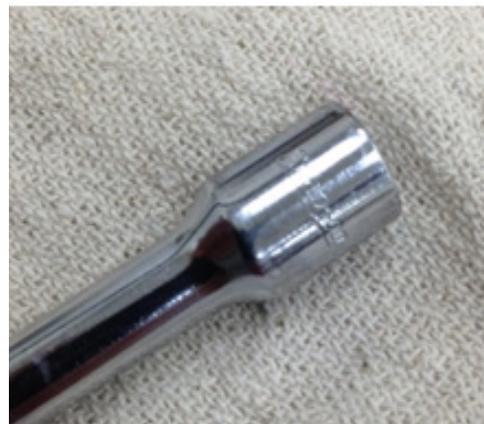
NOTE: As shown in the photo on Step 3, both stoppers are “staked” in place with punches or “dimples” in the support pipe (3 on Outback, 1 on Forester). You will be able to see these dimples by moving the covering material on the support pipe from side to side after the rivets have been removed.

Step 3- After drilling out the 2 rivets, the 3 stakes or dimples on each which secured the L/Hand stopper to the support pipe will need to be reduced (pushed back out) from the inside. This will provide clearance for the wood dowel and allow the new stoppers to be fully seated when installing them. The drive end of a 6” to 8” long 1/4” drive extension is close to 1/2” outside diameter and works well to push these dimples out. Place the drive end in the support tube then drive it past the dimples with a hammer. The support pipe is made of aluminum and is fairly soft making it a rather easy material to work with.

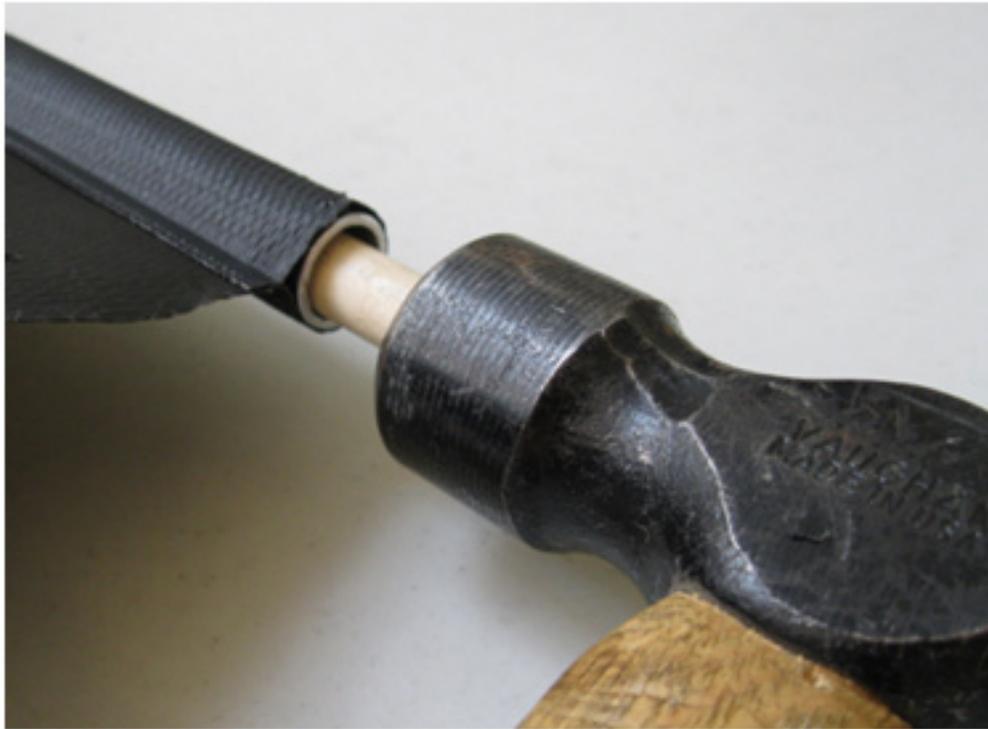
Step 4- Once the L/Hand stopper is removed and the dimples reduced, insert the wood dowel into the support pipe and drive the R/Hand stopper outer tube out the other end. You will need to use the drive end of the 1/4" drive extension again to push the dowel all the way through as the support pipe is longer than 48 inches. The wood dowel is relatively soft and will not reduce the dimples holding the R/Hand stopper outer tube in place. Once the broken stopper outer tube is removed, reduce the R/Hand dimples using the 1/4" drive extension as you did on the L/Hand end of the support pipe.

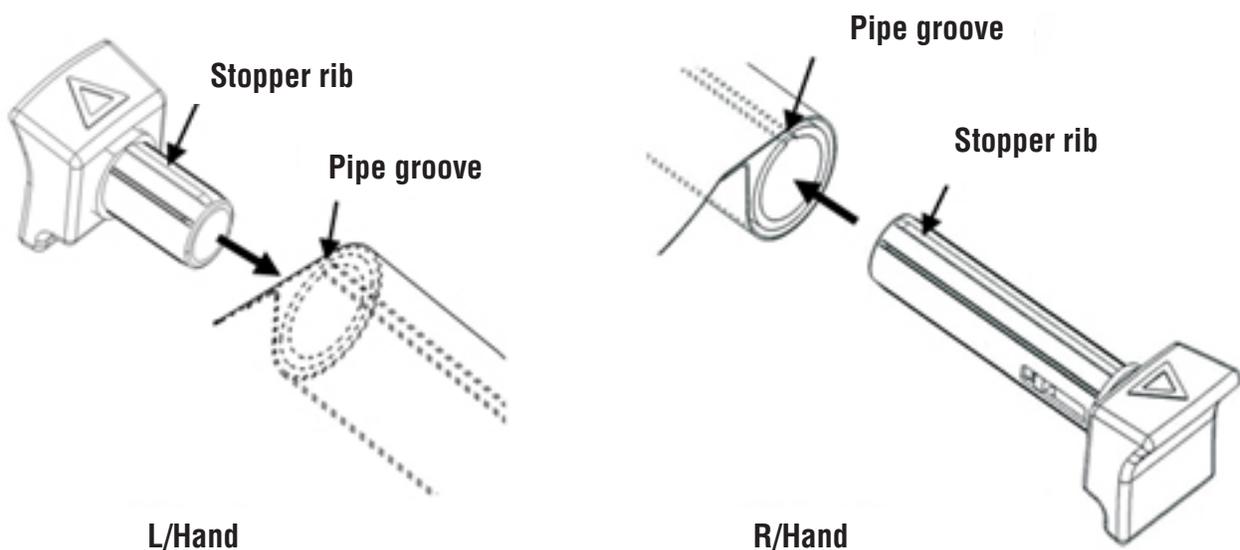
IMPORTANT- Make sure the ribs on the new parts align with the corresponding groove inside the support pipe as shown below.

Step 5- Push the new stoppers into the support pipe using moderate hand pressure.

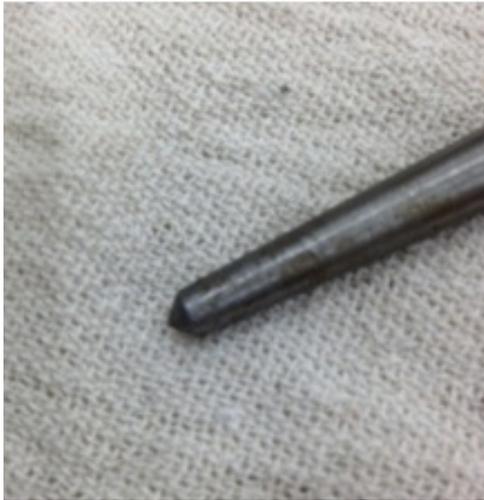
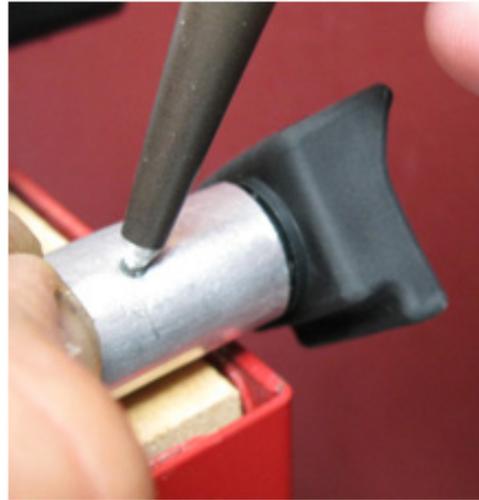
Step 6- Once both stoppers have been properly aligned, installed and are fully seated in the support pipe, stake them in position using the original dimples with a small hammer and pointed nose punch. Be sure to support the ends of the pipe as shown below to avoid bending it or damaging the stoppers. **REMINDER:** The aluminum support pipe and the plastic stoppers now inside it are soft. Be careful to not use any more force than necessary when re-staking the retaining dimples.

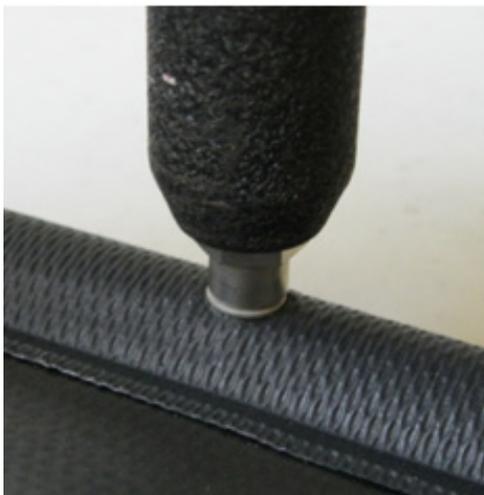
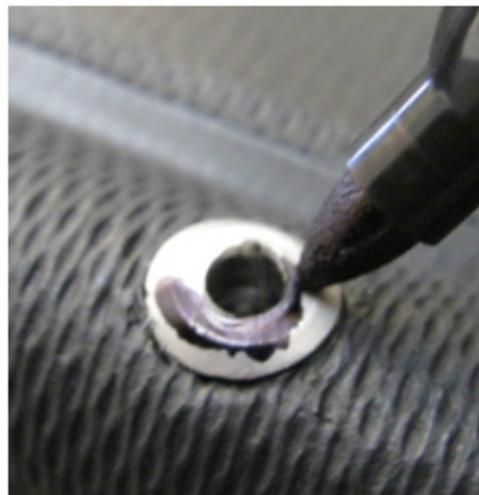
Step 7- Install the 2 pop rivets which position the tonneau cover material on the support pipe then touch up with a permanent black marker if necessary to complete the repair.
