**No.: 13 TS-30**  
September 30, 2013

SUBJECT: **GHG14 DD Engine EGR System Fault Codes**

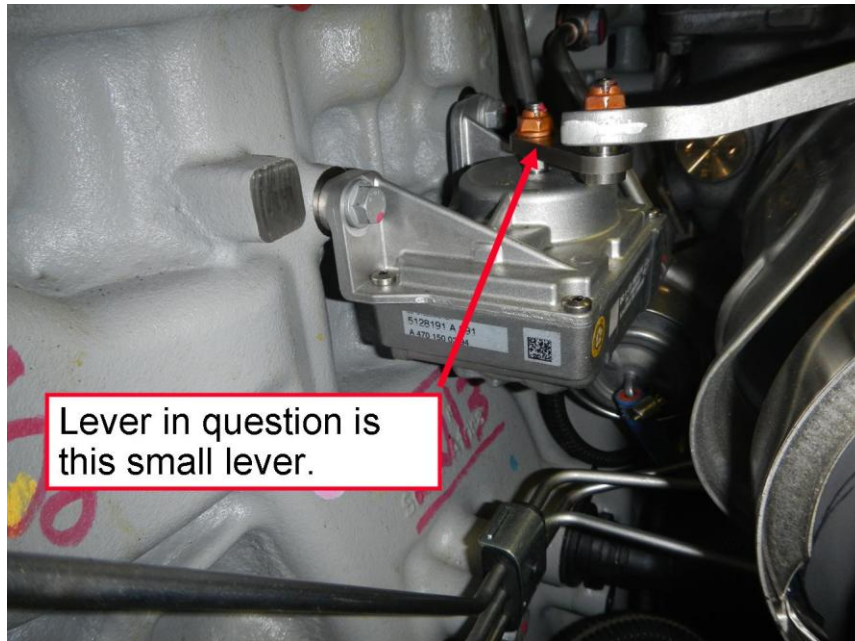
**Figure 1 – Location of Lever**

1. Carefully inspect the EGR valve system hardware consisting of the EGR valve actuator, lever, pull rod, and EGR valve for incorrect, missing, damaged, or loose parts. The lever on top of the EGR valve actuator is dependent on the type of engine. See Figures 1 and 2 for information on how to correctly identify the lever. Note the numbers stamped on the lever.

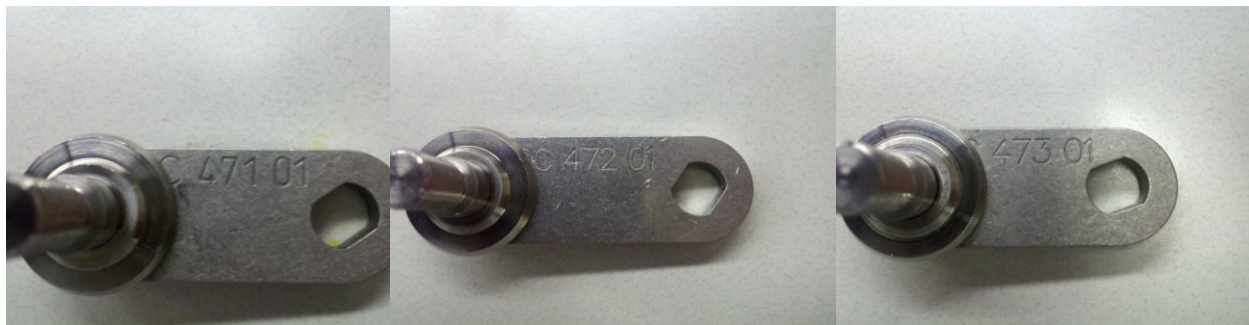
**Figure 2 – Identification of Lever**

| 471 used on DD13 | 472 used on DD15AT (model 472906) | 473 used on DD15TC (472909) and DD16 |

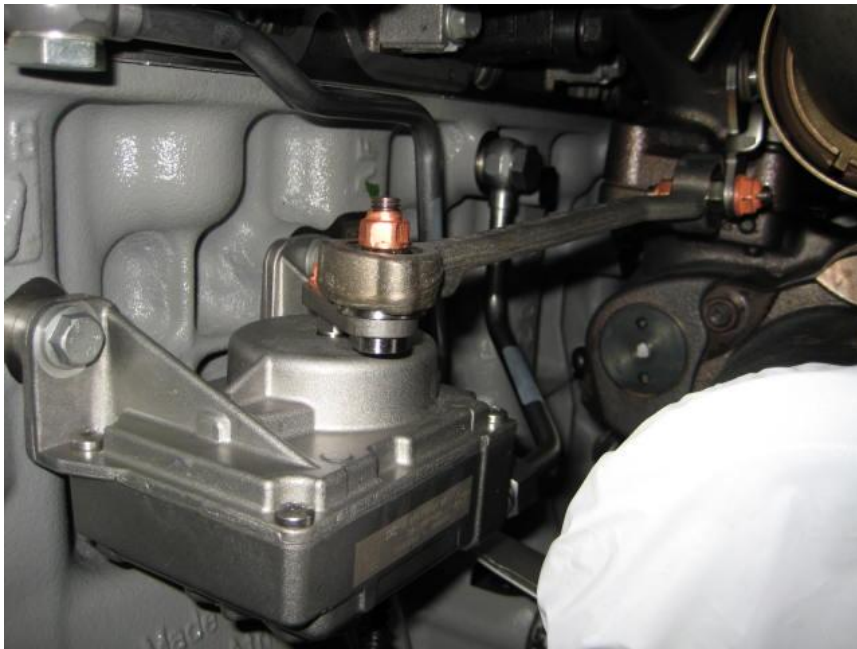
**Figure 3 – DD13 System, Pull rod P/N Located On Top**

2. Inspect the pull rod connecting the lever to the EGR valve. The hardware should be firmly tightened with no slack, and there should be no binding in movement. The pull rod has a “v” stamped on it at the EGR valve end, and an “s” stamped on it at the EGR valve actuator end. The DD15AT (472906) has some additional hardware at the EGR valve end consisting of a spacer that must also be correctly installed. The spacer is used on the connecting bolt between the top of the pull rod ball socket and the bottom of the EGR valve circular lever. Omission of the spacer can result in binding of the EGR valve during actuation. The EGR pull rod lever design is different on DD13, DD15TC, and DD16 engines and a spacer is not used on those applications. See Figures 3-6 for examples of the various configurations.

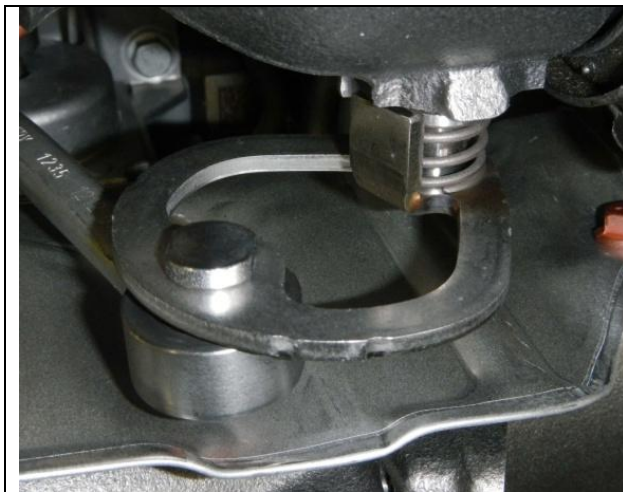
**Figure 4 – DD15AT (472906) System**

**EGR Valve Circular Lever**

**Spacer Between Pull rod and Circular Lever**
