### Damage to Side Airbag Trim Mount on Front Seat

F06

F12

F13

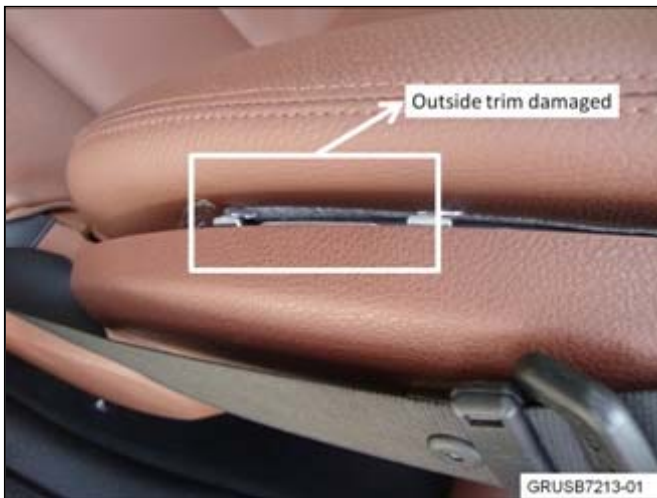
The side airbag trim mount on the left or right seat is separated (damaged).

The damage occurred during a previous seat repair.

This picture shows the separation of the trim from the side airbag.

When repairing a problem in the back seat area that requires removal of the side airbag on the front seat, you must follow ISTA Repair Instruction REP 72 12 050, "Removing and installing side airbag (front seat)."

**Important: If the situation as described above is present, do not attempt to repair the trim. In this case, the side airbag MUST be replaced.**
