SI M64 01 13
Heating and Air Conditioning

April 2013
Technical Service

Red or Blue Cap Missing from Temperature Control Wheel

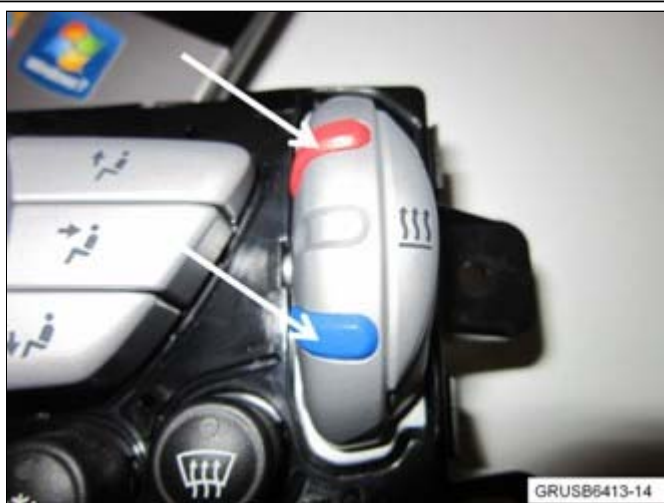
The customer states the red or blue cap is missing from the temperature control wheel of the heat and air conditioning control panel.

1. The red and blue caps can now be replaced separately. Note: Replacement of the complete heat and air conditioning panel is no longer permitted for this complaint. Replace the missing cap(s).
