Inconsistent Hybrid Display in CID

F10H (ActiveHybrid 5)

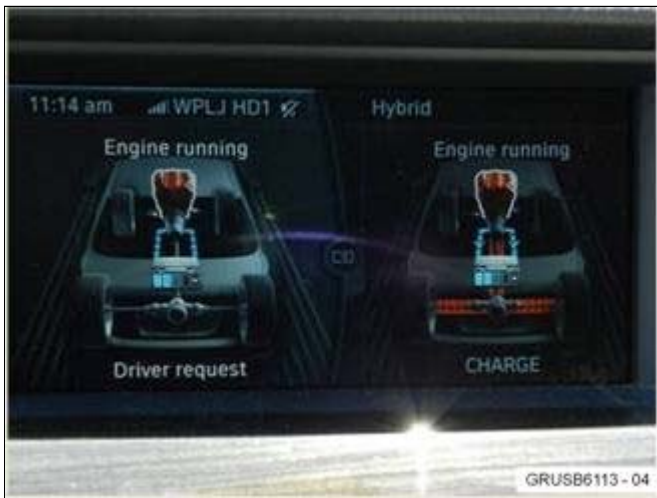
The following condition may be present when the split-screen option is selected in the Central Information Display (CID), and “Hybrid Display” is selected.

The displayed message and/or power flow display on either side of the screen is inconsistent. One example of the display is shown below.

The data displayed on each side of the CID uses slightly different parameters. In most use cases, only one of the displays is on at a time, so it is not noticeable. The displayed information on both is technically correct.

- Do not perform any work on the vehicle. Replacing parts or programming the vehicle will not change the display.
- This condition does not represent a failure and no action should be taken.
