SI B61 15 13
General Electrical Systems

ACSM and ICM Warning Lamps Are Illuminated

F30

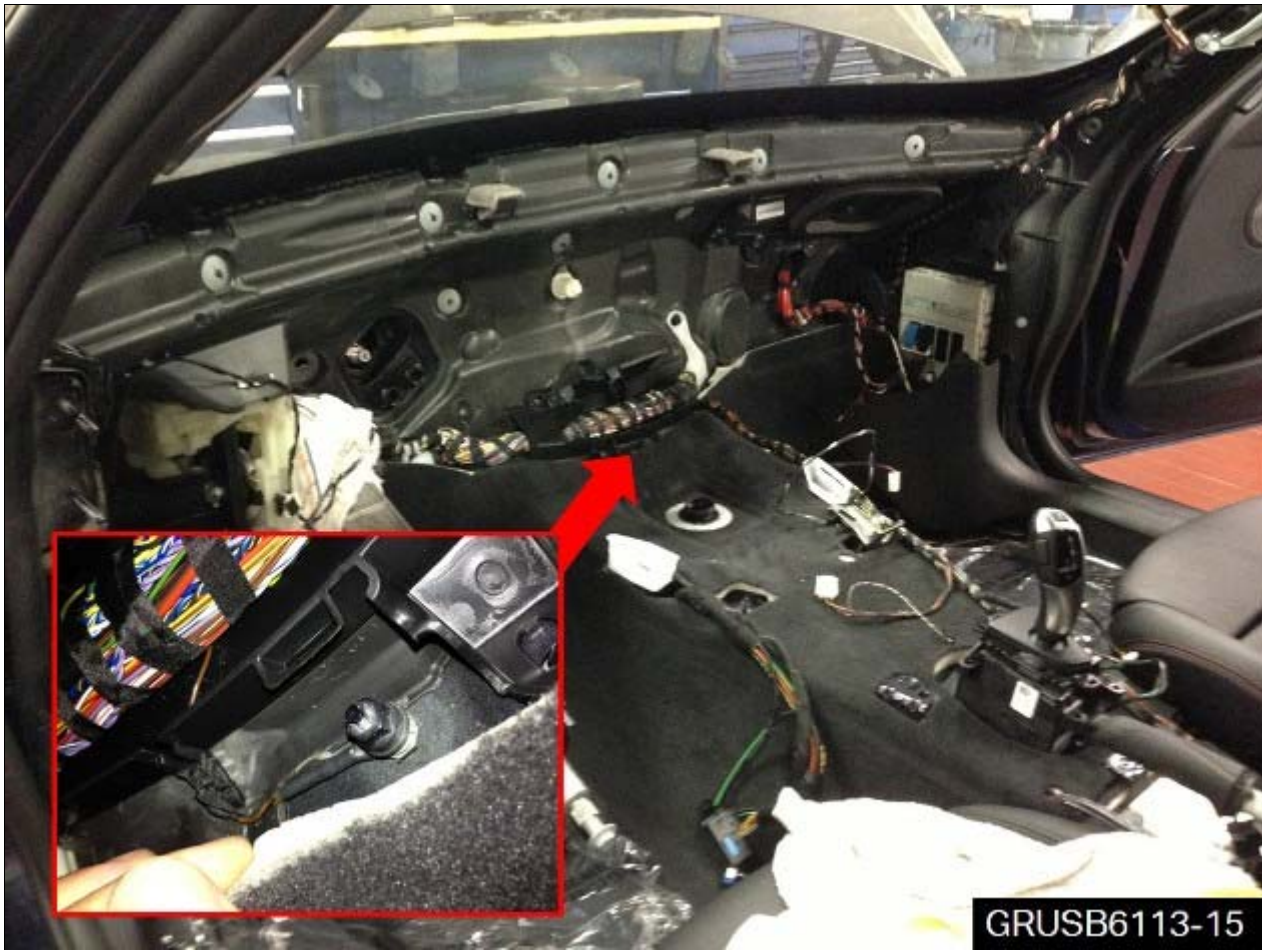
Ground point Z10*10B is loose.

1. Perform a vehicle test using ISTA and complete all test modules related to the stored faults.
2. Check the ground circuit of the ACSM (Advanced Crash Safety Module) and ICM (Integrated Chassis Management) modules for a voltage drop or high resistance, as recommended by the test module.
3. If the ground circuit check indicates high resistance or a high voltage drop, check the ground point Z10*10B, located under the dash, behind the heater box as indicated below. Tighten to 8Nm and clear the faults.
4. The wiring harness installation process at the factory has been improved as of April 2013.
