SI B64 01 13  
Heating and Air Conditioning

October 2013  
Technical Service

**IHKA Operating Panel Buttons Are Peeling**

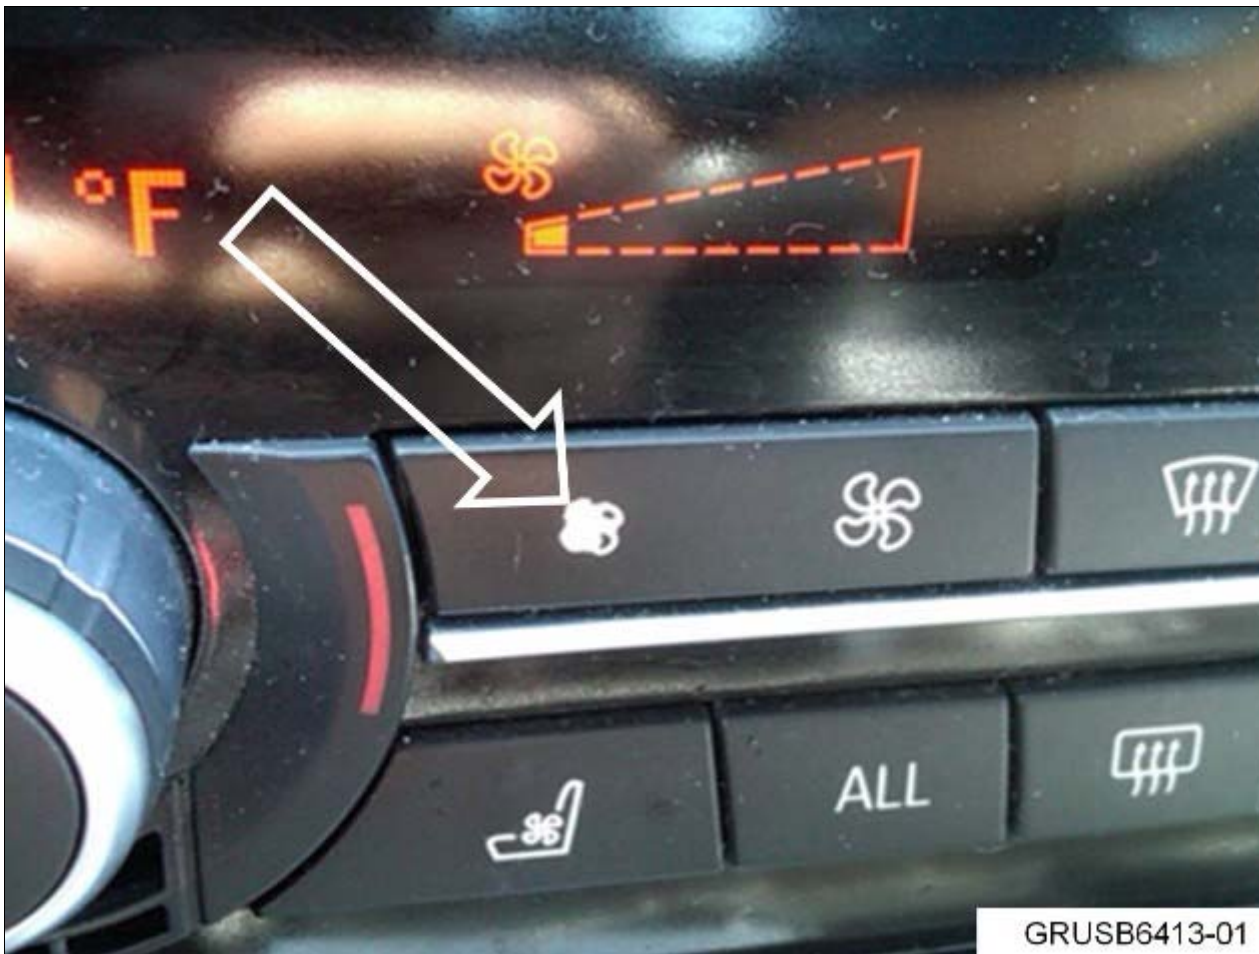
The surface is peeling off one or more of the IHKA operating panel buttons, and the button symbol may become unreadable.

Ingredients in certain skin care products, including sunscreens and hand lotions, causes the button surface to peel.

In the picture below, you can clearly see how the low fan speed button is just starting to peel. Two of the four fan blades are missing from the button symbol, and soon the entire symbol will be gone.

Improved replacement buttons for the IHKA panel are now available as a kit.

Refer to ETK for the correct part number for your model. Replace **ALL** the buttons included in the kit.

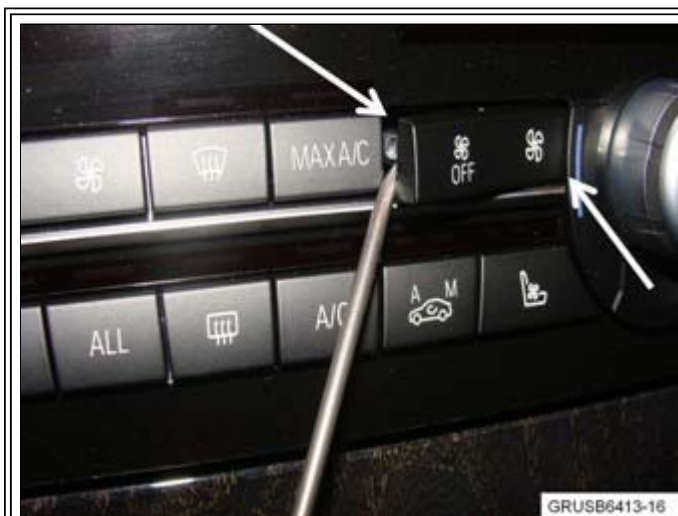
1. Use two narrow picks to carefully pry off the button caps. Since the button will be replaced, pay special attention not to damage the switch. Note: There are two types of button switches; a rocker type for the fan speed adjustment, and a regular push-button type for the others.

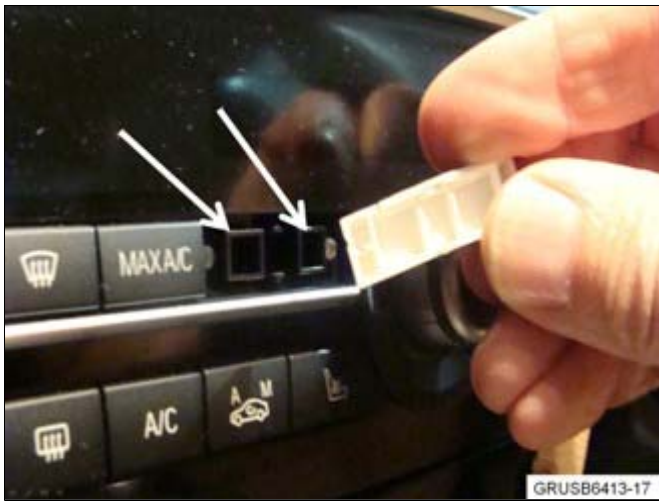
2. In this picture, the fan speed button cap has been removed. The cap is attached to the two individual square openings of the switch.

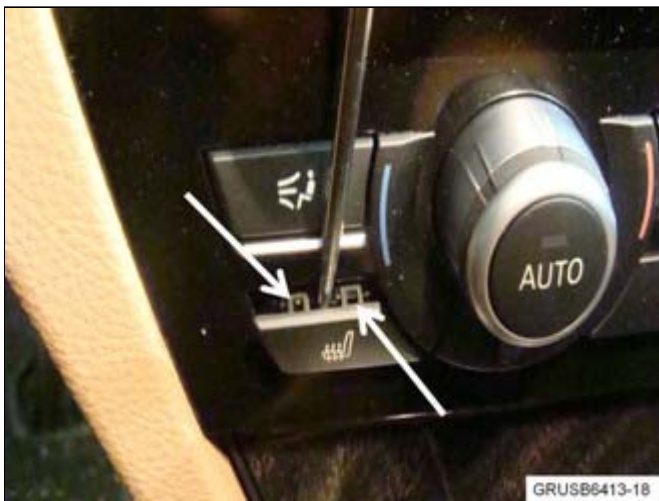
3. In this picture, the driver's side seat heating button is being removed. The cap is attached by four retaining tabs; two on the top, and two on the bottom. Remove the two top tabs, and then the two bottom tabs.

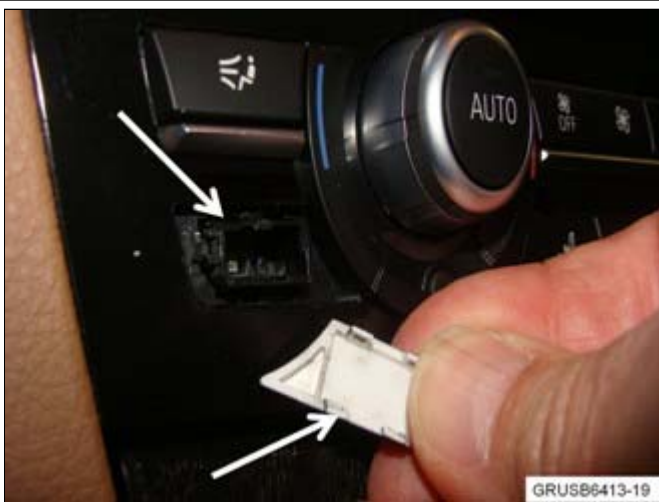
4. The cap has been removed, and the four retaining tabs can be seen.

5. After all button caps have been removed, install the new caps by aligning them squarely to the switch, and then pushing in firmly. Working from the center outward will simplify the installation. After the first cap is installed, check for functionality and smooth operation **before** installing the next cap. Continue installing
