Service Action Campaign

Code: 20T8

**Subject: Certain 2009-2012 Model Year Vehicles with TDI® Clean Diesel Engine
Install Misfueling Guard**

September 12, 2013

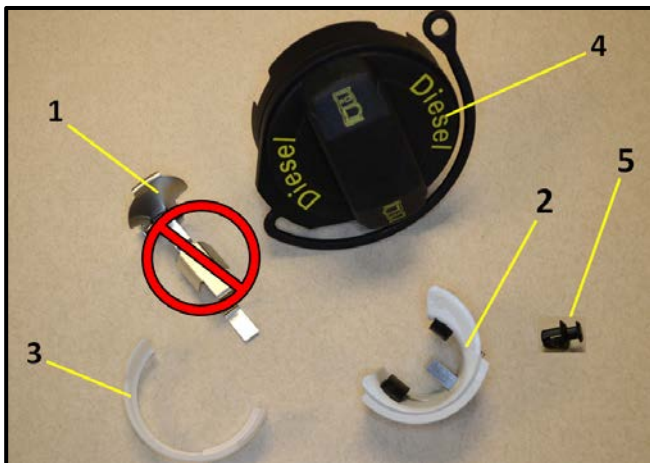
- Open the fuel filler door
- ⇐ Remove the fuel cap and the fuel cap tether <circle> from the vehicle.

Tip: If the customer has installed their own locking or aftermarket fuel filler cap, be sure to return the old fuel cap to the customer.

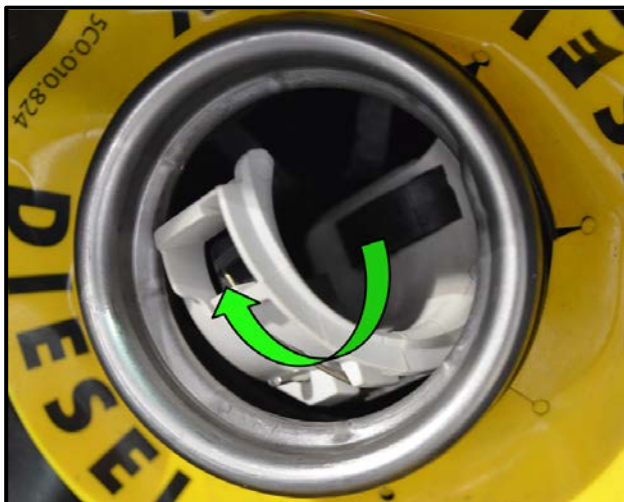
- ⇐ The misfueling guard kit p/n - 5K0 201 400 consists of five pieces <left>.

NOTE: DO NOT INSTALL the spring loaded flap insert (#1)

1. Spring Loaded Flap Insert (**NOT USED**)
2. Fuel filler lockout mechanism.
3. Plastic retaining ring.
4. Replacement fuel cap w/tether.
5. Mounting pin for fuel cap tether.

Note: On SportWagen and Golf Wagon models the tether is attached to a permanent anchor inside the fuel filler housing. On Jetta sedans the tether is mounted to the fuel filler door hinge using a plastic mounting pin (#5 above). A replacement pin is included in every misfueling guard kit, but is not used on some models.

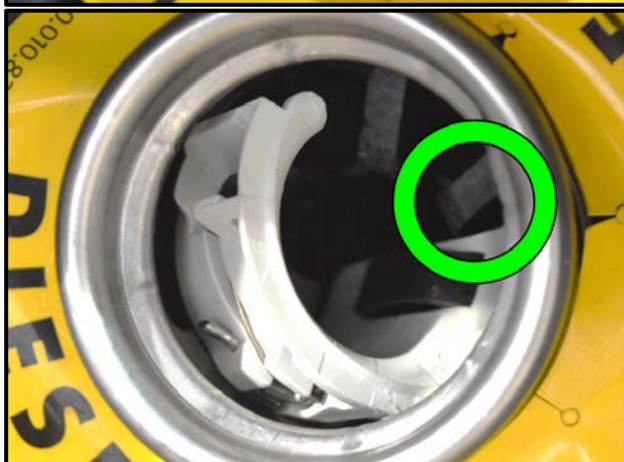
⇐ Insert the lockout mechanism into the filler neck and rotate from right-to-left <arrow> to seat properly into position.

Tip: The right side of the mechanism must be placed into the filler neck opening first.

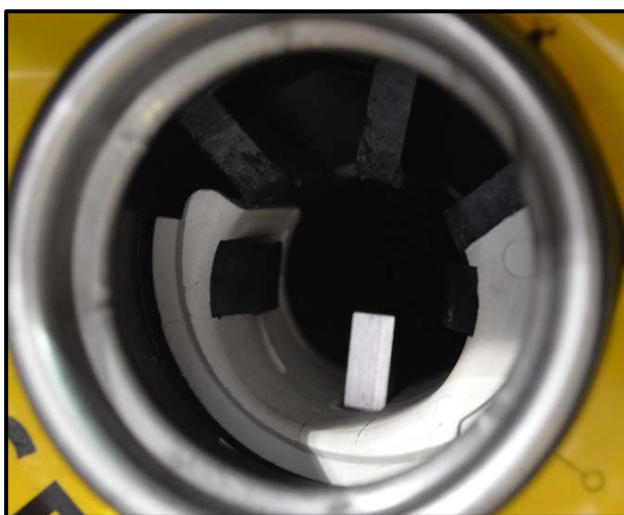
⇐ During installation the lockout mechanism must remain to the right of the right tab in the filler neck opening <circle>.

- With the right side of the lockout mechanism properly lined up, press the left side into the filler neck.

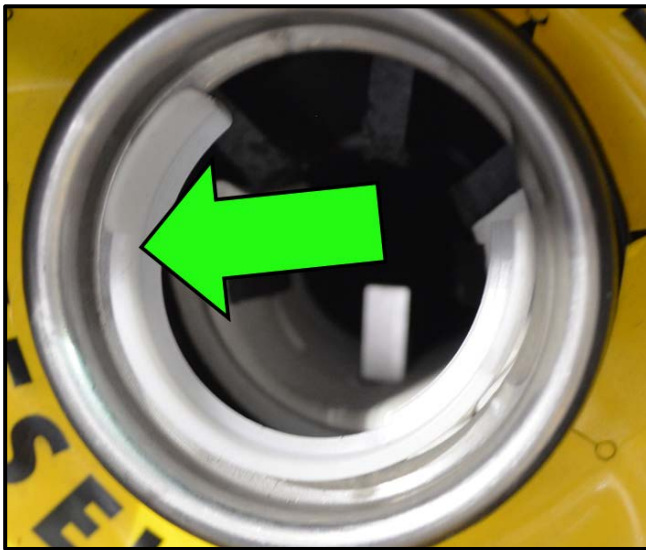
⇐ The retaining ring is installed into the filler neck with the alignment pins <circles> facing toward the fuel tank.
