**Title: CF- CityStar 500 - 600: Mud, Water and Debris Collecting In Driver's and /or Passenger Door**

**Applies To: CF, CityStar 500, 600**

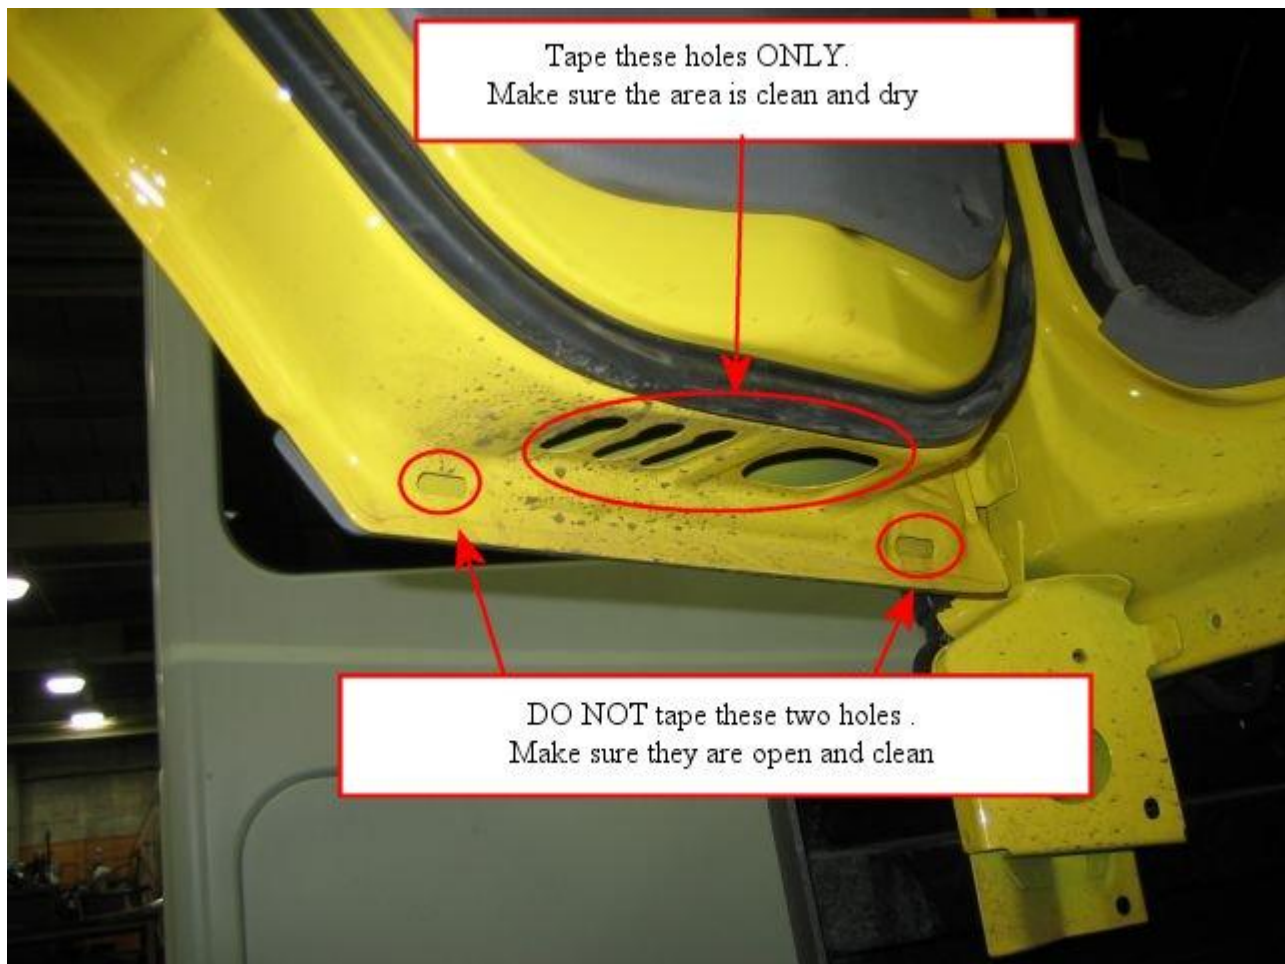
Photo 1 Tape holes shown

Mud, water and other debris may have entered through the openings (holes) in the bottom of the driver's and / or passenger's door.

1. Make any repairs caused by the mud, water or debris inside door.
2. Clean all mud and debris from the inside of the door.
3. Make sure the two lower drain hole shown in Photo 1 are open and clean.
4. Completely dry the inside of the door.
5. If the interior door trim was removed Install clear tape 3M part number 75-3470-1910-3 on inside of door covering holes just above the cab step see Photo 1.
6. Clean and dry the bottom edge of the door.
7. Cut the 14" tape from (2596245C91) into two (2) 7" pieces or cut two (2) 7" strips off roll (3672943C1).
8. Install clear tape on outside of door covering holes just above the cab step. TAPE LOWER HOLES ONLY.

9. DO NOT tape over the two lower drain holes. These must remain open.
