Countries: Document ID: IK1200893  
 Availability: Revision: 0  
 Major System: ENGINES Created: 3/8/2013  
 Current Language: English Last Modified: 3/8/2013  
 Other Languages: NONE Author: David Smith  
 Viewed: 81

**Title: 2010 MaxxFORCE 11/13 Oil Filter Cap and Bypass Valve Assembly**

**Applies To: Prostar, LoneStar, WorkStar, TranStar, 2010 MaxxFORCE 11/13**

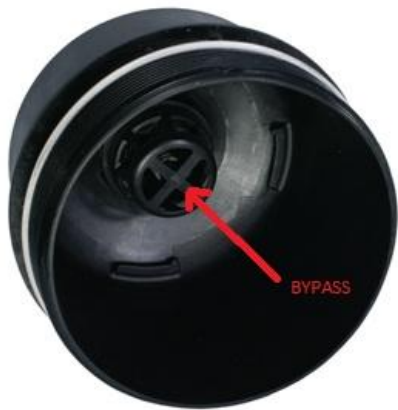
For the Bypass Valve location refer to the image below:

Warranty returned oil filters have been sent back along with the Oil Filter Cap Bypass Valve. The valve allows oil to pass through the engine if the filter becomes restricted. Please verify that at every oil change that the Oil Filter Cap has an intact Bypass Valve. If the Oil Filter Cap is missing the Bypass Valve please replace the Oil Filter Cap assembly with the part number 3007511C91. The kit will include : Oil Filter Cap with Bypass Valve, and Oil Filter Cap Seal.

**NOTE: THE BYPASS VALVE SHOULD NOT BE REMOVED FOR ANY REASON**

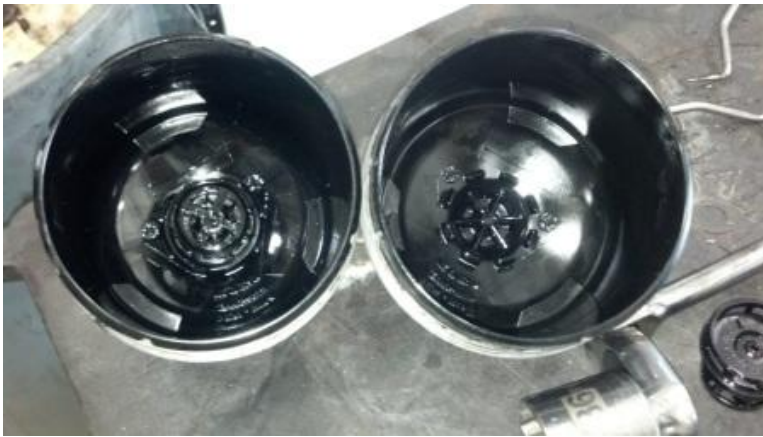
Picture Below is an Oil Filter Cap with a Bypass Valve (on the left), and without the ByPass Valve (on the right).
