Title: One piece sunshade mounting bracket becomes loose or comes off the cab

Applies To: HPV style (DuraStar, TerraStar, WorkStar, TranStar, ProStar, LoneStar) day cabs, extended cabs, and travel crews built in Garland or Springfield between June 2010 and February 2012. This does not affect Escobedo built vehicles.

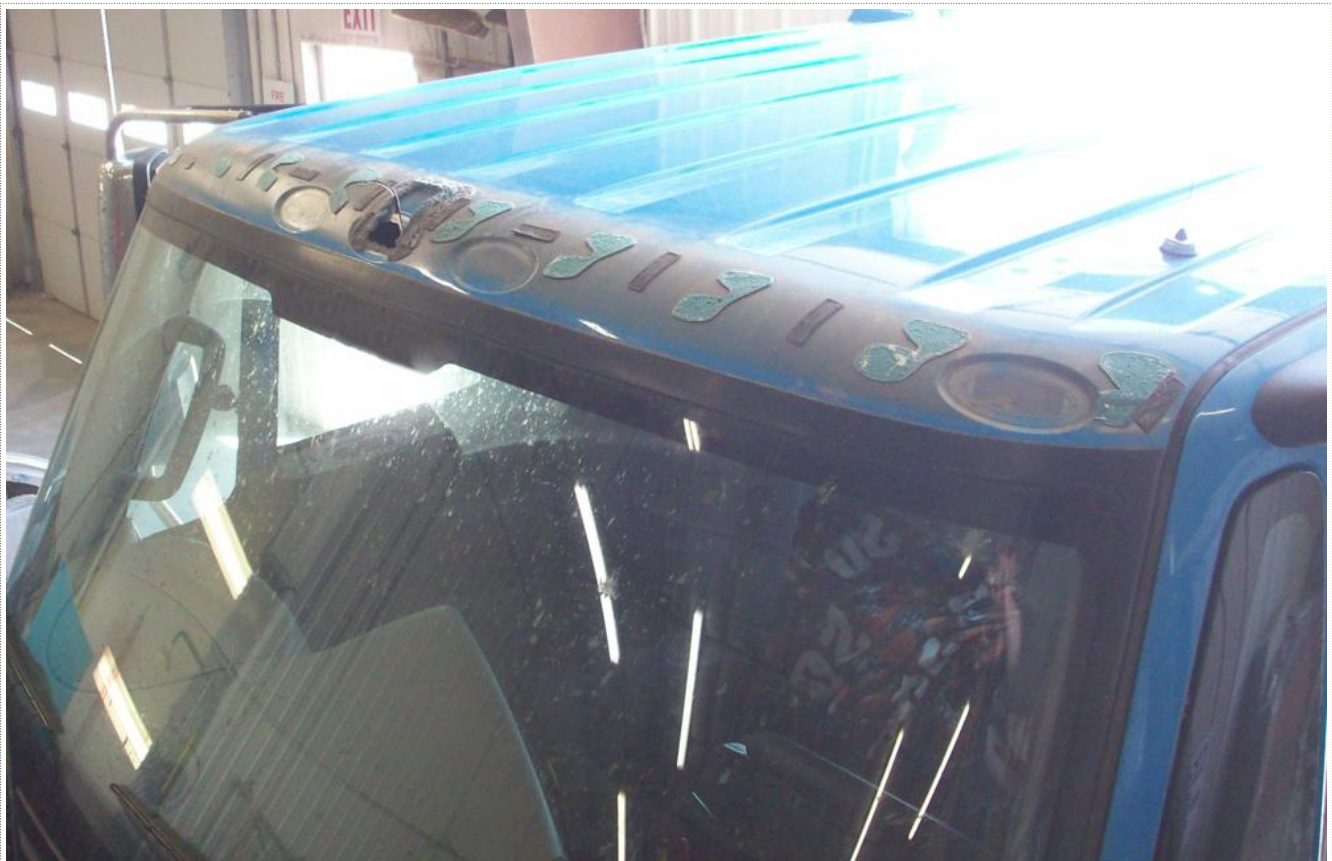
The one piece sunshade mounting bracket used on all model day cabs have been seeing instances where the adhesive patches fail and the sunshade mounting bracket becomes loose and/or comes completely off the vehicle.

The sunshade mounting bracket has completely detached from the vehicle.

- For installation of the mounting bracket, remove any remaining adhesive from cab roof, prime/paint the attachment area, and reinstall the new mounting bracket using Lord Fusor 120, T20, or T21 SMC Repair Adhesive. Then seal the perimeter with an all weather adhesive/sealant such as SikaFlex 221.

- For removal and installation of the sunshade to the bracket [CLICK HERE](#)
- If the bracket has not come off yet but is loose or in the process of detaching, follow the above procedure to repair. If the old bracket is not damaged during removal, just remove the adhesive patches from the mounting surface and reuse, otherwise reinstall with a new mounting bracket.

- Note: The sunshade mount can be removed successfully by heating the sunshade mount with a small heating device while gently lifting the sunshade mount with trim removal tools. It is not necessary to remove the inner trim of the cab. CAUTION: DO NOT GET TOO CLOSE WITH THE SMALL TORCH OR HEAT GUN. DAMAGE TO THE PAINT WILL RESULT. PAINT REPAIRS WILL THEN HAVE TO BE MADE.

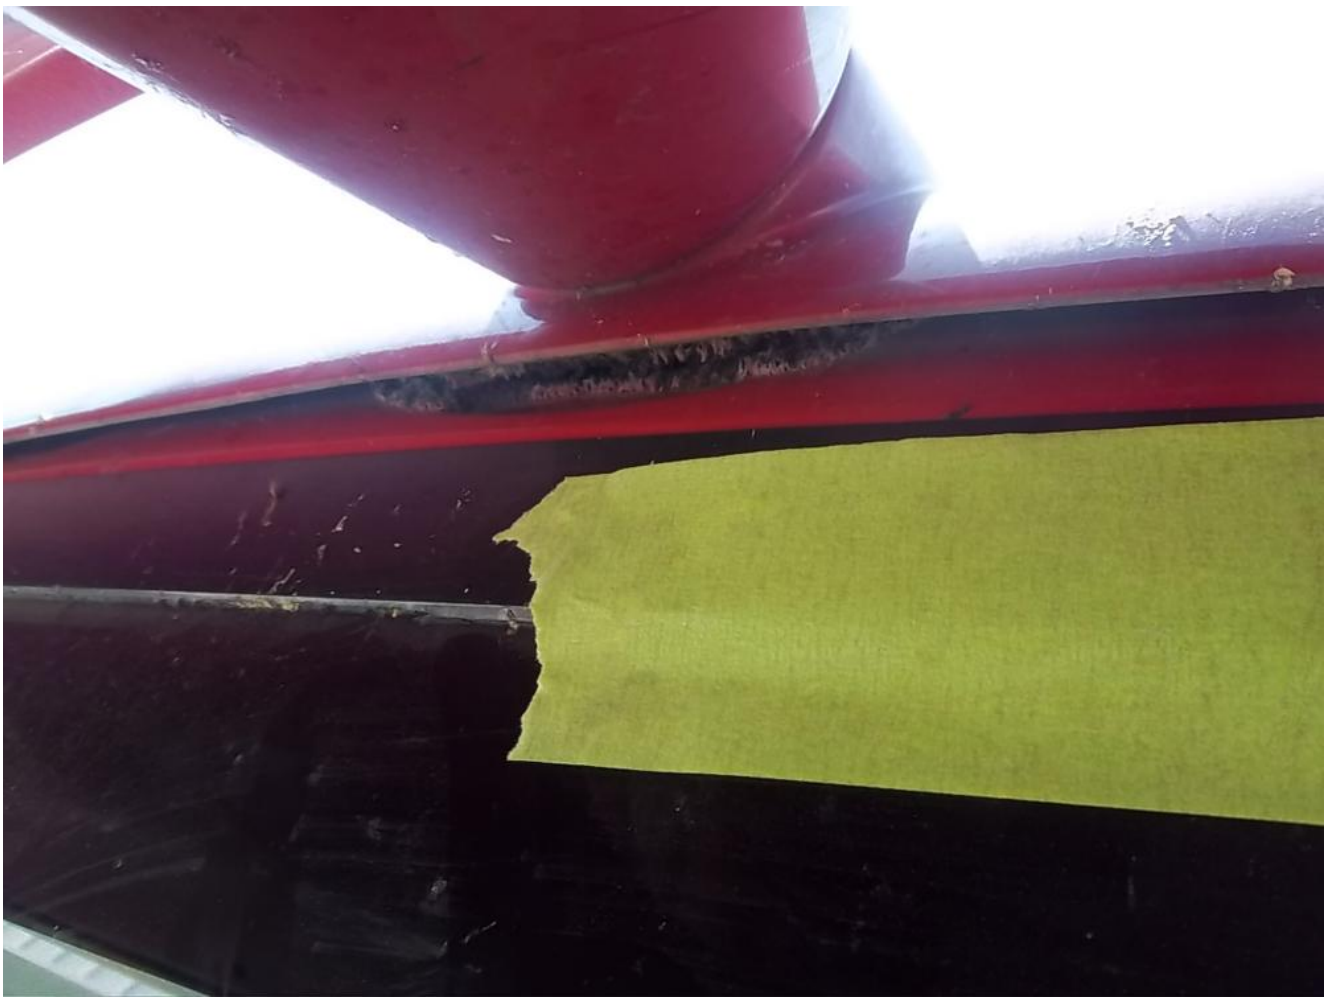
The sunshade mounting bracket is starting to come loose from the vehicle - the adhesive patch at the center mount is pulling apart.
