**MIN – 13103**28 February 2013

This procedure applies ONLY to certain WorkStar® trucks with MaxxForce® 9 engines and flagged with MIN # 13103. All other vehicles built during this period have either been repaired prior to shipment or determined not to require this repair procedure.

WorkStar® with MaxxForce® 9

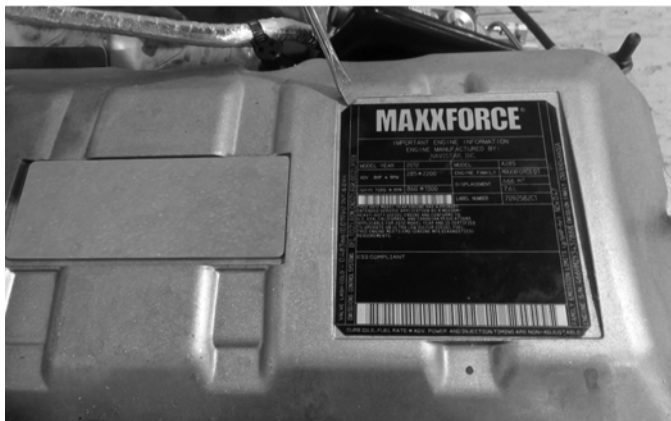
**Figure 1. Emissions Label Removal.**

This MIN applies to certain WorkStar® trucks with MaxxForce® 9 engines that were built 8 February 2012 through 9 January 2013. This procedure is required ONLY for the vehicles coded in Service Portal<sup>SM</sup> system with MIN # 13103. Vehicles involved in this campaign were released from assembly plants with incorrect engine emissions labels. These vehicles will require a new EPA emissions label to be affixed to the engine.

2. Remove International Emissions Control Information Label (Figure 1) by lifting one corner with gasket scraper or screwdriver.
