Triton Truck Concept

GROUP 00 – General

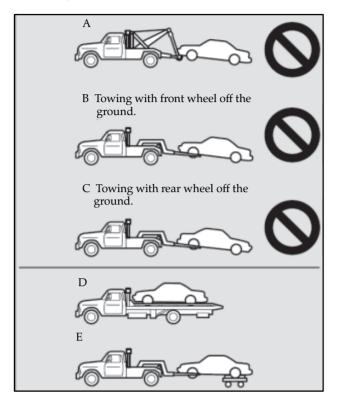
AWD models must be transported on a "flatbed" tow truck (D, above) or, at minimum, by using a "tow-dolly" on the non-lifted axle of the vehicle (E, above).

- This vehicle must not be towed by a tow truck using sling lift type equipment (Type A) as illustrated. Using a sling lift will damage the bumper and front end.
- Do not tow all-wheel drive vehicles with the front or rear wheels on the ground (Type B or Type C) as illustrated. This could result in the driving system damage or vehicle may jump at the carriage. If you tow all-wheel drive vehicles, use Type D or Type E equipment.

If you suspect that a drive train issue may be due to improper towing, consult with your DPSM <u>before</u> beginning any repairs.

Damage to drivetrain components caused by improper towing is not covered under warranty.
