## Service Campaign 63-04

**AFFECTED:** Certain 2013 Winnebago Sightseer/Vista and Itasca Sunova/Sunstar coaches equipped with motoraid

**SUBJECT:** Motoraid Hose Routing Near Engine

# Motoraid Heater Hose Routing

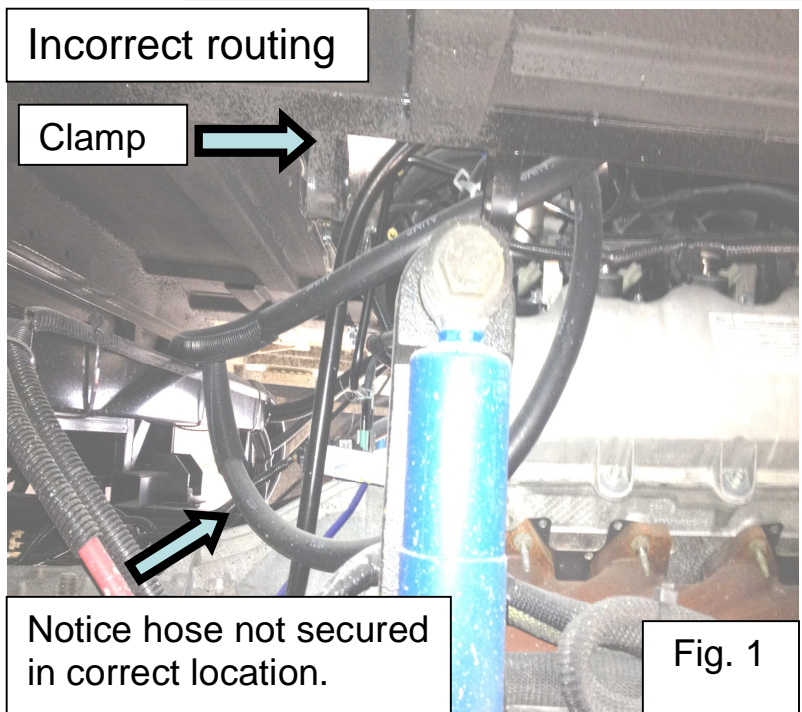
1. Inspect motoraid heater hose routing (fig.1). If hose is lying near engine manifold and not supported by clamp proceed to step 2.

**Note:** Repair hose with splice if damaged.

2. Install hose into clamp, (fig. 1). Fasten any excess hose securely to channel at rear of engine with wire ties. Make sure to keep hose away from any sharp edges (fig. 2).
