NUMBER: 26-001-13 REV. A

Dodge Dart Racetrack Lighting Customer Initiative

This bulletin involves removing and replacing the center rear lamp secured to the decklid assembly after disclosing promotional pricing the customer will be responsible for.

2013 (PF) Dart (U.S. Markets Only)

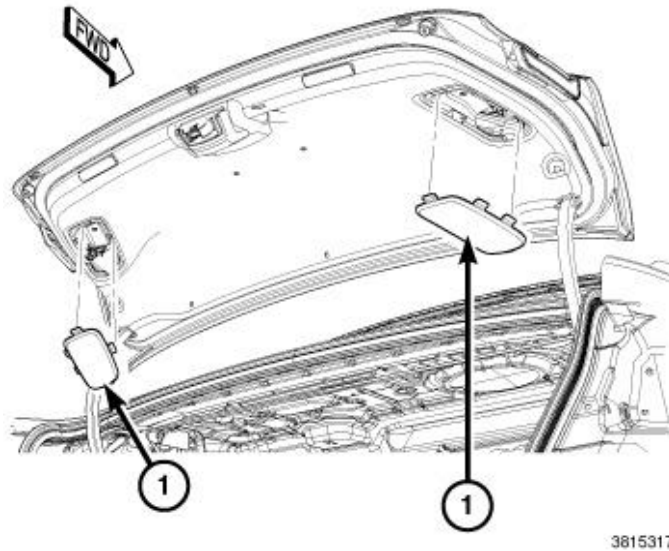
Fig. 1 Access Covers

1. Open the deck lid.
2. Disconnect and isolate the battery negative cable.
3. Using Trim Stick C-4755 , remove the access covers (1) from the decklid insulator/trim panel (Fig. 1).

1 - Access Covers

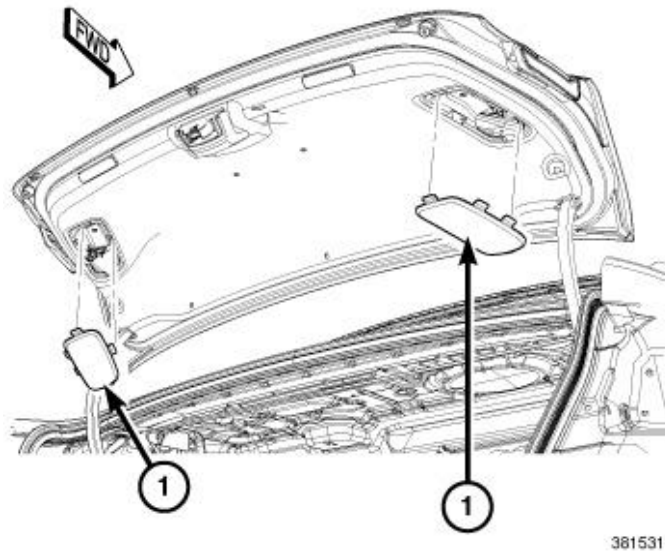
Fig. 12 Access Covers

26. Install the access covers (1) to the decklid insulator/trim panel (Fig. 12).

- 1 - Access Covers
