SERVICE BULLETIN

EM10-002b

ALTIMA SEDAN AND COUPE, SENTRA, AND ROGUE WITH QR25DE ENGINE; OIL LEAK

APPLIED VEHICLES: 2007 - 2012 Altima Sedan (L32)
2008 - 2013 Altima Coupe (CL32)
2007 - 2012 Sentra (B16)
2008 - 2013 Rogue (S35)

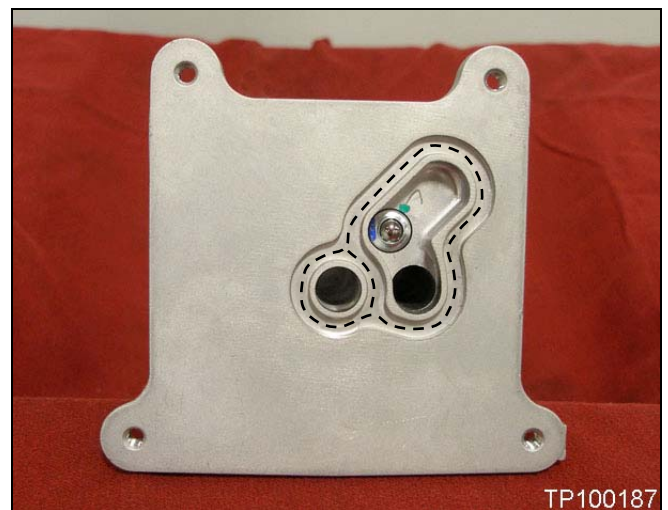
3. Remove the O-ring gasket, and then thoroughly clean out the gasket area and around it with a suitable cleaner.
 - The dashed line in Figure 3 shows the O-ring gasket area to be cleaned.
 - Make sure no debris or contaminants get into the holes.
 - Also clean underneath the upper half of the oil cooler (no picture shown).

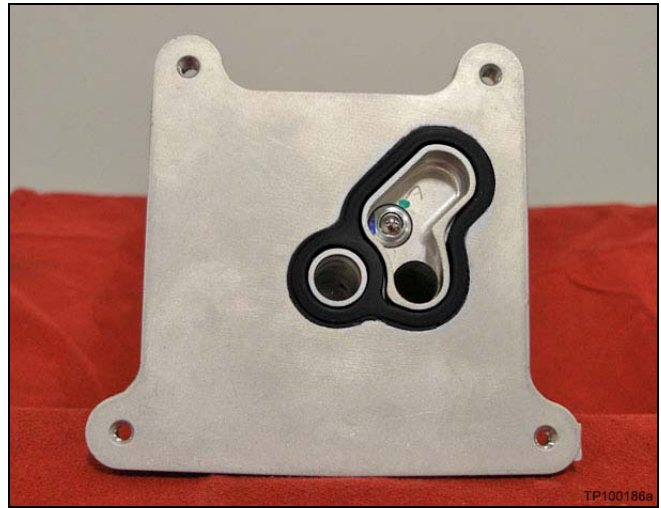
Figure 4

4. Lightly coat the new O-ring gasket (see **PARTS INFORMATION**) with engine oil, and then put it in place. See Figure 4.
