SERVICE BULLETIN

2013 ALTIMA NAVIGATION DISPLAY GOES BLANK, AND/OR iPod AUDIOBOOKS PLAY AT 2x SPEED

APPLIED VEHICLES: 2013 Altima (L33) equipped with navigation system.

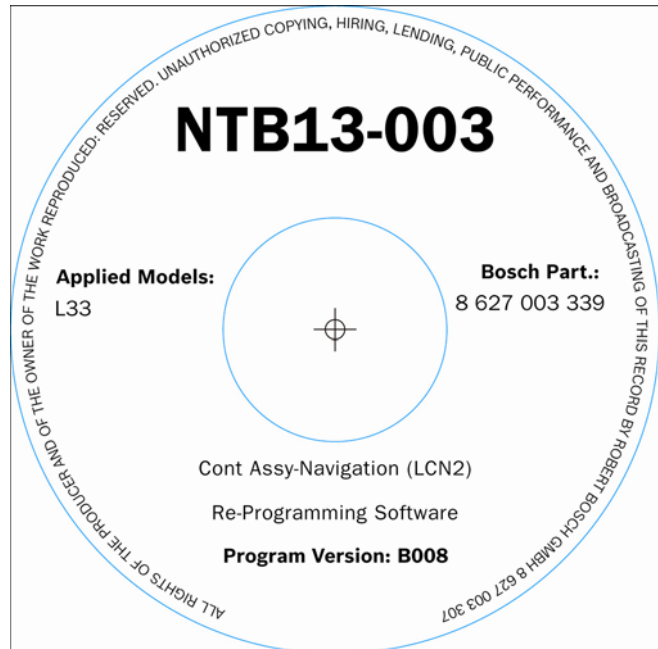
Figure A

Reprogramming software Disc required for this procedure:

- Each dealer has been mailed one NTB13-003 Reprogramming Disc free of charge, from Bosch.
- Should you require an additional disc due to loss or damage, it can be ordered free of charge by using the Bosch version of the “Nissan Audio Direct Exchange Order Form” available on <http://www.NNAnet.com>

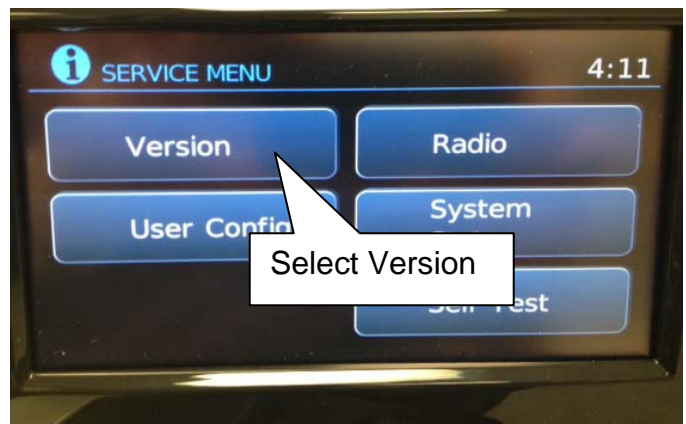
Figure 1

4. Turn the audio system OFF.
5. Access the Service Menu as follows.
 - a. Push and hold the **MENU** button.
 - b. Turn the **TUNE-SCROLL** knob:
 - Counterclockwise 3 or more clicks, then
 - Clockwise 3 or more clicks, then
 - Counterclockwise 3 or more clicks, then
 - Clockwise 3 or more clicks, then
 - Repeat the above turns until the SERVICE MENU screen is displayed (see Figure 1).

- a. Push and hold the **MENU** button.
- b. Turn the **TUNE-SCROLL** knob:
 - Counterclockwise 3 or more clicks, then
 - Clockwise 3 or more clicks, then
 - Counterclockwise 3 or more clicks, then
 - Clockwise 3 or more clicks, then
 - Repeat the above turns until the SERVICE MENU screen is displayed (see Figure 1).

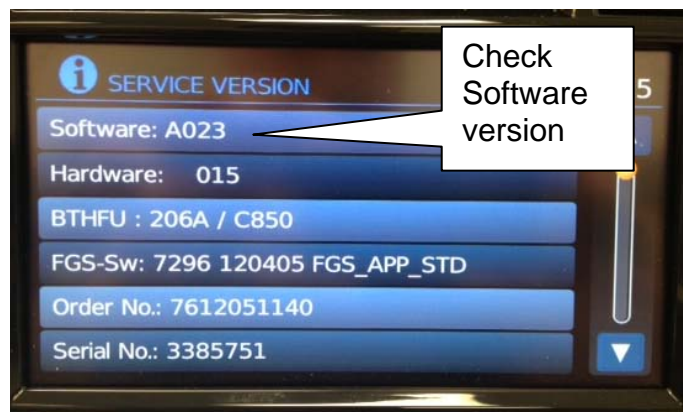
Figure 2

7. Check the **Software** version.
 - Make sure the version is **A023**.
 - If the version is anything other than A023, this bulletin does not apply. **Do not** install NTB13-003 reprogramming disc.

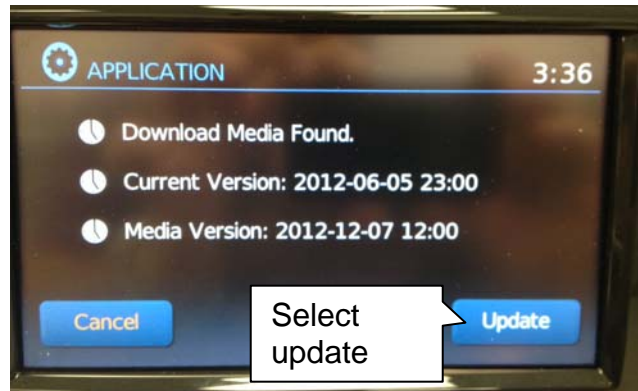
Figure 3

9. Wait for the **APPLICATION** screen to appear.

10. Make sure the Current Version and Media Version are different.

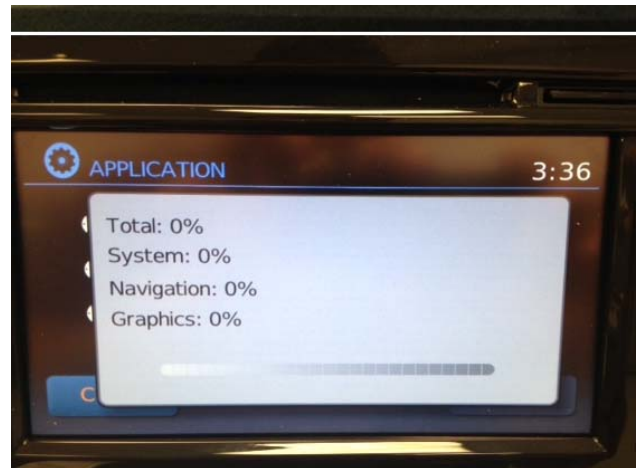
- First, the screen in Figure 4 will be displayed for several minutes,
- Then the screen in Figure 5 will display for several minutes.
- Do not touch any switches, buttons, knobs, or the ignition during the update process.

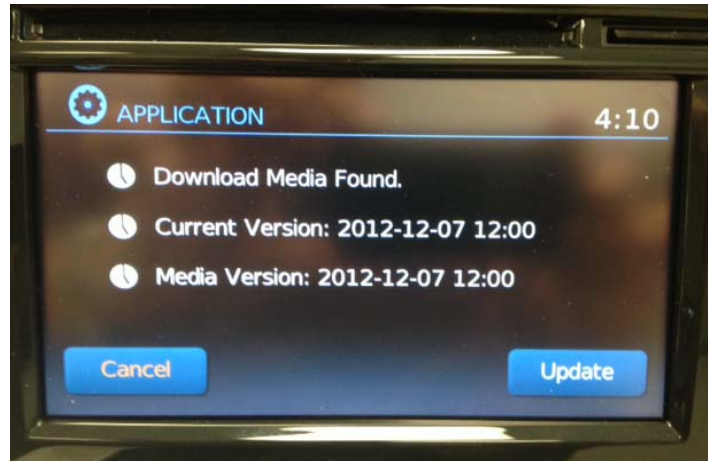
Figure 6

13. When the update is complete the Application screen will again display.

14. The Current Version and Media Version should be the same.

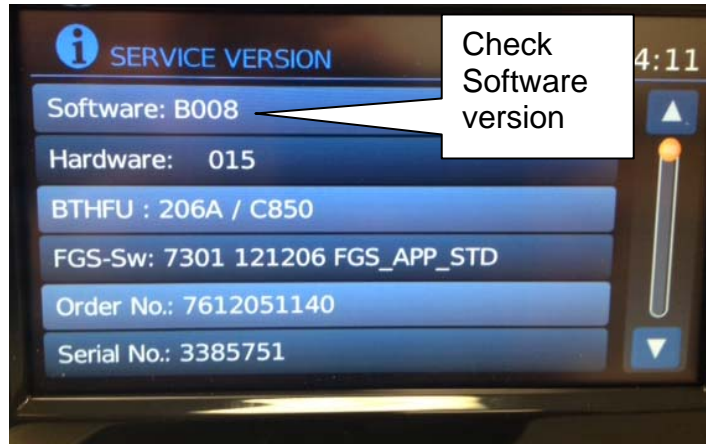
Figure 8

- Make sure the version is now **B008**.
- If the version is still A023, install the reprogramming disc again (steps 8 though 15).
