SERVICE CAMPAIGN BULLETIN

NTB13-025

VOLUNTARY SERVICE CAMPAIGN 2011 QUEST TOW HITCH INSPECTION

CAMPAIGN I.D.: PC196

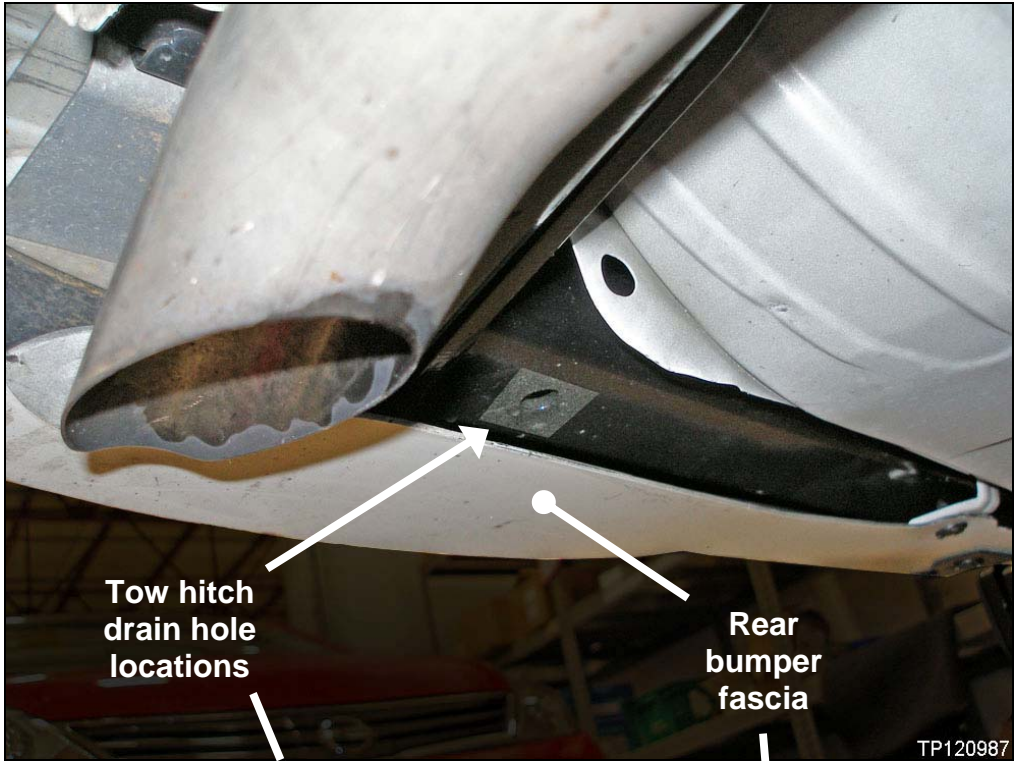
Passenger side

- The tow hitch does not have drain holes where shown on the next page.
 - If both apply, a part order approval is needed.
 - For part order approval, send the VIN, your dealer code and “facing” PDC, and clear pictures of the genuine Nissan accessory tow hitch without holes to nafgasupport@nissan-usa.com. You will get a return confirmation of approval to order the replacement tow hitch.

- There is a genuine Nissan accessory tow hitch with drain holes

WARNING: Be careful if inspecting from the passenger side. The exhaust tail pipe may be hot.

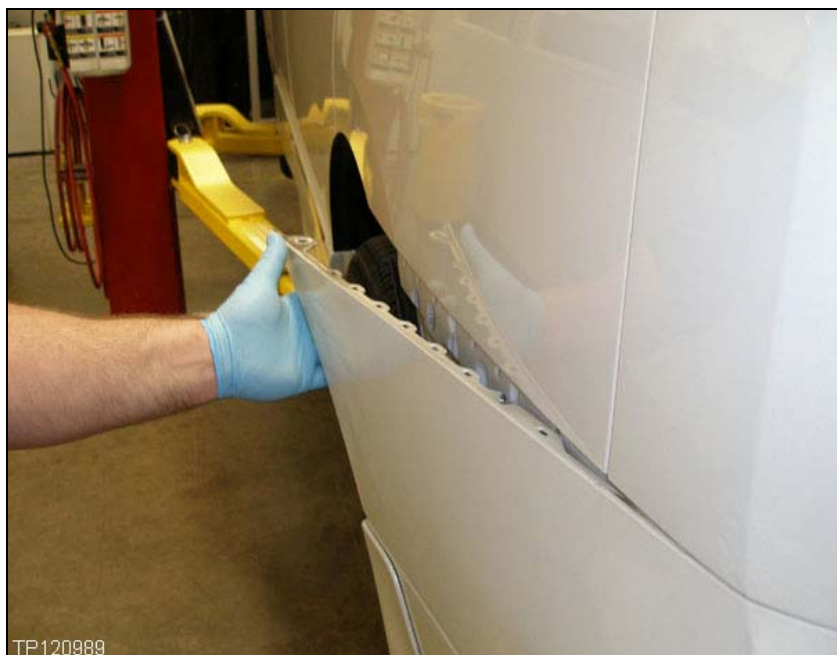
Figure 4

5. Carefully unfasten both sides of the rear bumper fascia by pulling outward.

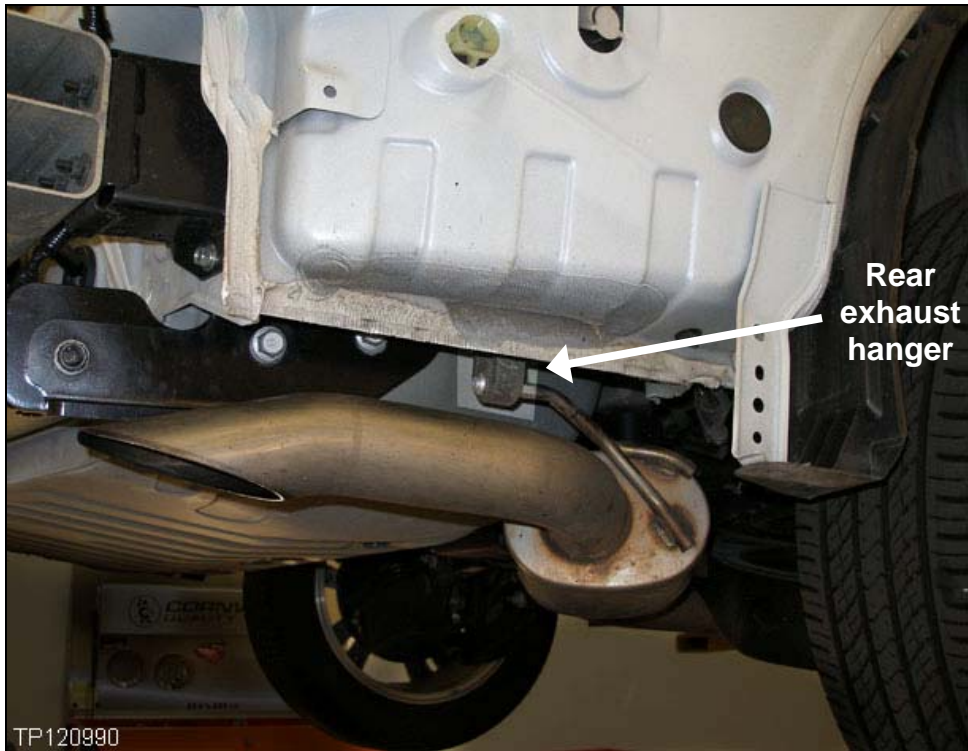
Figure 7

5. Unhook the rear exhaust hanger (for additional clearance).
