RECALL CAMPAIGN BULLETIN

NTB13-037

VOLUNTARY SAFETY RECALL 2013 NV AND TITAN BRAKE SHIFT INTERLOCK FOAM DAMPER

CAMPAIGN ID #: PC220
APPLIED VEHICLES: 2013 Titan (A60)
2013 NV (F80)
NHTSA #: 13V-094

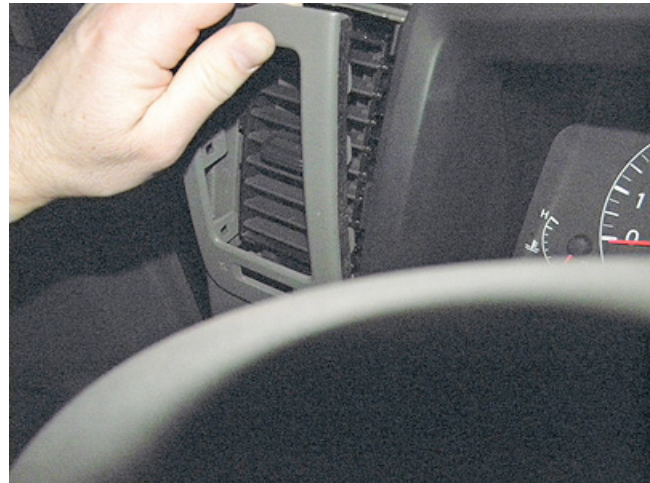
Figure 1

1. Remove driver's left side Ventilator Grille (left of combination meter).

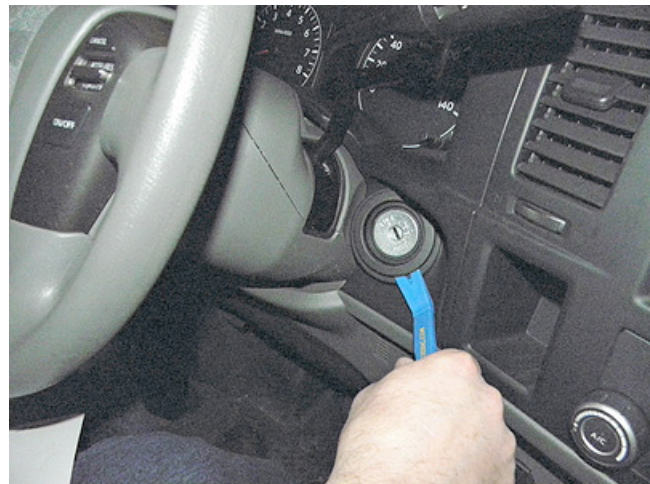
Figure 2

2. Remove Key Cylinder Escutcheon using plastic trim tool.

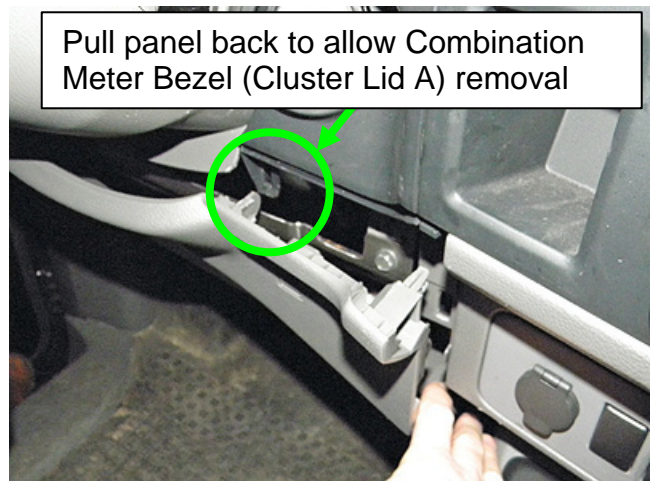
Figure 3

3. Disconnect upper portion of the Instrument Lower Panel, to the right side of the steering wheel.
 - Pull back to allow Combination Meter Bezel (Cluster Lid A) removal

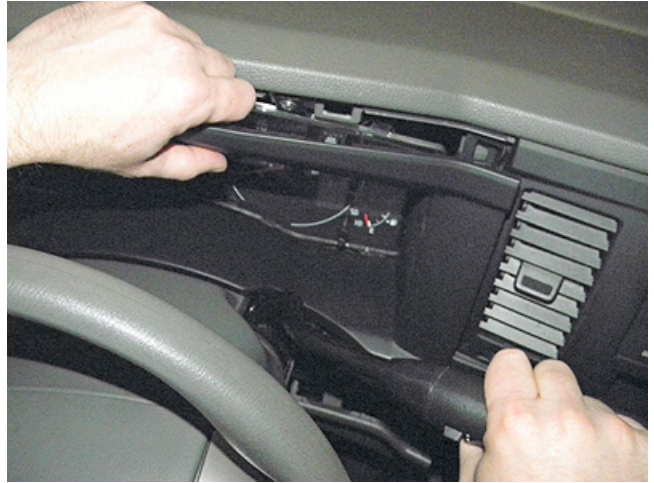
Figure 4

4. Remove Combination Meter Bezel (Cluster Lid A) using plastic trim tool.

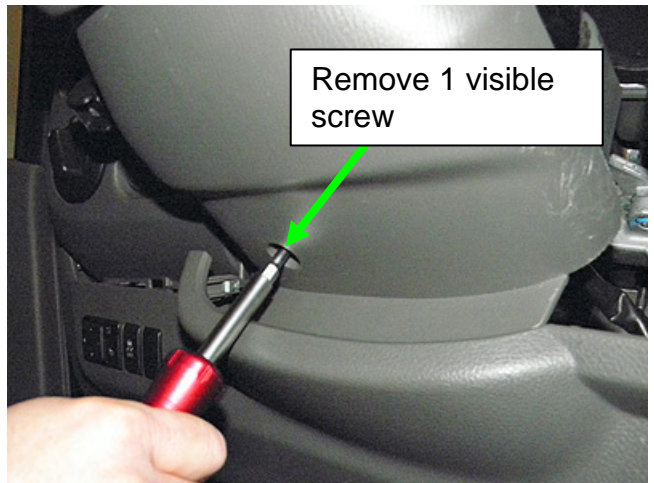
Figure 5

5. Remove 1 Phillips screw from bottom of Steering Column Covers trim.

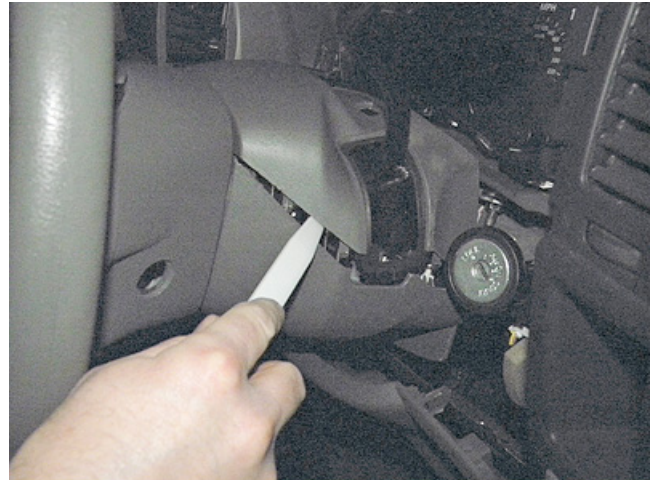
Figure 7

7. Separate and then remove upper portion of Steering Column Cover using a plastic trim tool.
