SERVICE BULLETIN

Classification: RS13-007	Reference: NTB13-044	Date: April 10, 2013
-----------------------------	-------------------------	-------------------------

2004 – 2006 TITAN KING CAB; AIR BAG LIGHT ON, SEAT BELT INOPERATIVE, OR REAR AUDIO SPEAKERS INOPERATIVE

APPLIED VEHICLES: 2004 – 2006 Titan (A60) King Cab models only

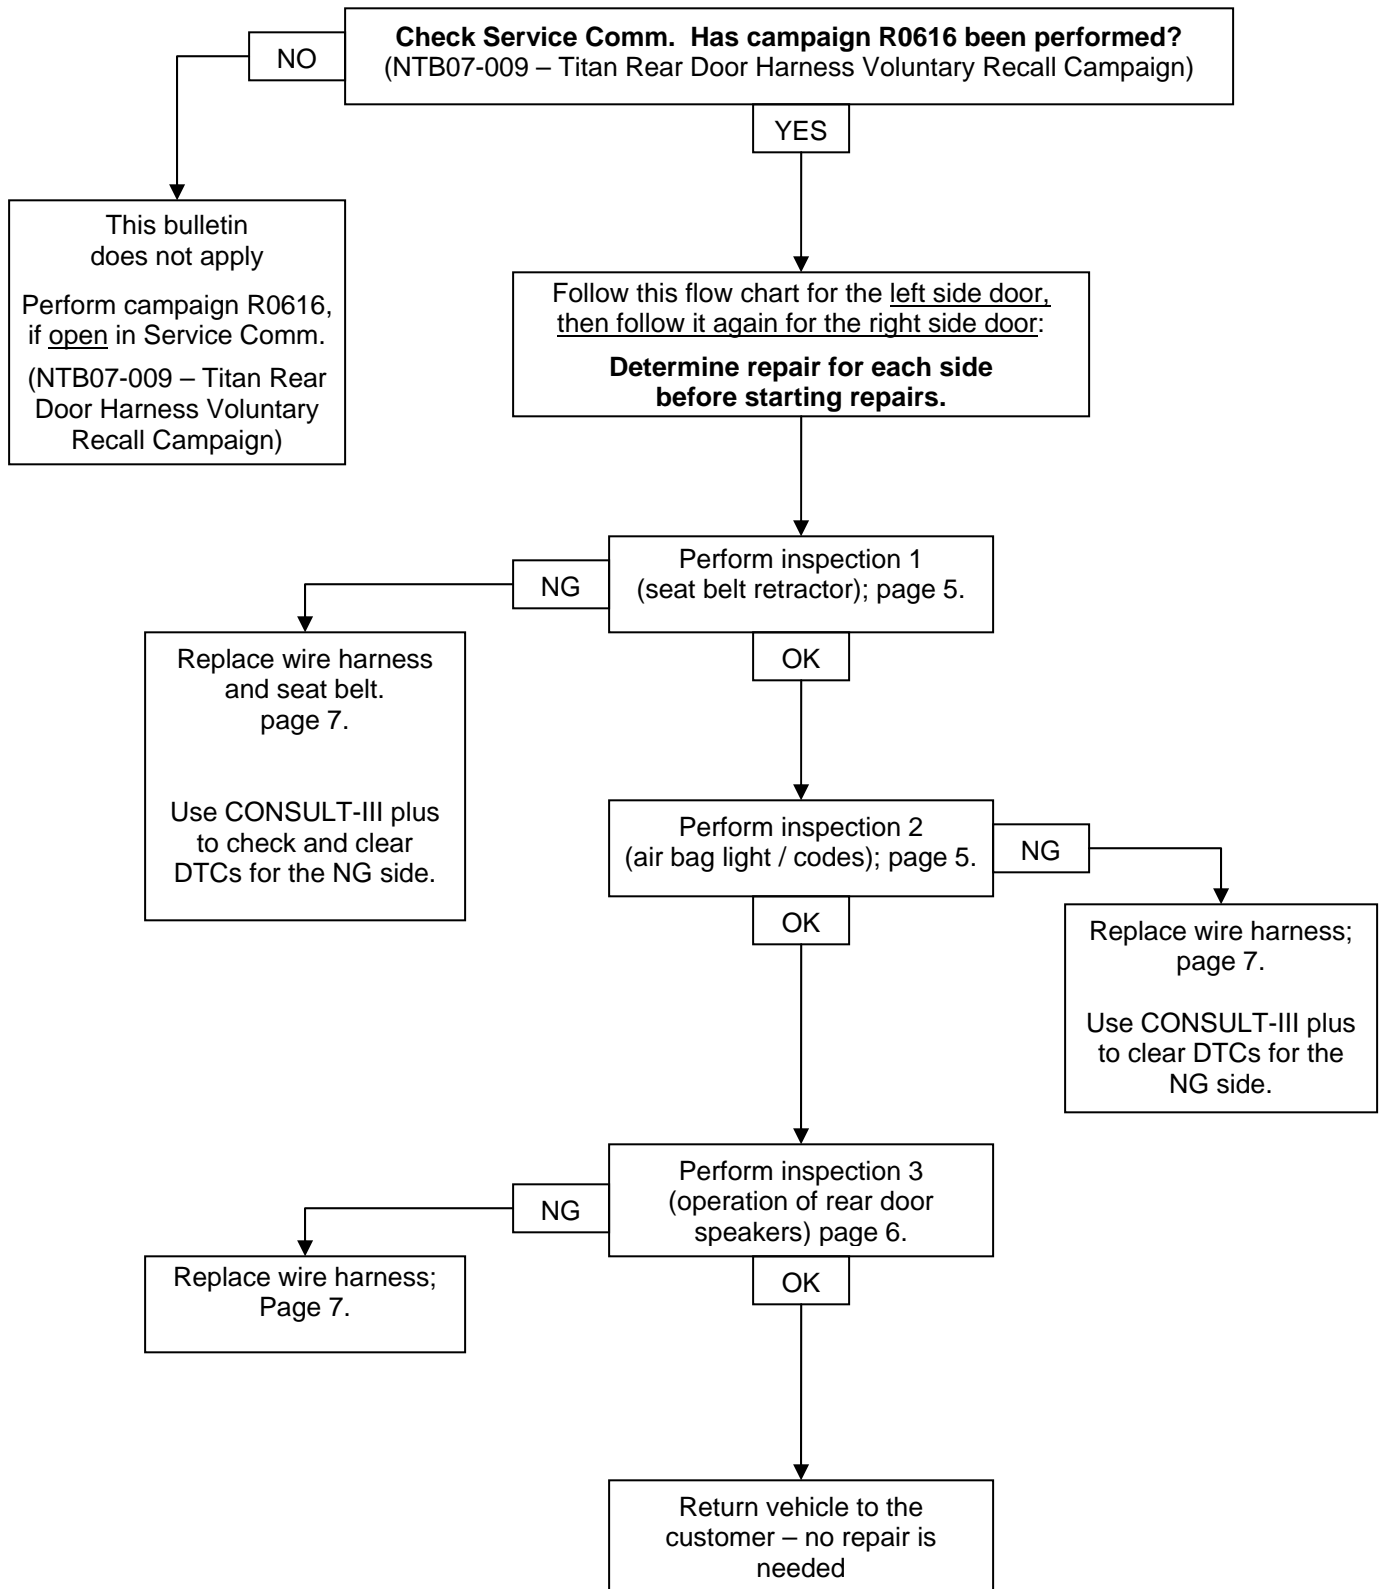
REPAIR FLOW-CHART

1. Check Service Comm to determine if Campaign R0616 has been performed.
 - If campaign R0616 has **not** been performed, this bulletin does not apply.
2. Follow the Repair Flow-Chart on the next page.

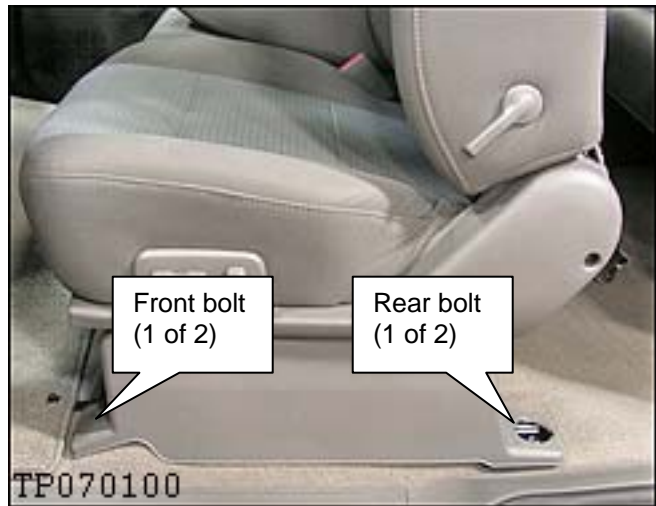
Figure C1

5. Remove the front seat.

- a. Remove the 4 seat mounting bolts.
- b. Disconnect all of the seat electrical connectors.
- c. Remove the seat from the vehicle and place it in a clean area.

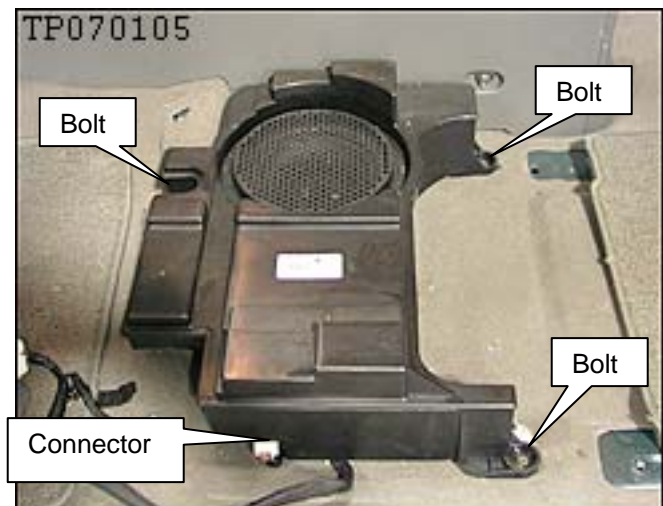
Figure C2

Sub Woofer—under driver's seat

- a. Disconnect the electrical connector.
- b. Remove the 3 mounting bolts.
- c. Remove the sub-woofer from the vehicle.

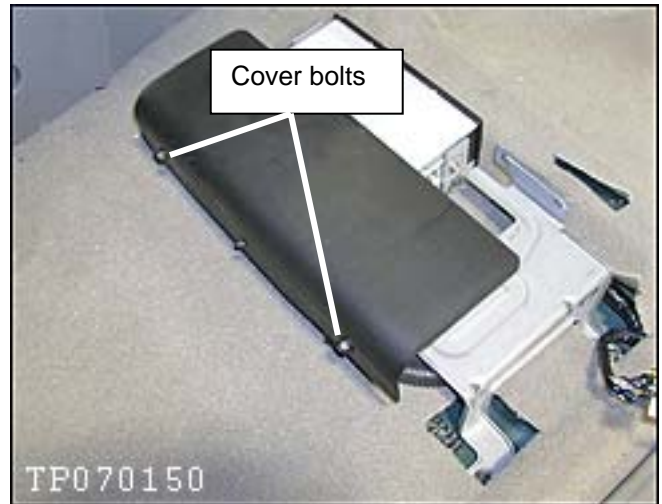
Figure C3

Navigation Control Unit—under passenger seat

- a. Remove the control unit cover; 2 bolts.

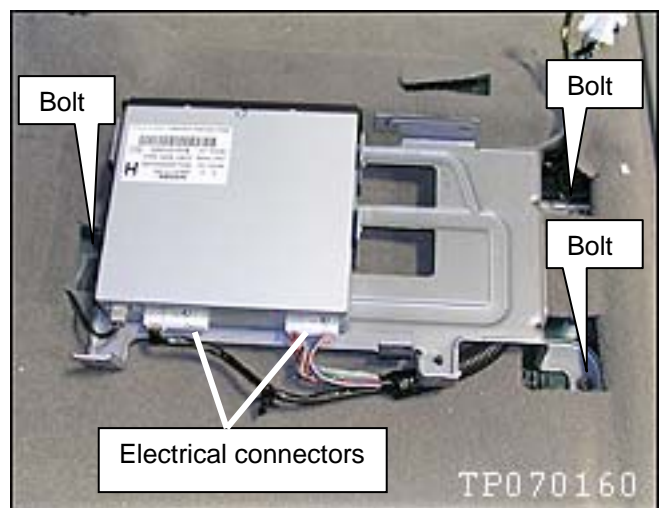
Figure C4

- b. Disconnect the electrical connectors.
- c. Remove the 3 mounting bolts.
- d. Remove the control unit from the vehicle.

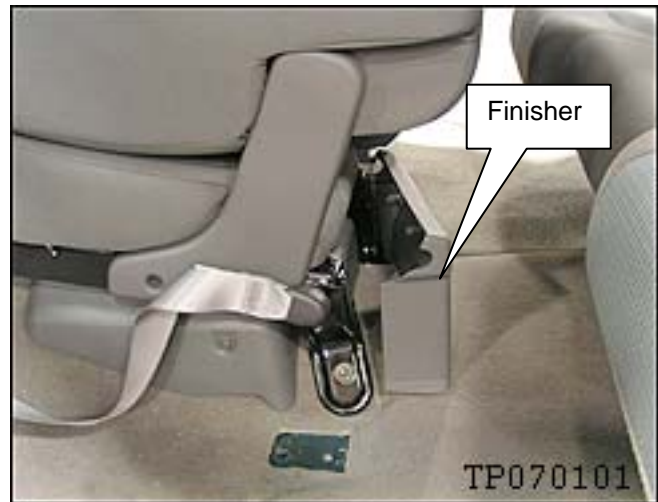
Figure C5

7. If equipped with front bench seat (shifter on steering column), remove the center seat and cup holder:

a. Remove the finisher at the rear of the center seat.

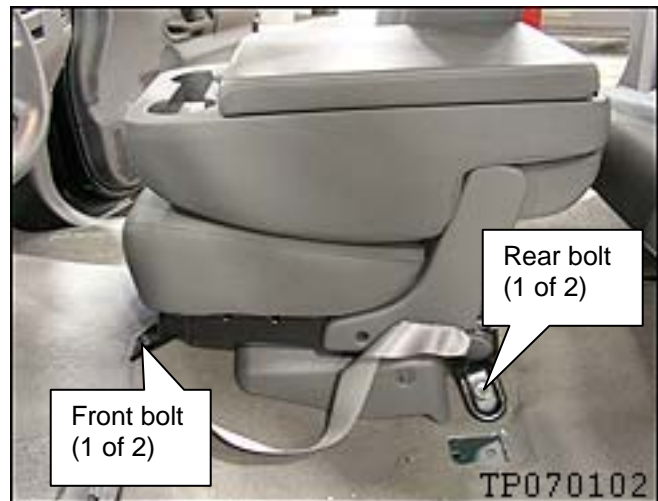
Figure C6

a. Remove the 4 center seat mounting bolts.
b. Remove the seat from the vehicle and place it in a clean area.

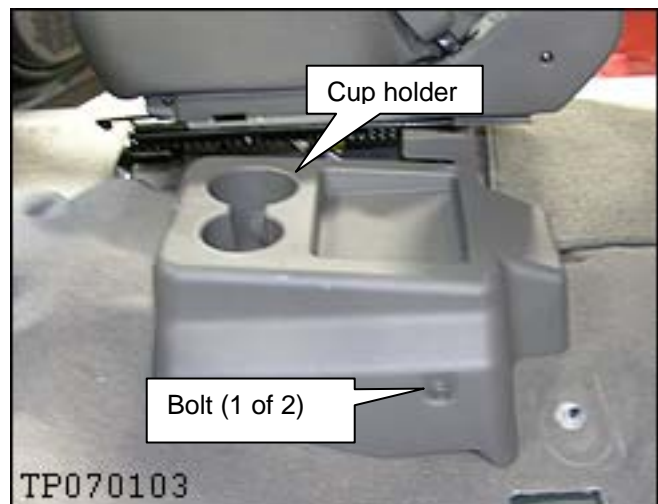
Figure C7

c. Remove 2 cup holder mounting bolts.
• Left side is shown, right side not shown
b. Remove the cup holder from the vehicle.

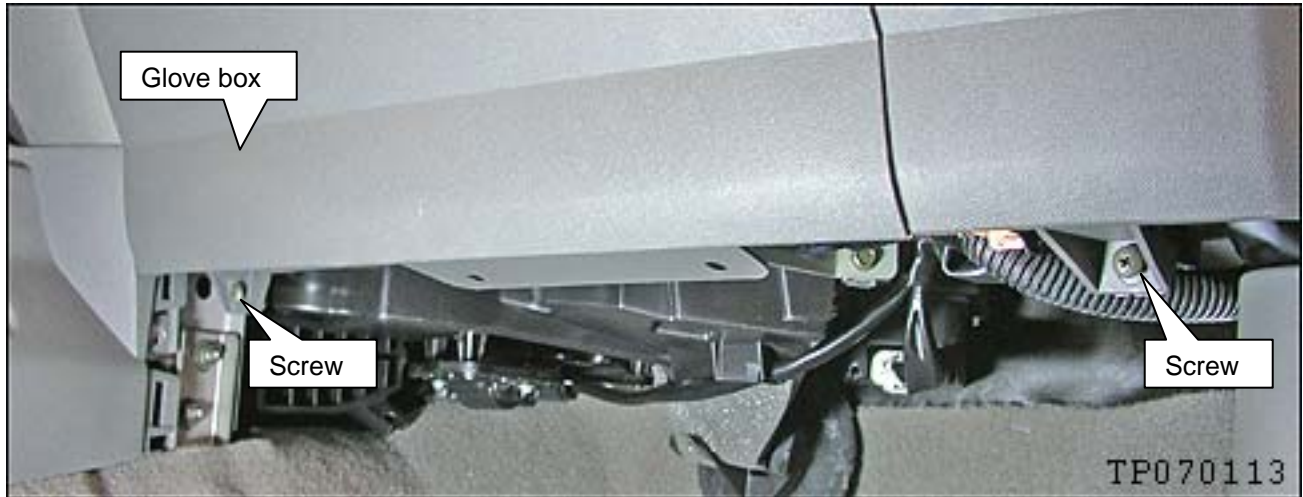
Figure C8

8. If equipped with front bucket seats (shifter is in the center console); remove the center console:
 - a. Remove 2 screws from the bottom of the glove box assembly.

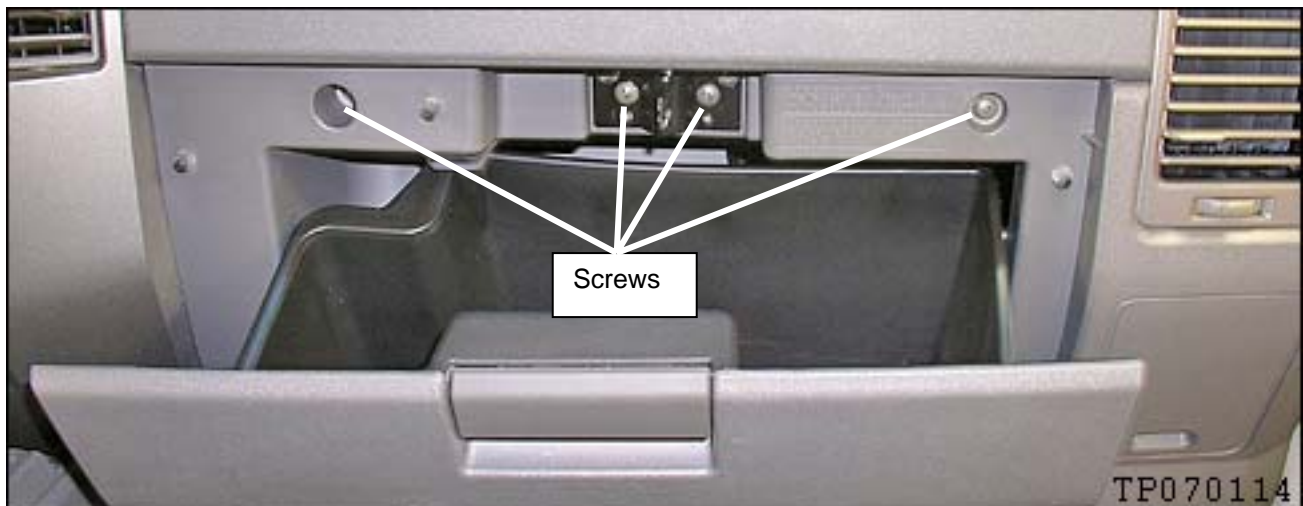
Figure C9

- b. Remove 4 screws at the top of the glove box assembly, then
 - c. Remove the glove box assembly.

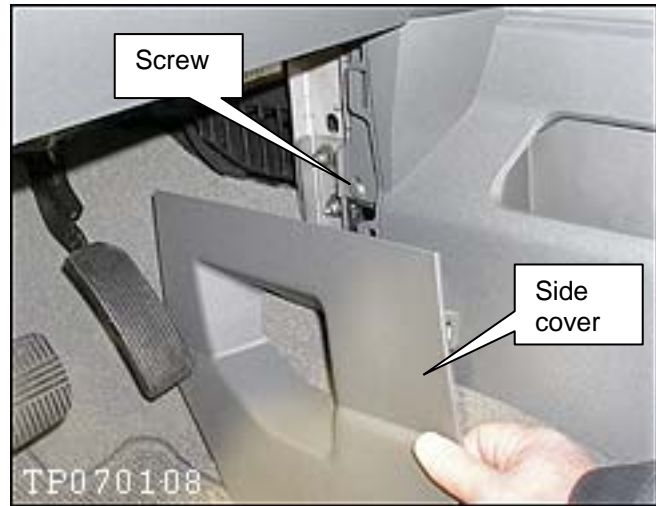
Figure C10

- d. At the front of the console; remove side covers and screws.
- Left side cover shown; remove right side cover also.
 - 1 screw on each side.

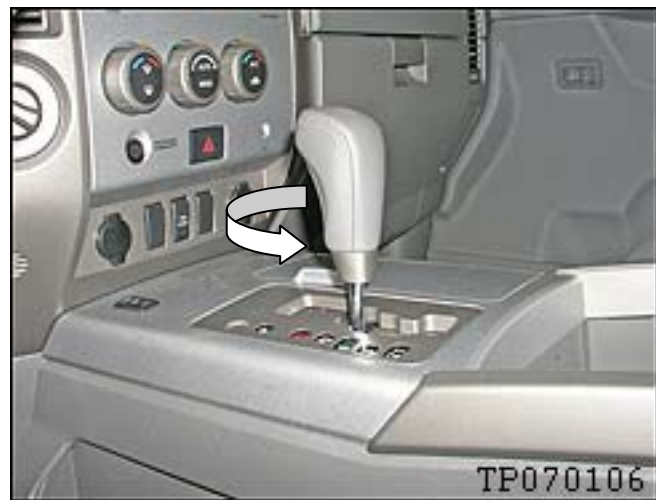
Figure C11

- e. Remove the shift knob; unscrew it counterclockwise.

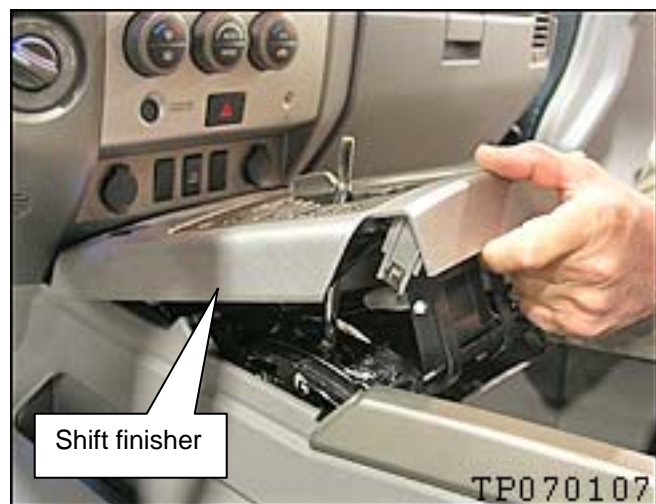
Figure C12

- f. Lift and remove the shift finisher.
- Disconnect electrical connectors.

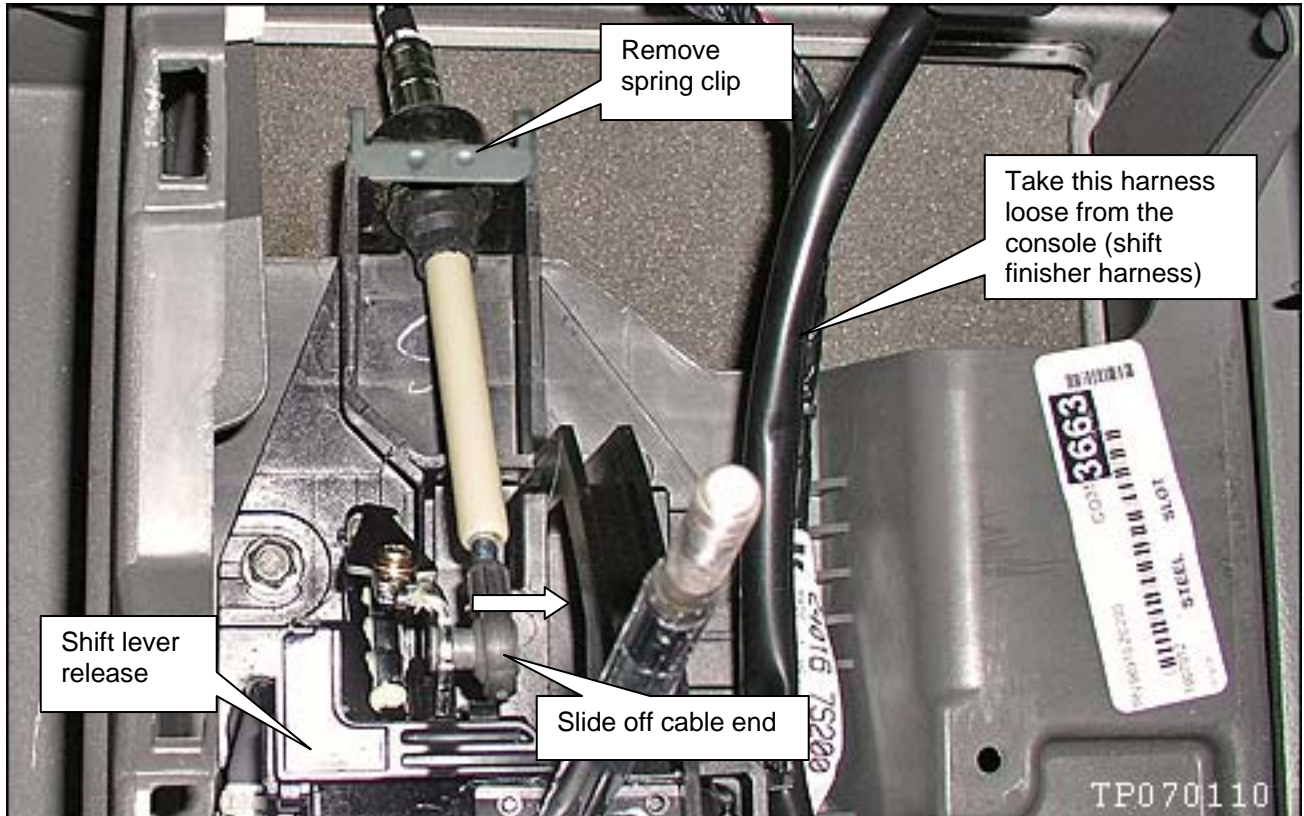
Figure C13

- g. Disconnect the shift cable.
 - Push the shift lever release to move shift lever to Park.
- h. Take the shift finisher harness loose from the console.

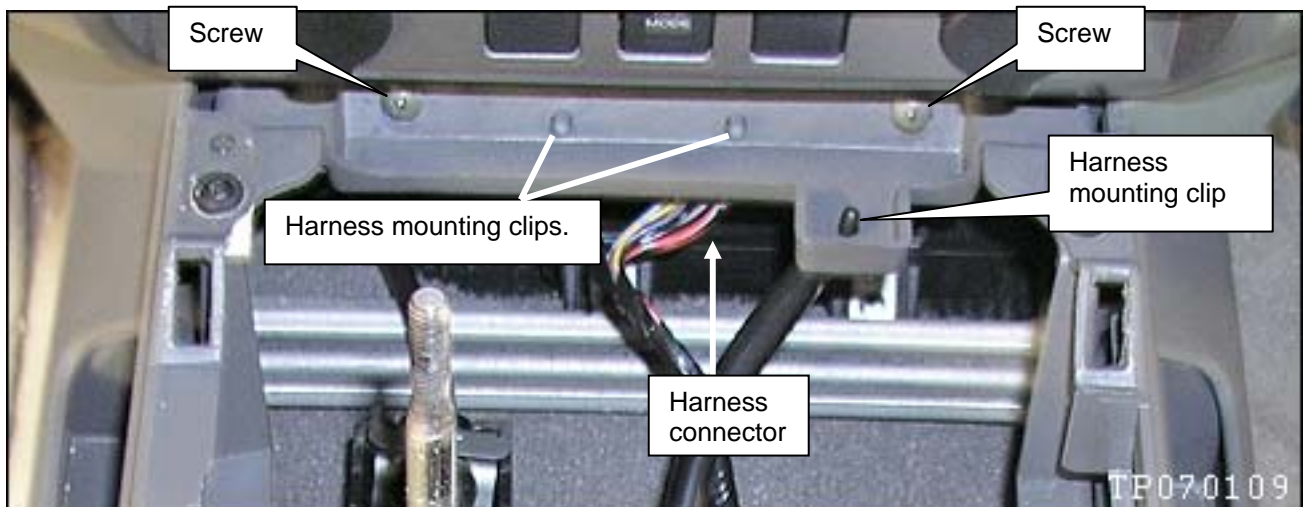
Figure C14

- i. At the front of the console, release harness mounting clips, disconnect harness connector, and remove 2 screws.

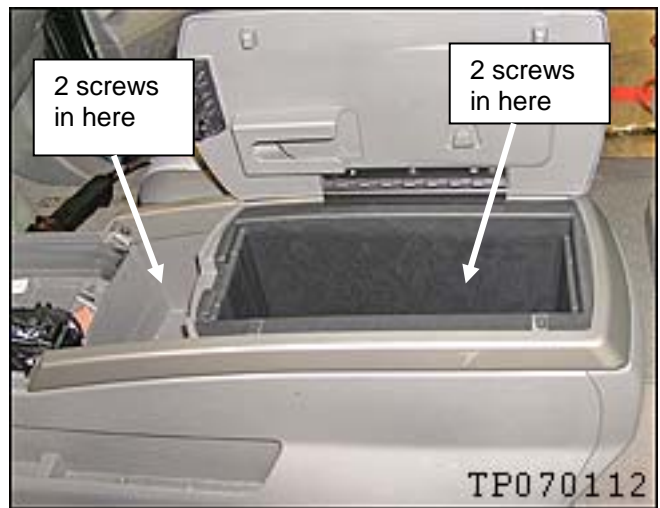
Figure C15

- j. Remove 4 screws from the bottom of the console compartments.

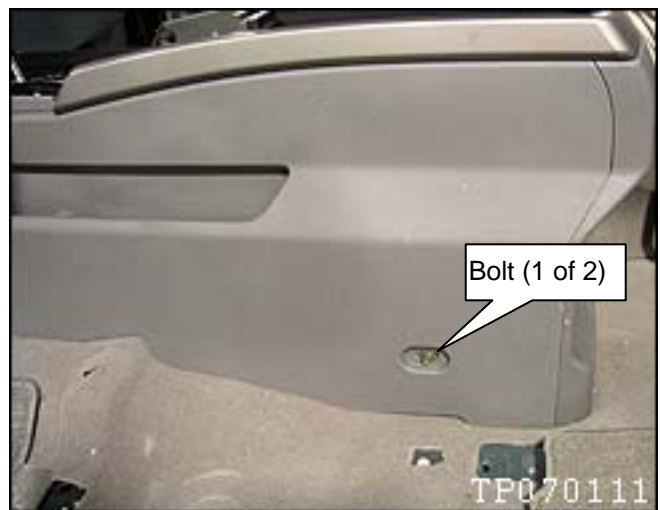
Figure C16

- k. Remove 2 bolts from the sides of the console.
- Left side is shown, right side not shown.

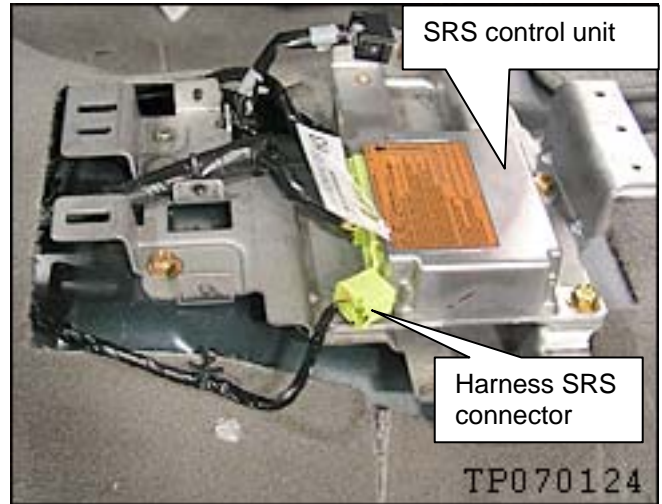
Figure C17

9. Disconnect the harness SRS connector from the SRS control unit.

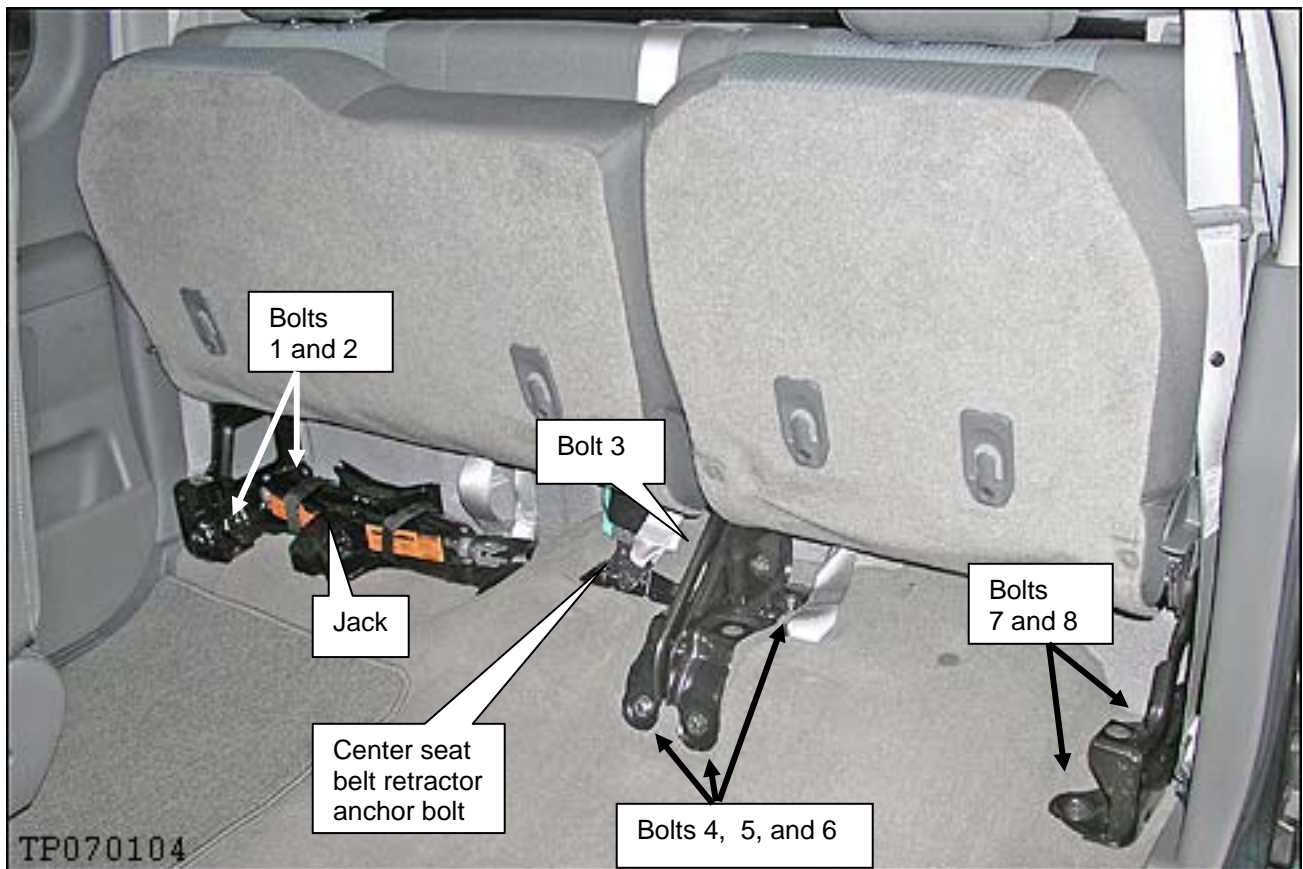
Figure C18

10. Remove the rear seat from the vehicle:
- Move the jack out of the way.
 - Remove the center seat belt retractor anchor bolt.
 - Remove the 8 seat mounting bolts.
 - Remove the seat from the vehicle and place it in a clean area.
- NOTE:** Use two people to lift the rear seat out of the vehicle.

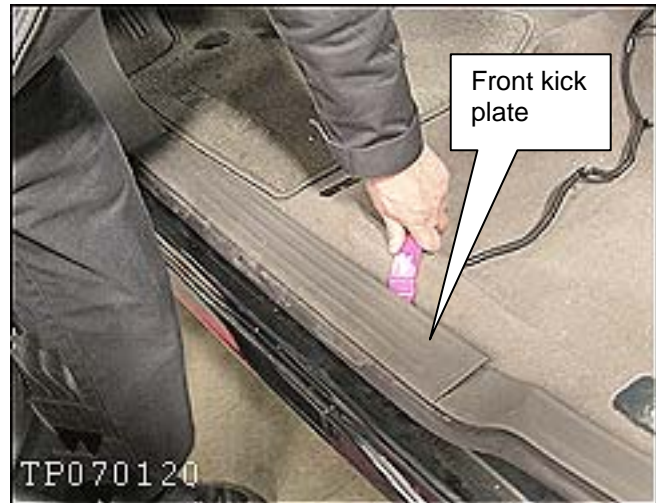
Figure C19

11. Remove the front kick plate.

- Use a plastic trim tool to snap it loose.

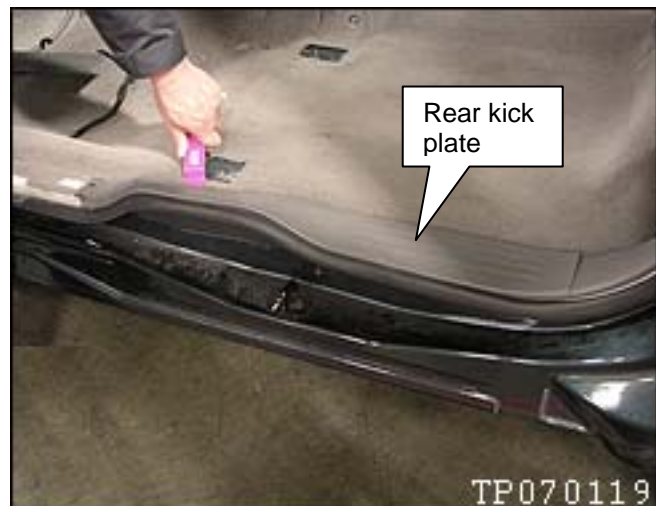
Figure C20

12. Remove the rear kick plate;

- Use a plastic trim tool to snap it loose.

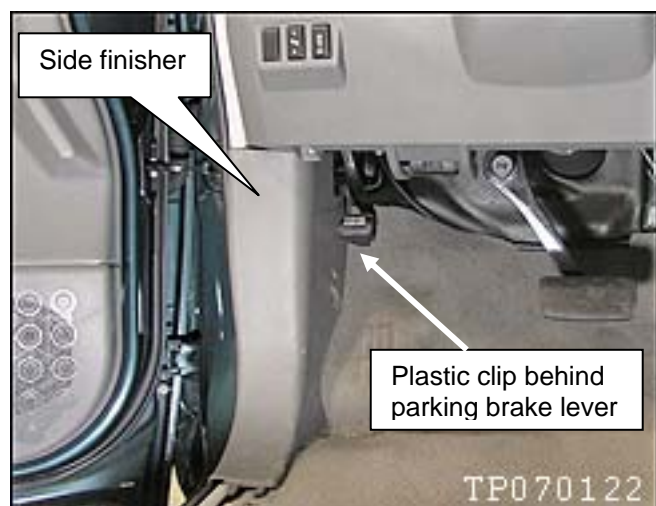
Figure C21

13. Remove the lower dash side finisher.

- There is a plastic clip behind the parking brake lever.

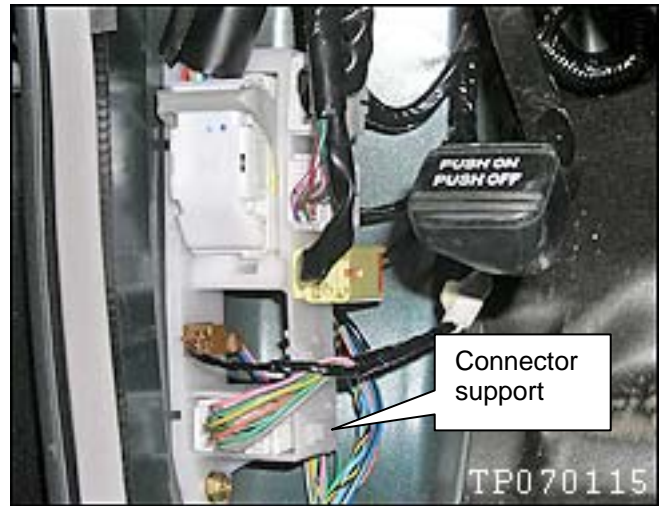
Figure C22

14. Disconnect each of the electrical connectors on the connector support.

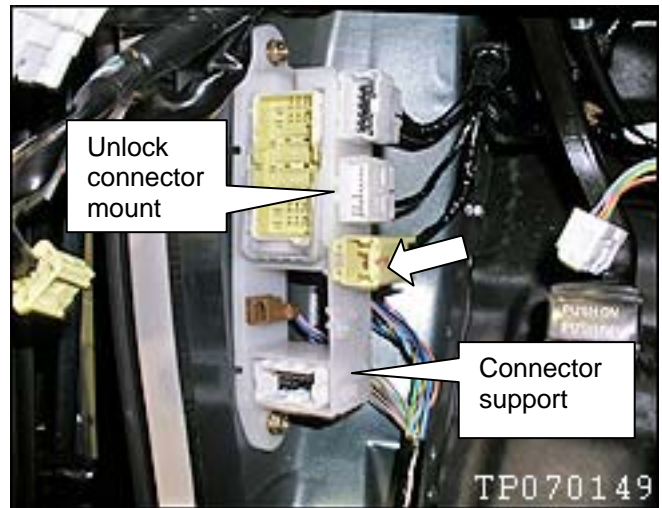
Figure C23

15. Remove the connector support.

For each connector that is not part of the body harness:

- a. Use a small flat blade screwdriver to unlock the connector mounts,
- b. Then slide the connectors forward to remove them from the connector support.

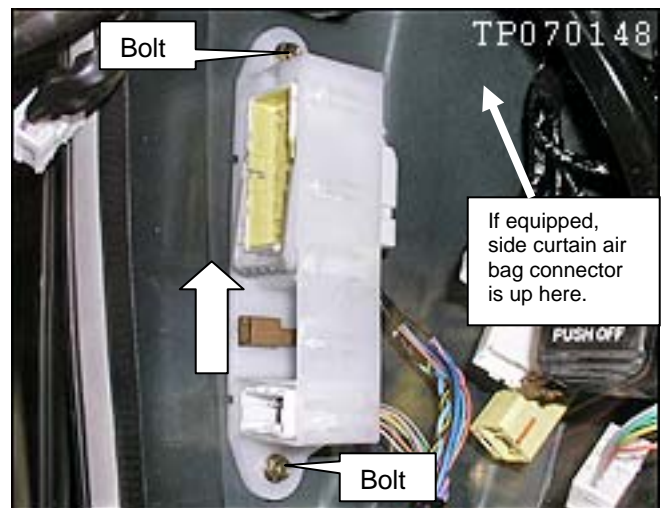
Figure C24

- c. Remove the 2 connector support bolts.
- d. Slide the connector support UP to remove it.

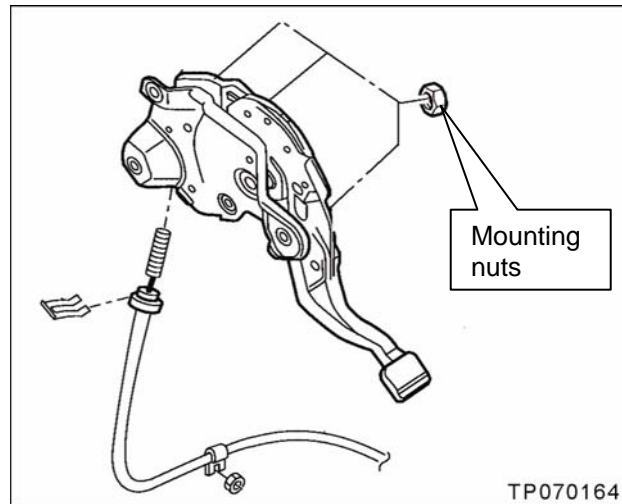
Figure C25

- a. Remove the 3 mounting nuts for the parking brake pedal assembly and move the assembly out of the way.

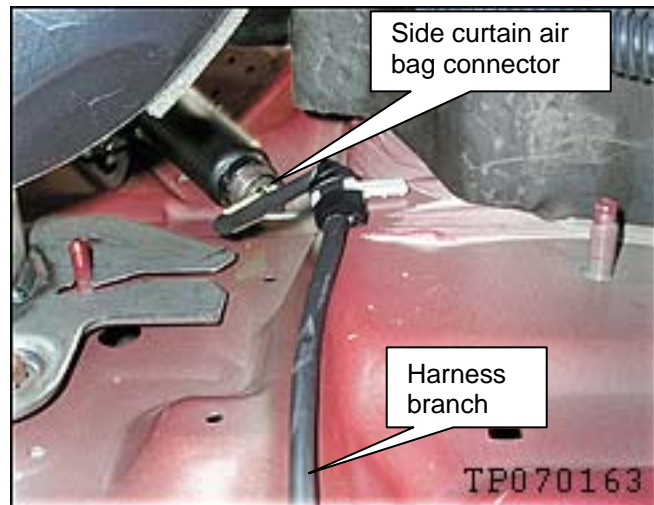
Figure C26

- b. From the floor, look up towards the front pillar and locate the side curtain air bag connector.
- c. Disconnect the side curtain air bag.
- d. Take the harness branch loose from the body.

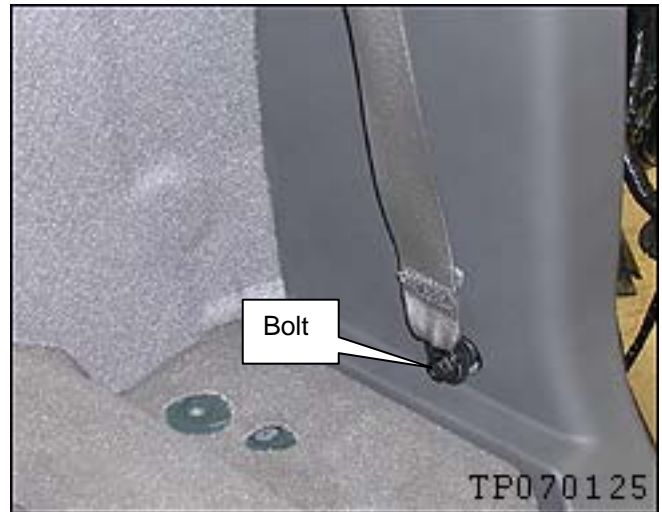
Figure C27

17. Remove the lower anchor bolt for the rear seat belt.

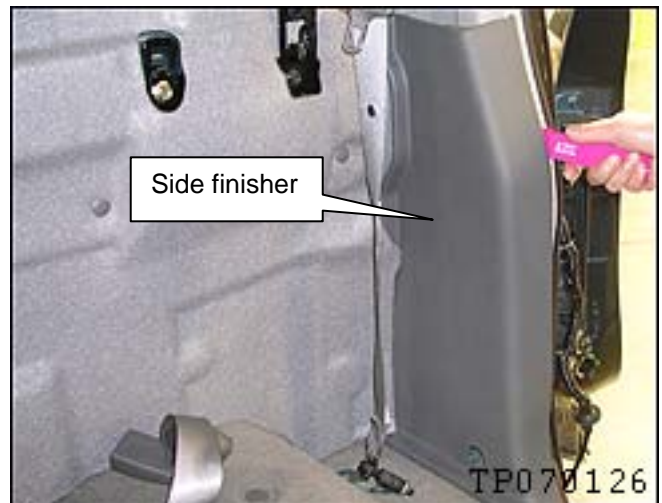
Figure C28

18. Remove the lower side finisher.

- Use a plastic trim tool.

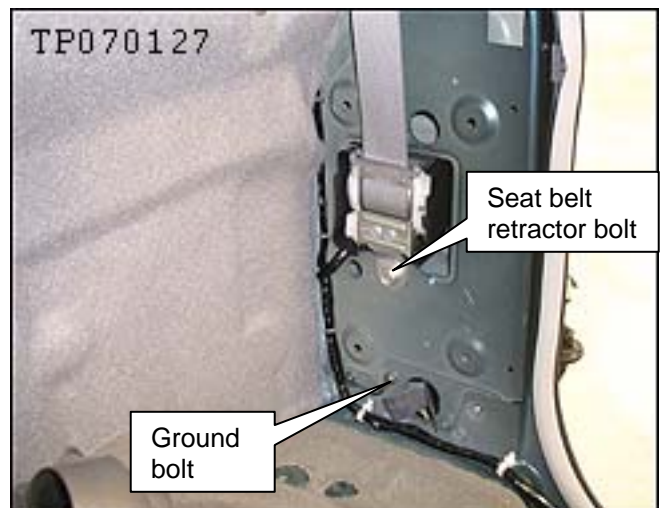
Figure C29

19. Remove the seat belt retractor; 1 bolt.

20. Remove the harness ground bolt.

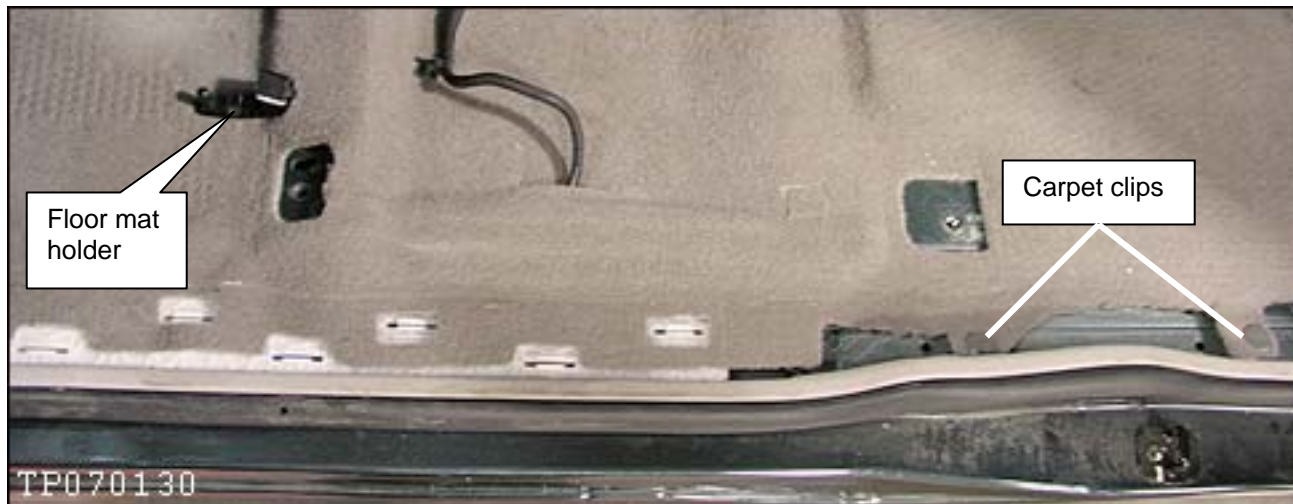
Figure C30

21. Remove the floor mat holder.

22. Remove the carpet clips shown in the figure below.

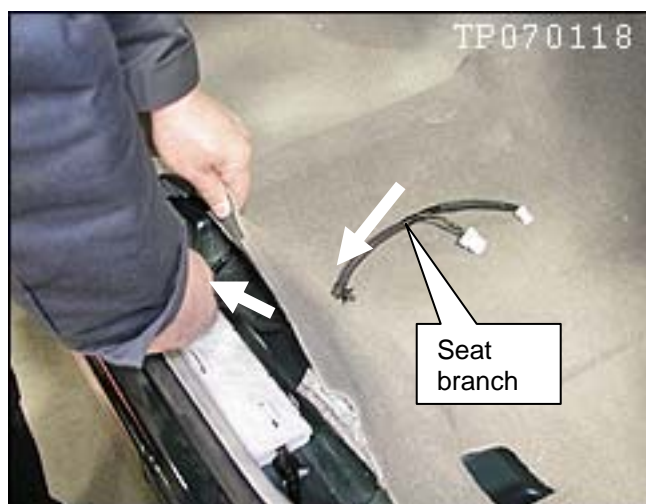
Figure C31

23. Pull the seat branch through the carpet.

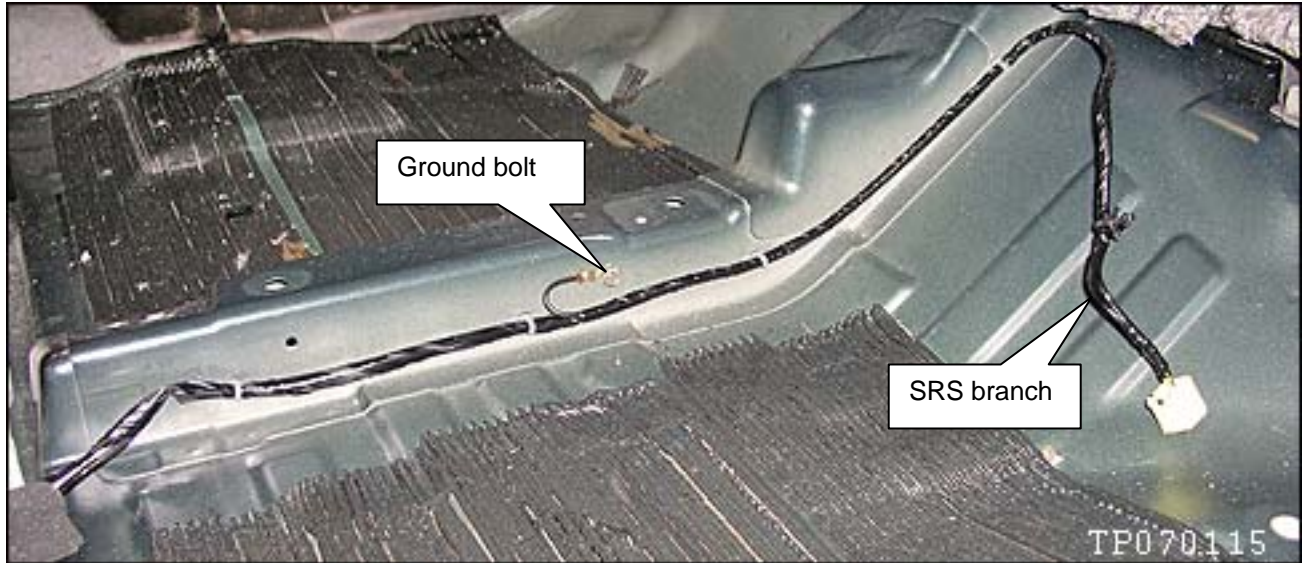
Figure C32

24. Lift the floor carpet, remove the ground bolt and take the SRS branch loose from the floor.

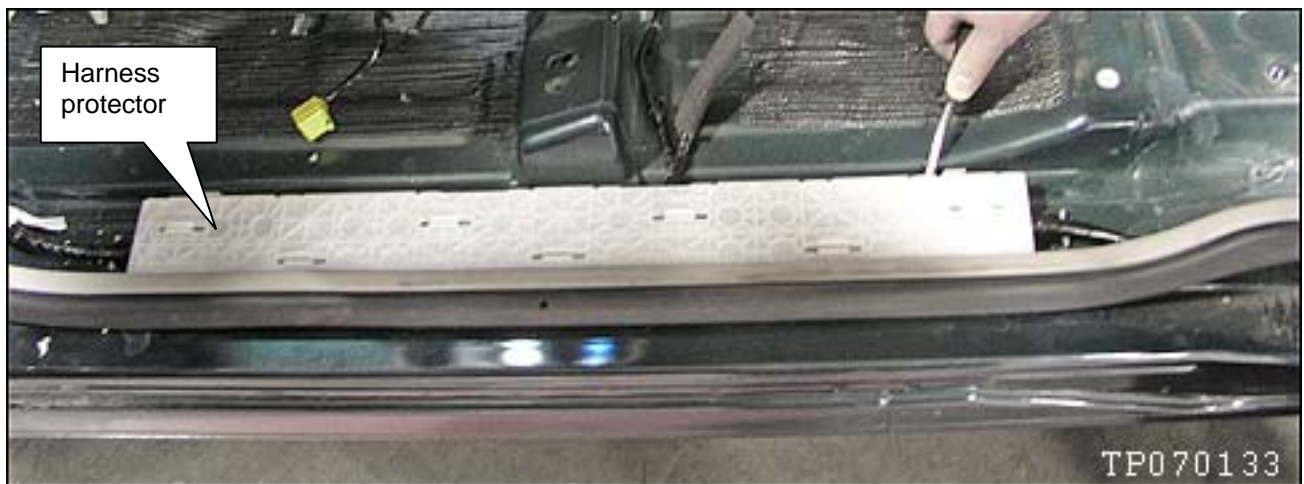
Figure C33

25. Snap the plastic harness protector loose from the floor.

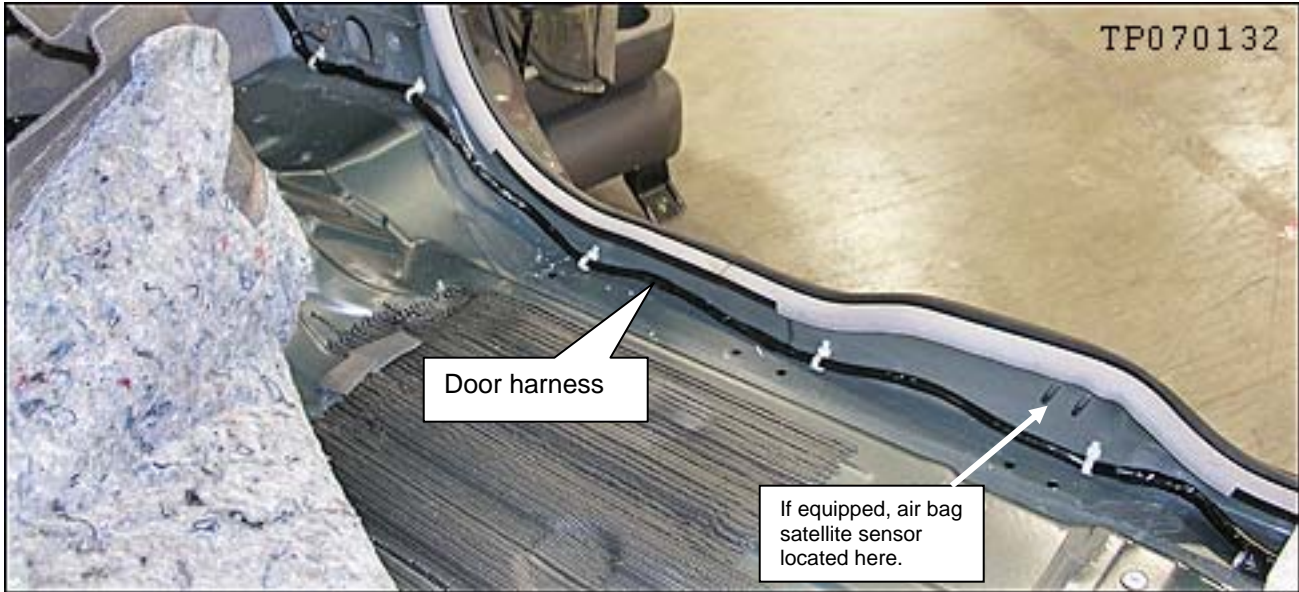
Figure C34

26. Take the harness loose from along the floor.

NOTE: If the vehicle is equipped with side curtain air bags, disconnect the air bag satellite sensor that's located on the rocker panel (see figure above).

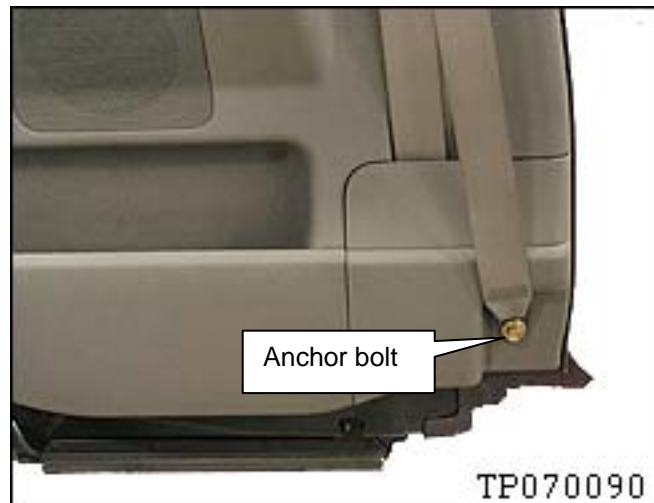
Figure C35

27. On the rear door, remove the lower seat belt anchor bolt.

NOTE: For the passenger side, this bolt does not need to be removed unless you are going to replace the seat belt.

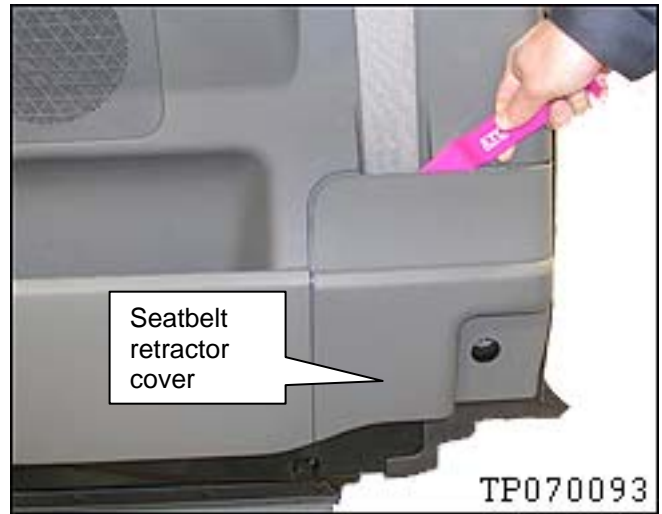
Figure C36

28. Remove the seatbelt retractor cover.

- Use a plastic trim tool.

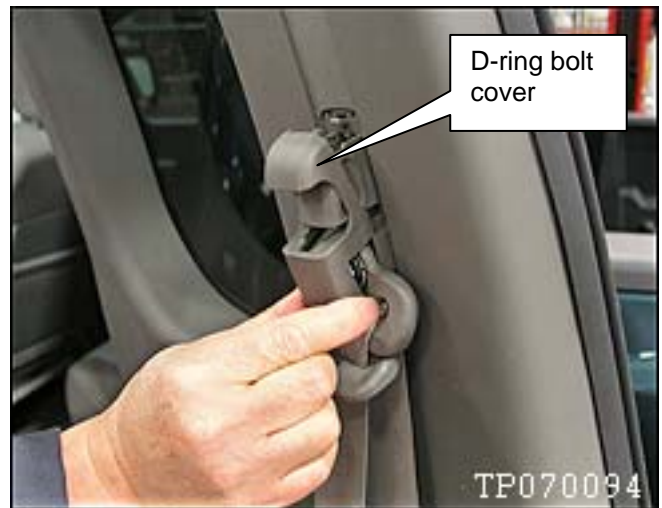
Figure C37

29. Carefully remove the D-ring bolt cover.

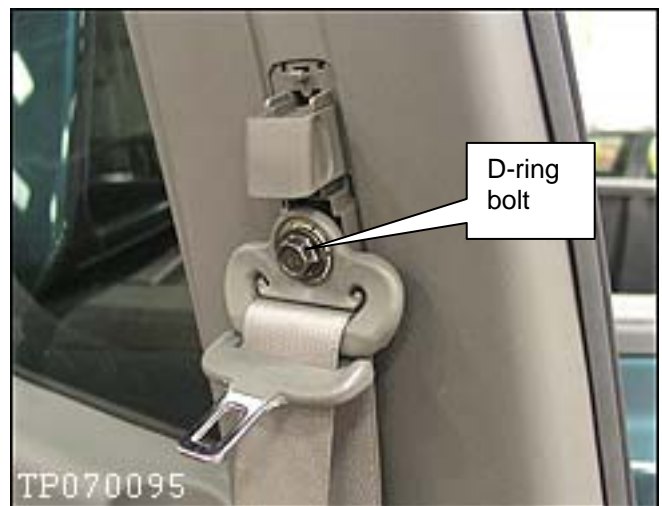
Figure C38

30. Remove the D-ring bolt.

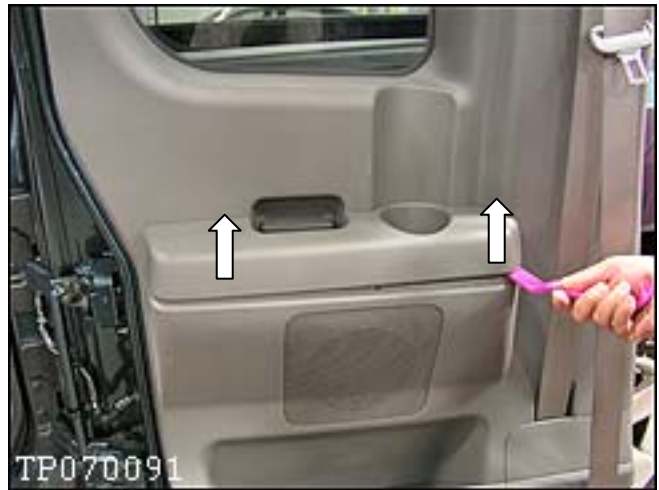
Figure C39

31. Snap loose the armrest.

- Use a plastic trim tool.

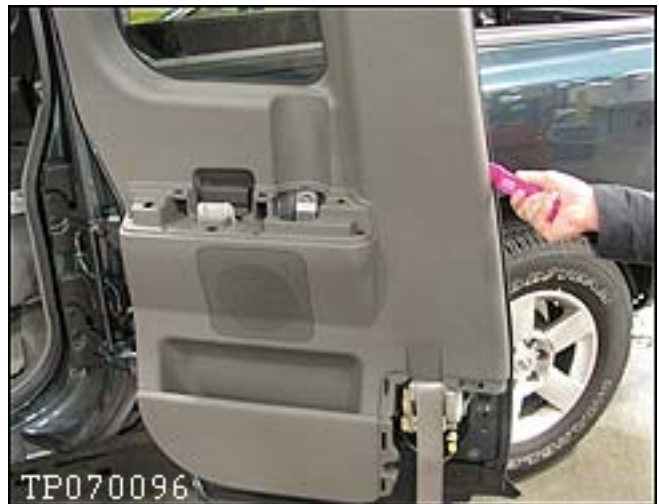
Figure C41

33. Remove the rear door panel.

- Use a plastic trim tool.

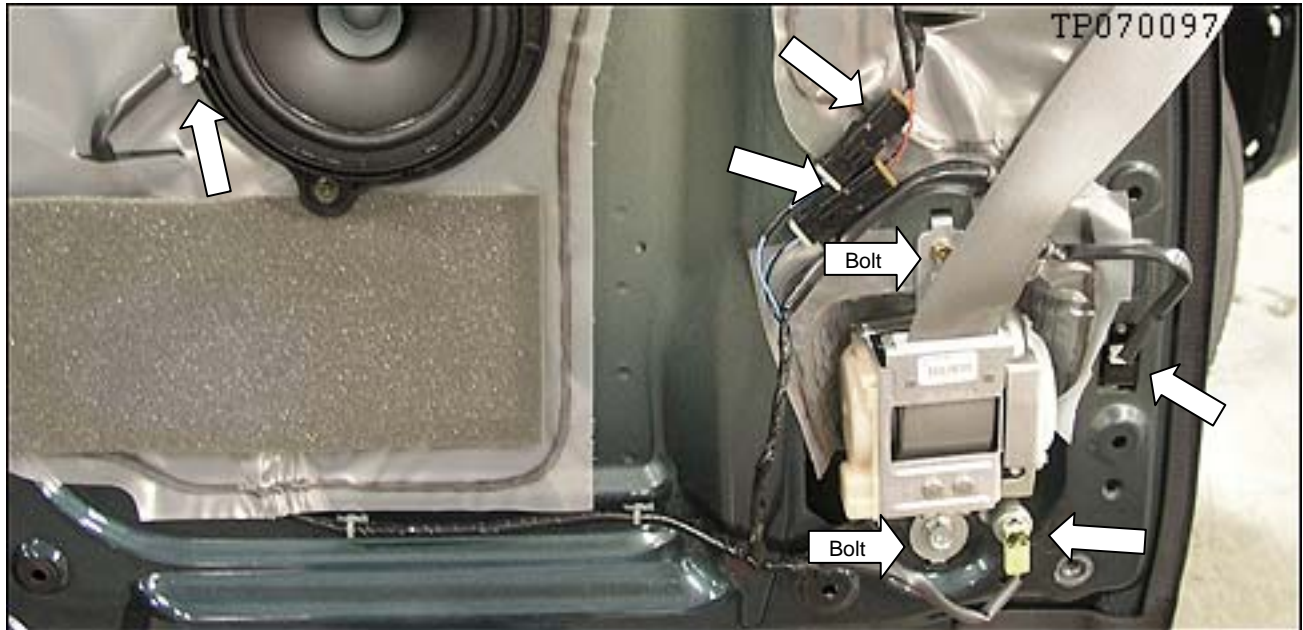
Figure C42

34. Disconnect the 5 connectors shown in the figure below.

NOTE: The passenger side will have a 6th connector (not shown).

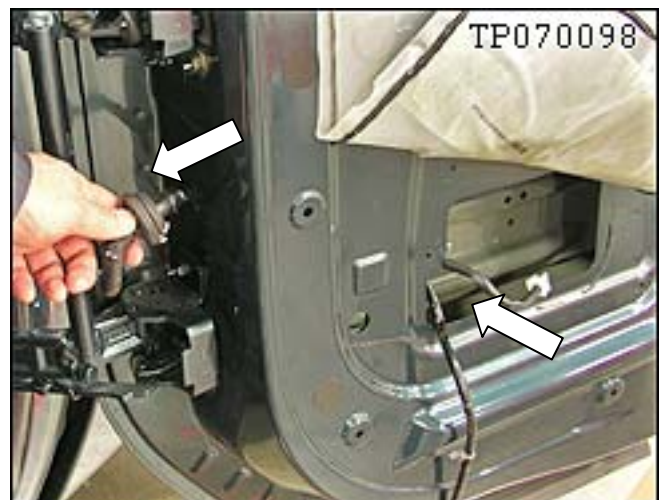
Figure C43

36. Take the harness loose from the door mounting points.

37. Pull the harness out of the door.

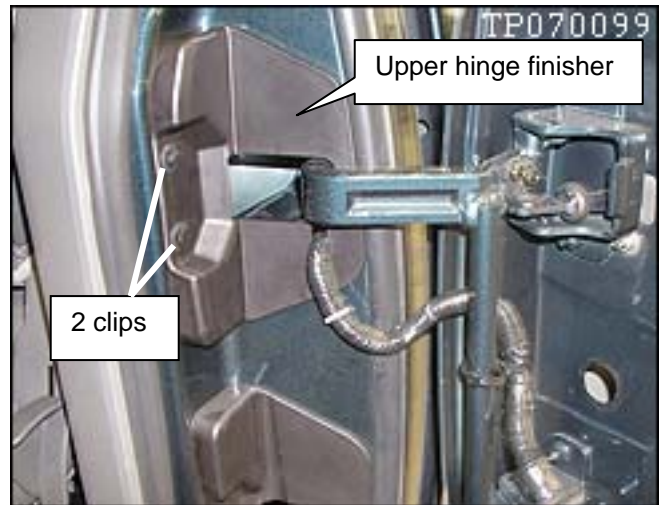
Figure C44

38. Remove the upper door hinge finisher;
2 clips.

39. Take the harness loose from the hinge
rod and the body.
