SERVICE BULLETIN

Classification: RS13-007	Reference: NTB13-044	Date: April 10, 2013
-----------------------------	-------------------------	-------------------------

2004 – 2006 TITAN KING CAB; AIR BAG LIGHT ON, SEAT BELT INOPERATIVE, OR REAR AUDIO SPEAKERS INOPERATIVE

APPLIED VEHICLES: 2004 – 2006 Titan (A60) King Cab models only

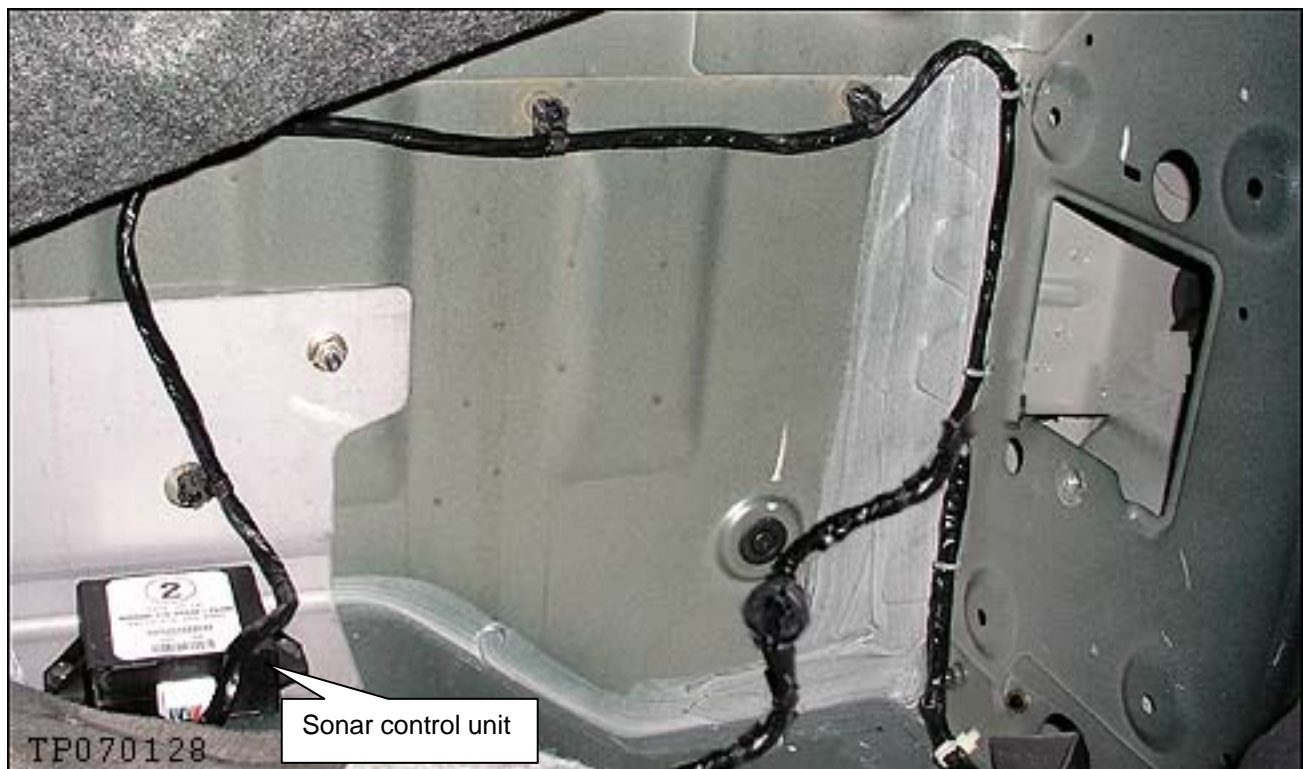
Figure C46

41. Lift the carpet on the rear cabin wall.

42. Disconnect the control unit(s).

43. Take the harness loose from the rear cabin wall.

44. Harness should now be completely loose—remove it from the vehicle.

NOTE: The vehicle you are working on may have a differential lock control unit (not shown) mounted near the sonar control unit.

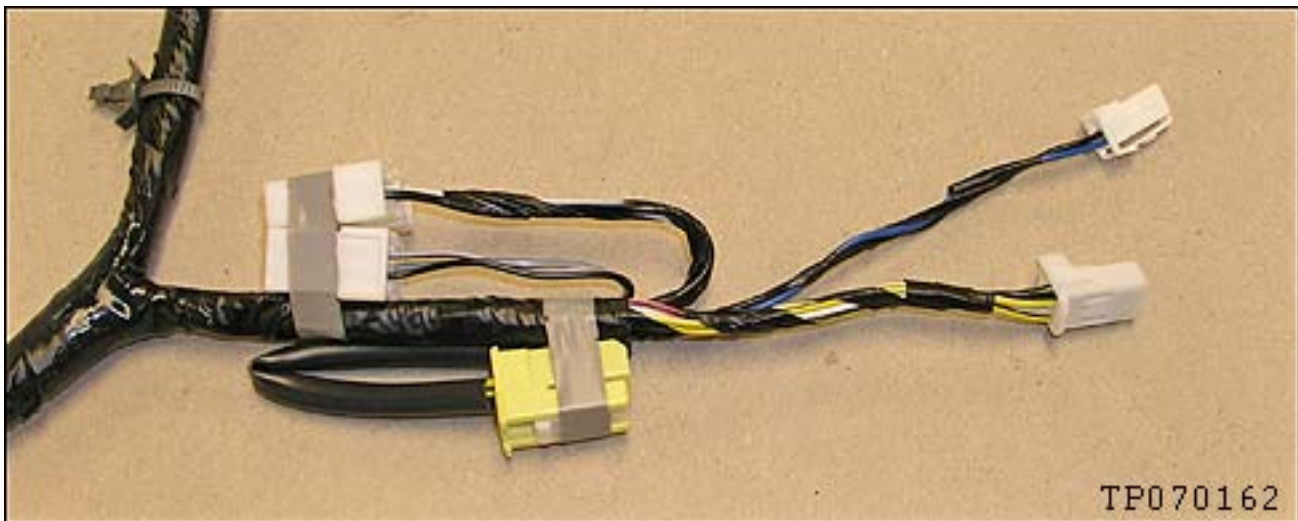
Figure C47

- During installation of the new harness you will find some connectors taped to the harness as shown in the figure below.
- Some of the connectors will be for options that the vehicle you are working on does not have.
- Un-tape the connectors that are needed. Leave the connectors you don't need taped to the harness.

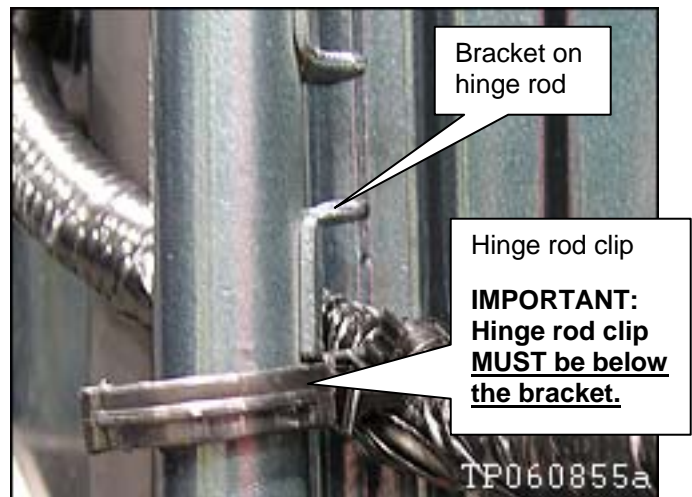
Figure D23

- Make sure the hinge rod clip is below the bracket on the hinge rod as shown.

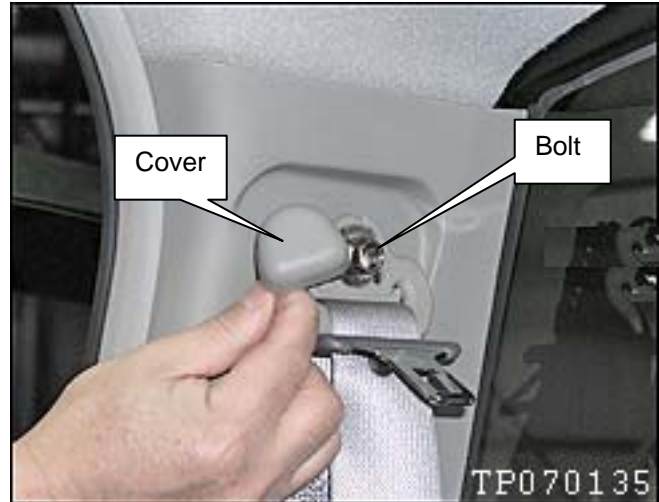
Figure D1

51. Remove the rear seat belt D-ring covers and bolts—left and right side.

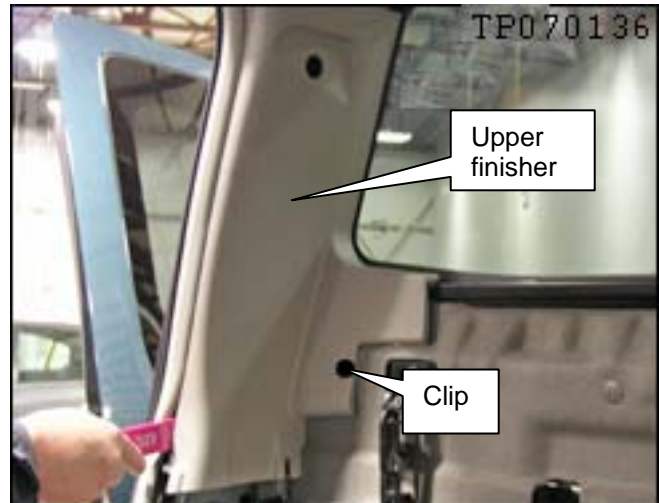
Figure D2

52. Remove the rear upper finishers—left and right side.

- Remove the clip.
- Use a plastic trim tool.

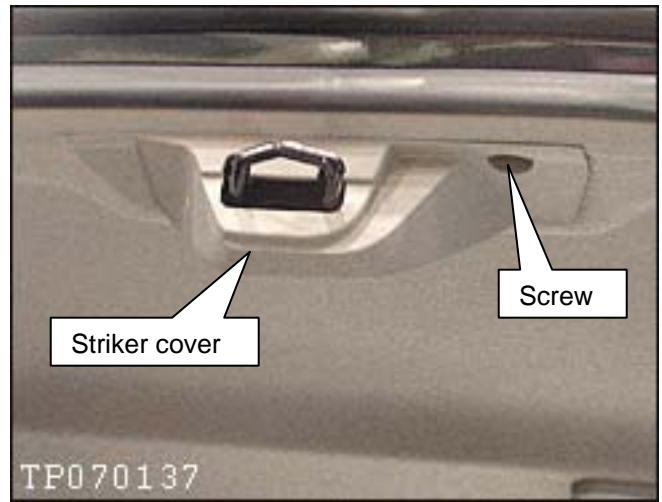
Figure D3

53 Remove the upper door latch striker covers—left and right side.

- 1 screw on each side.

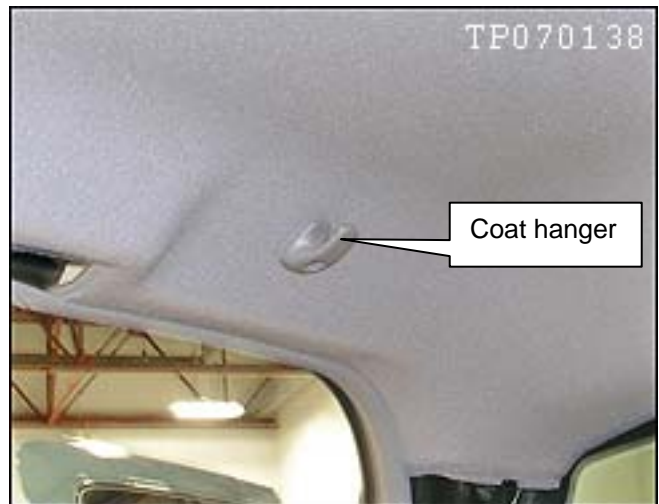
Figure D4

54. Remove the coat hangers; left and right side.

- 1 screw for each coat hanger.

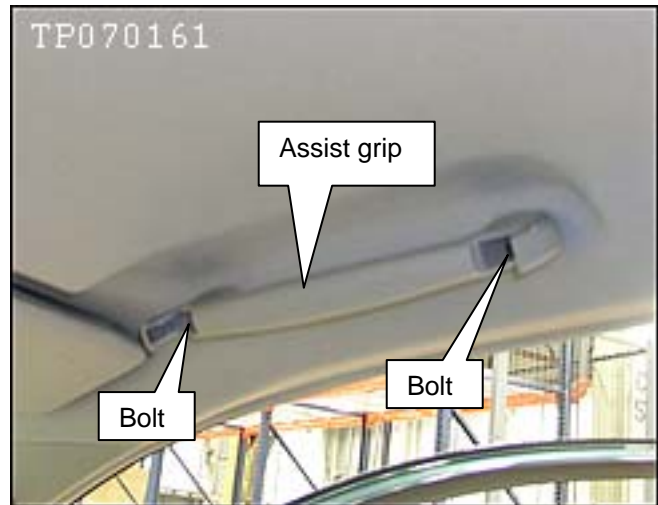
Figure D5

55. Remove the assist grip (passenger side only).

- Open the side bolt covers.
- Remove the 2 bolts.

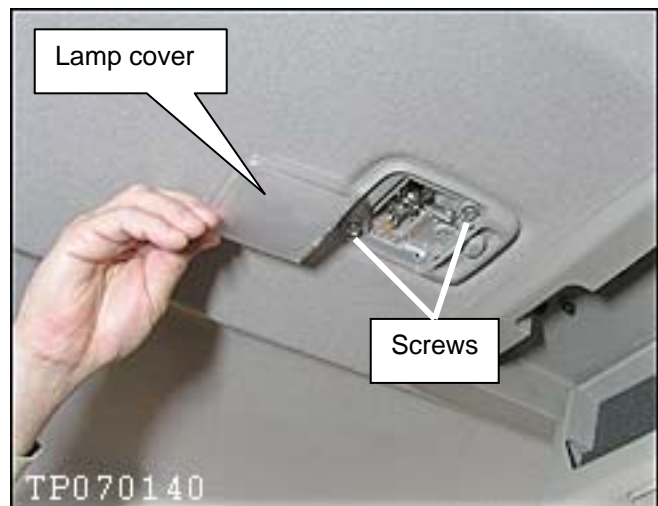
Figure D6

56. Remove the dome lamp.

- a. Remove the clear lamp cover
- b. Remove the 2 screws.
- c. Let the lamp hang by the electrical connector.

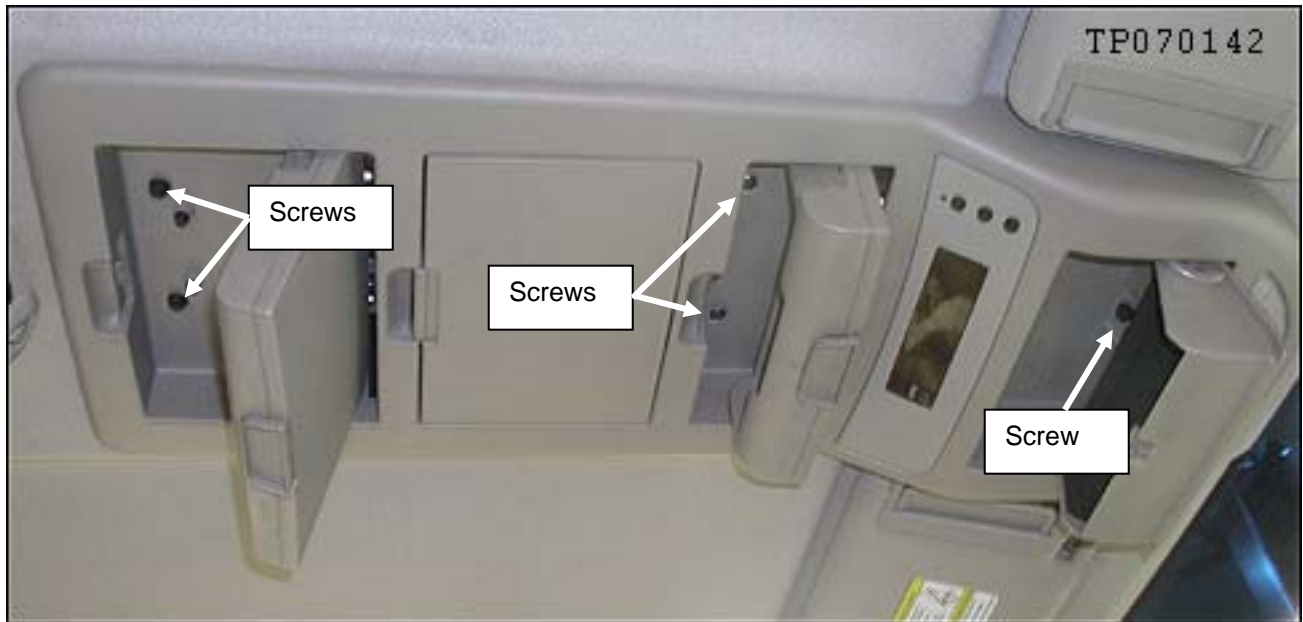
Figure D7

57. Remove the 5 screws (shown in the figure below) from the center roof console.

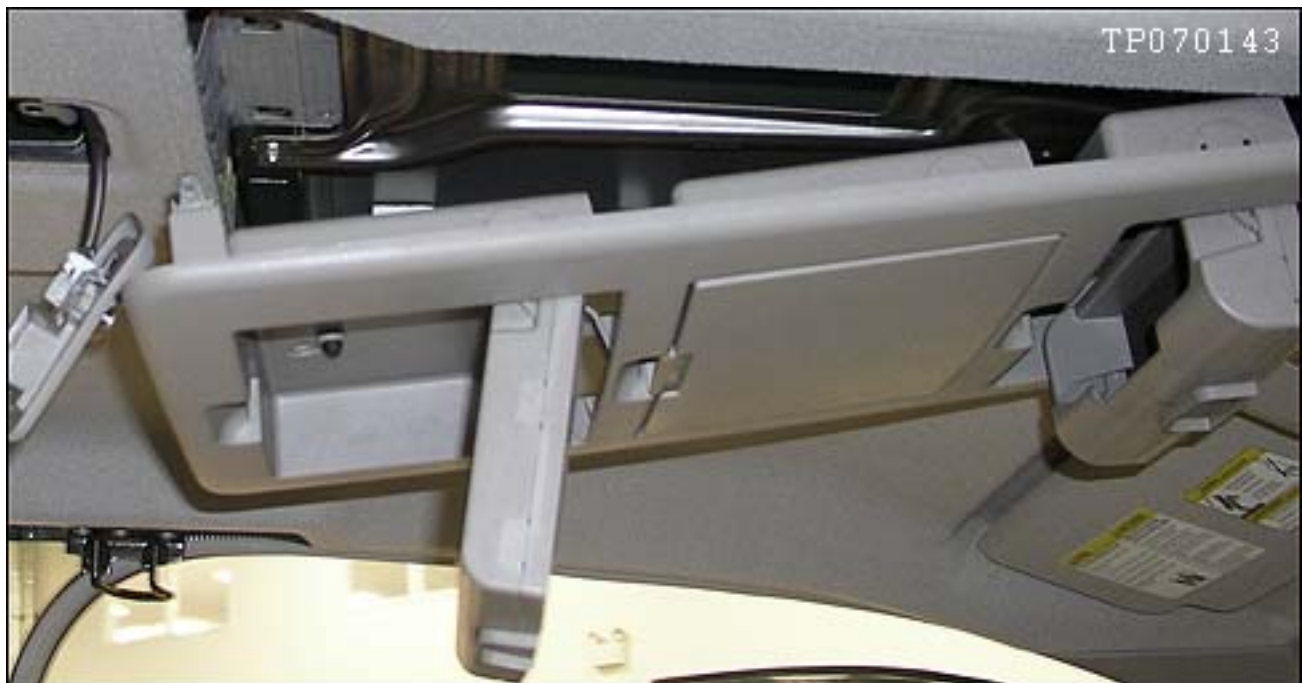
Figure D8

58. Pull the console loose at the rear and let it hang in place.

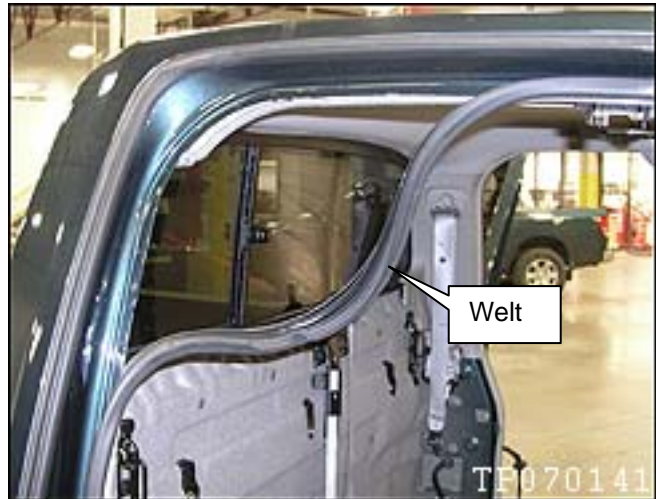
Figure D9

59. Pull the door welt loose from the top and rear of the door opening (both sides).

CAUTION: Don't get butyl sealer from the welt on any of the interior trim surfaces.

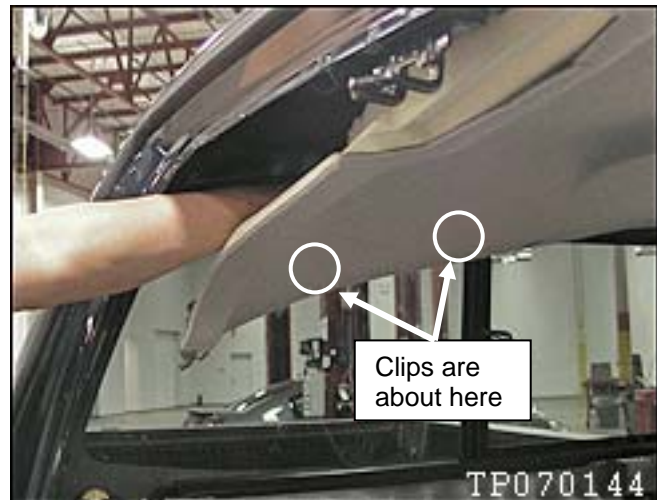
Figure D10

60. Carefully pull down the side of the headlining, at the rear, just enough to get your arm above it.

61. Reach above the headlining and pop loose the rear clips (left and right side).

- 2 clips on each side.

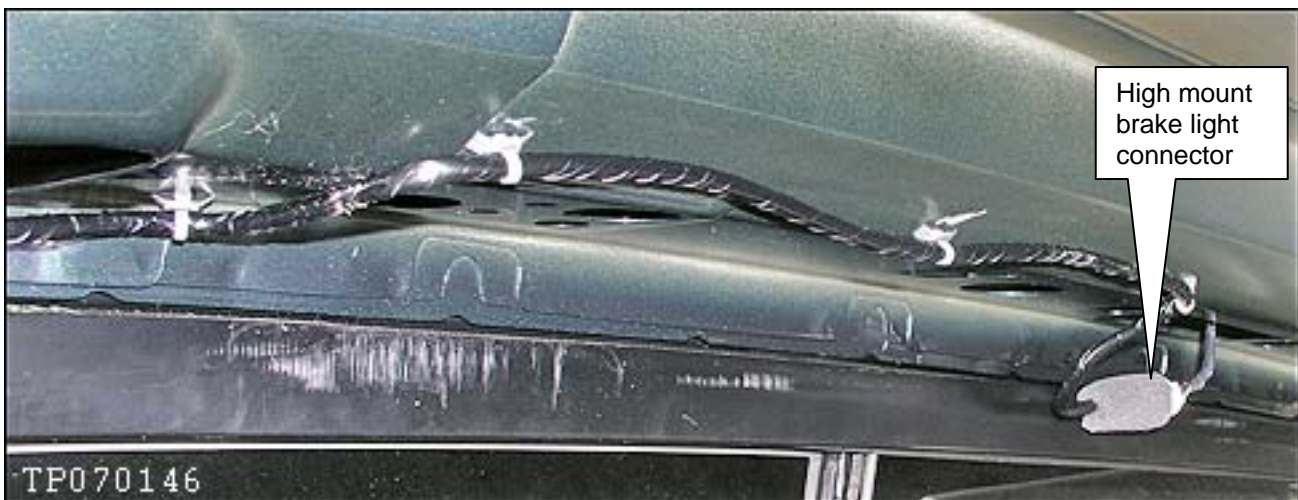
Figure D11

62. Look above the headlining, locate and disconnect the high mount brake light connector.

63. Take the harness loose from the body roof.

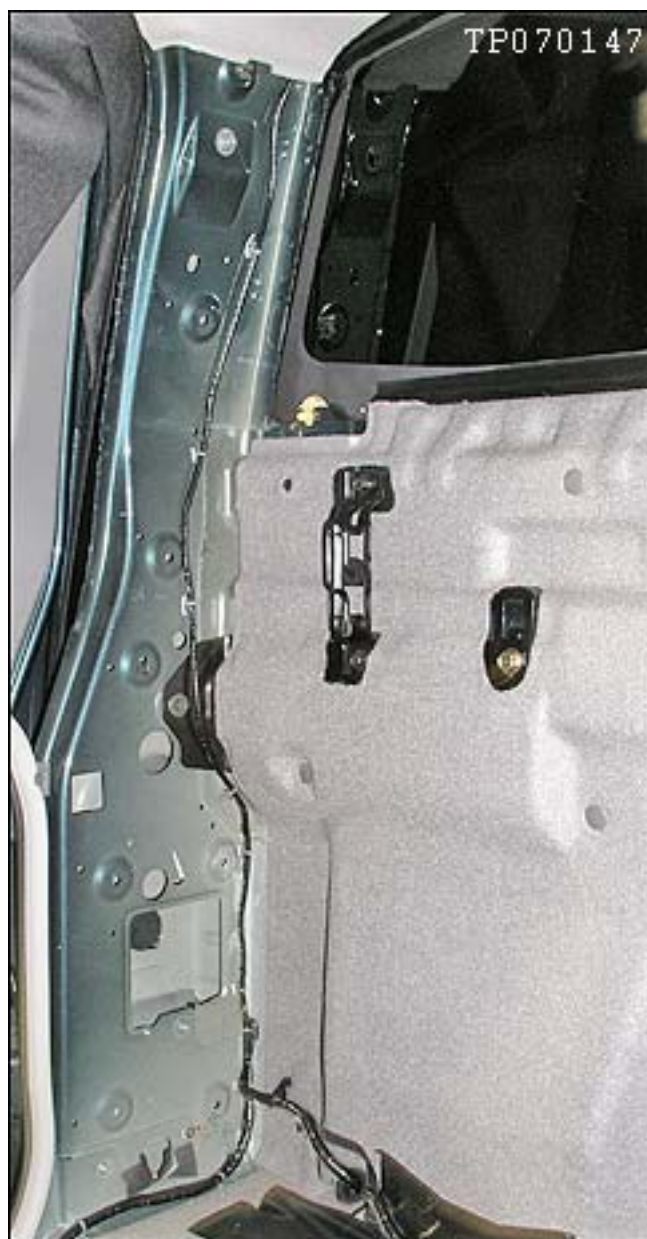
Figure D12

64. Take the harness loose from the side of the cabin.

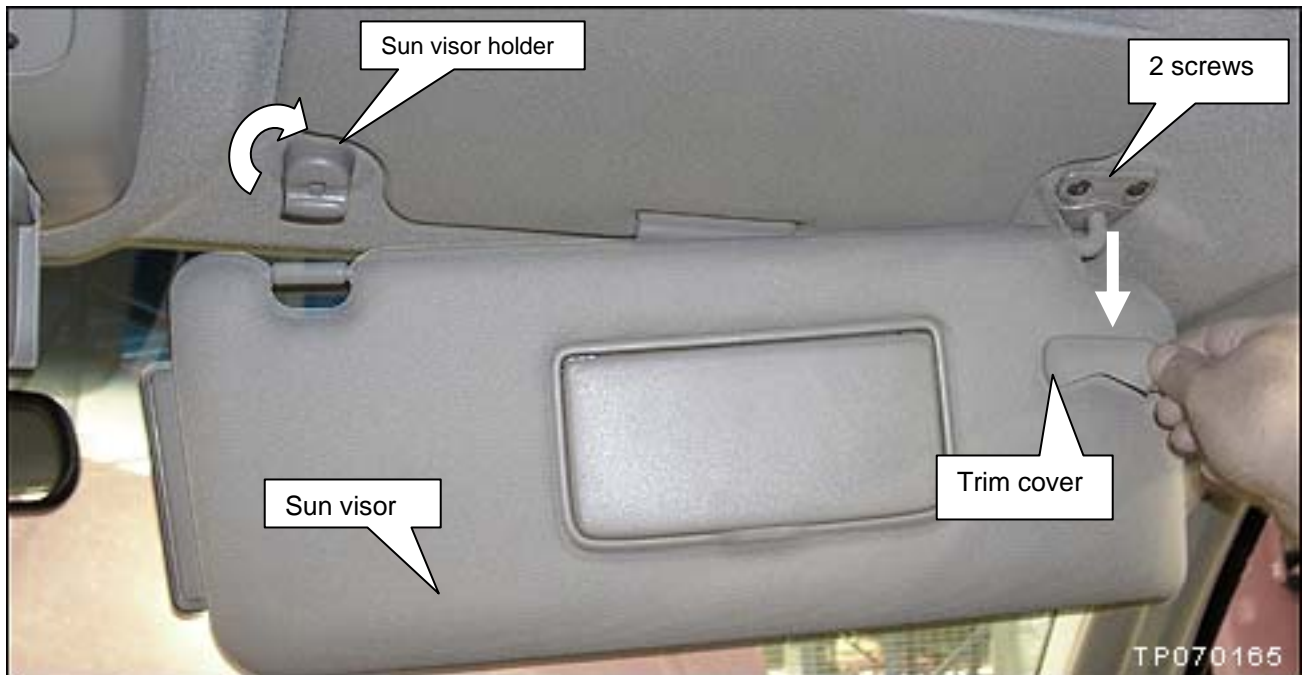
Figure D13

- a. Remove the right side sun visor, 2 screws under the trim cover.
 - Use a plastic trim tool to remove the trim cover.
 - Disconnect the electrical connector.

- b. Remove the right side sun visor holder, twist $\frac{1}{4}$ turn to remove.

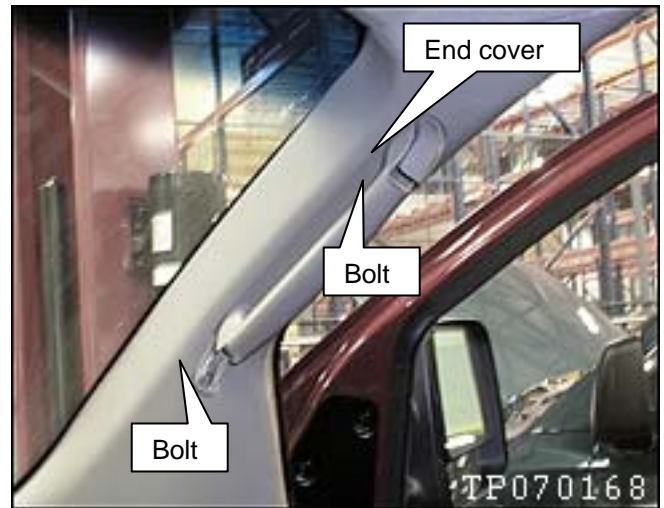
Figure D15

- d. Remove the front pillar assist grip;
- 2 bolts; under end covers.

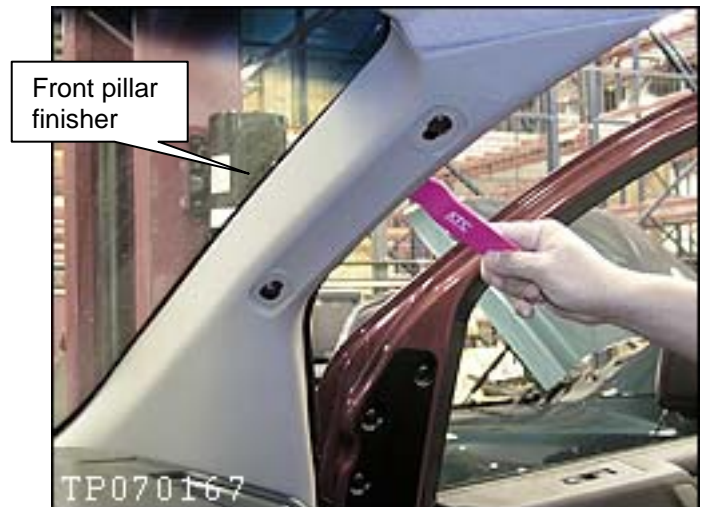
Figure D16

- e. Remove the front pillar finisher.
- Use a plastic trim tool.

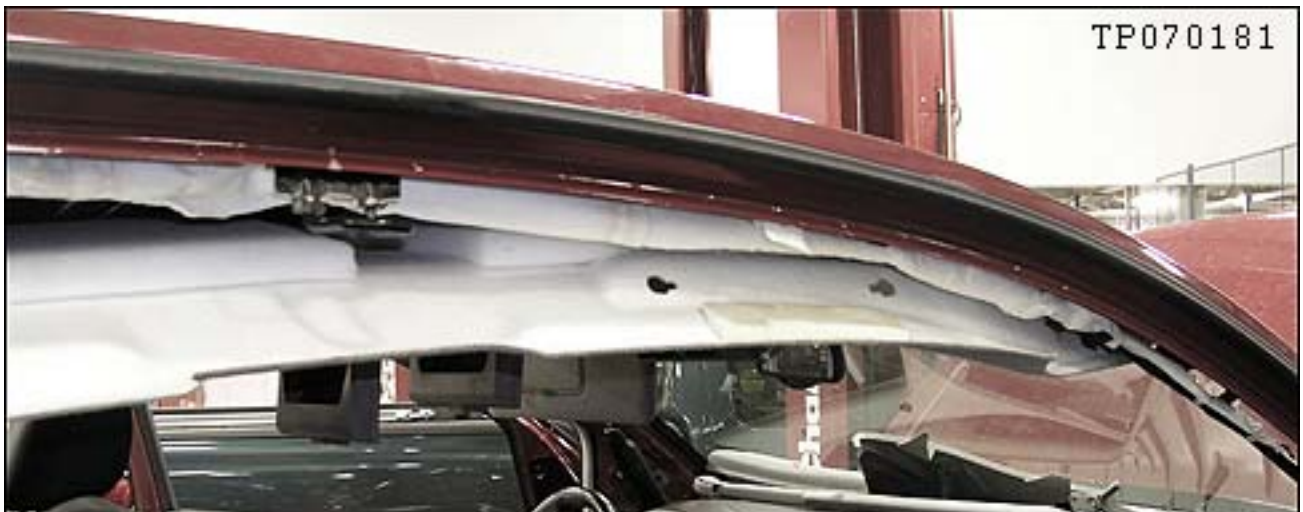
Figure D17

NOTE: With the sun visor and front pillar finisher removed the headlining will be loose all along the passenger side. This will allow access to the side curtain air bag mounting bolts.

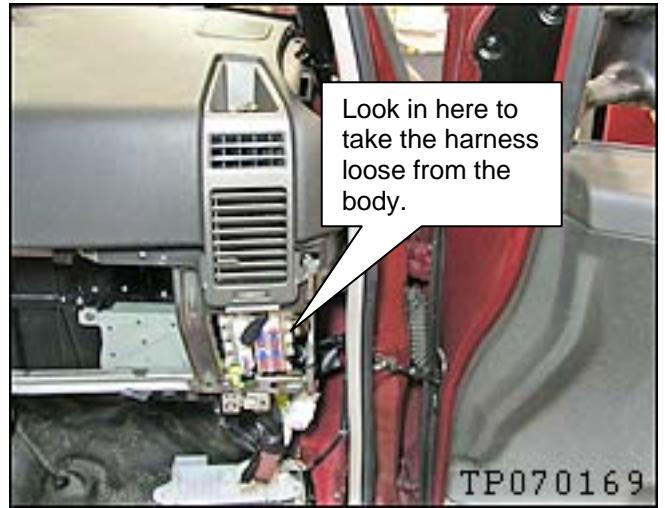
Figure D18

- f. Take the side curtain air bag branch of the harness loose from the body.

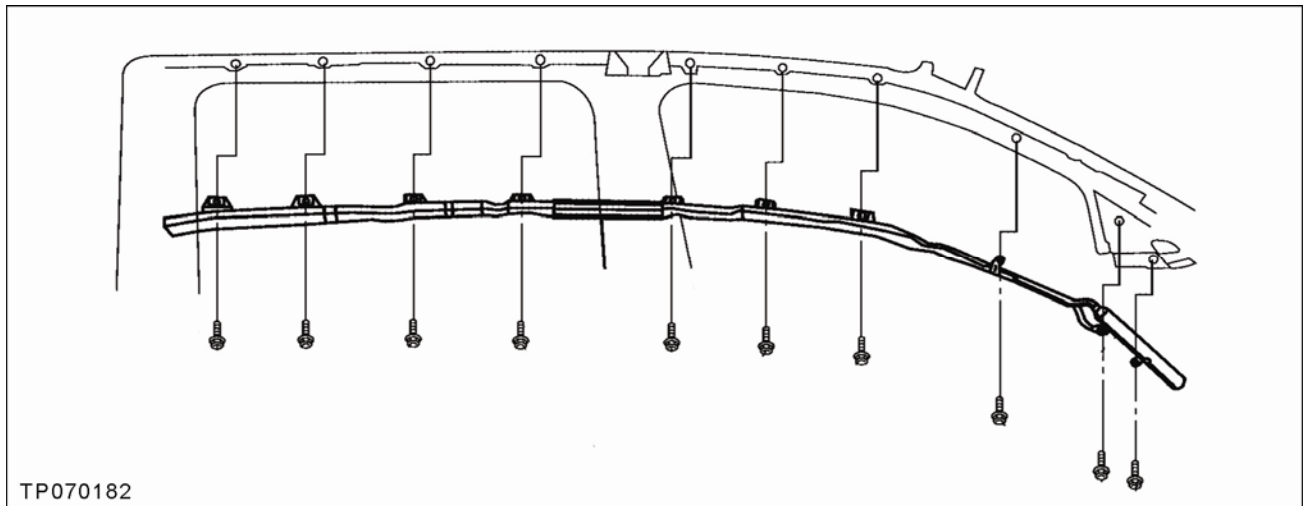
Figure D19

- g. Remove the 10 side curtain air bag mounting bolts.

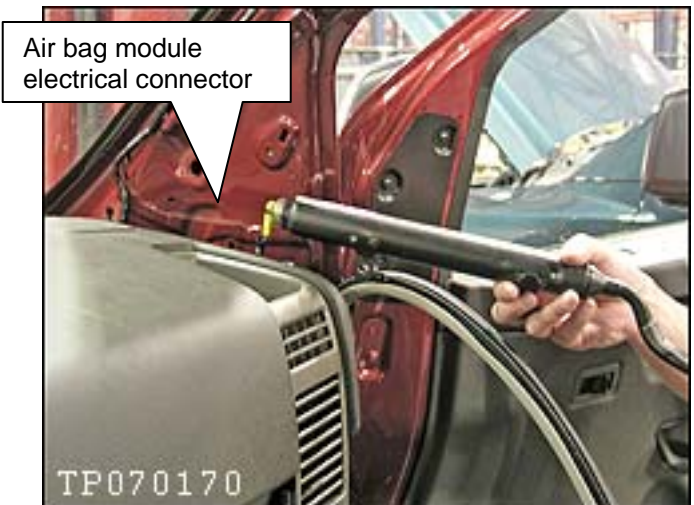
Figure D20

- h. Remove the side curtain air bag module and disconnect the electrical connector.

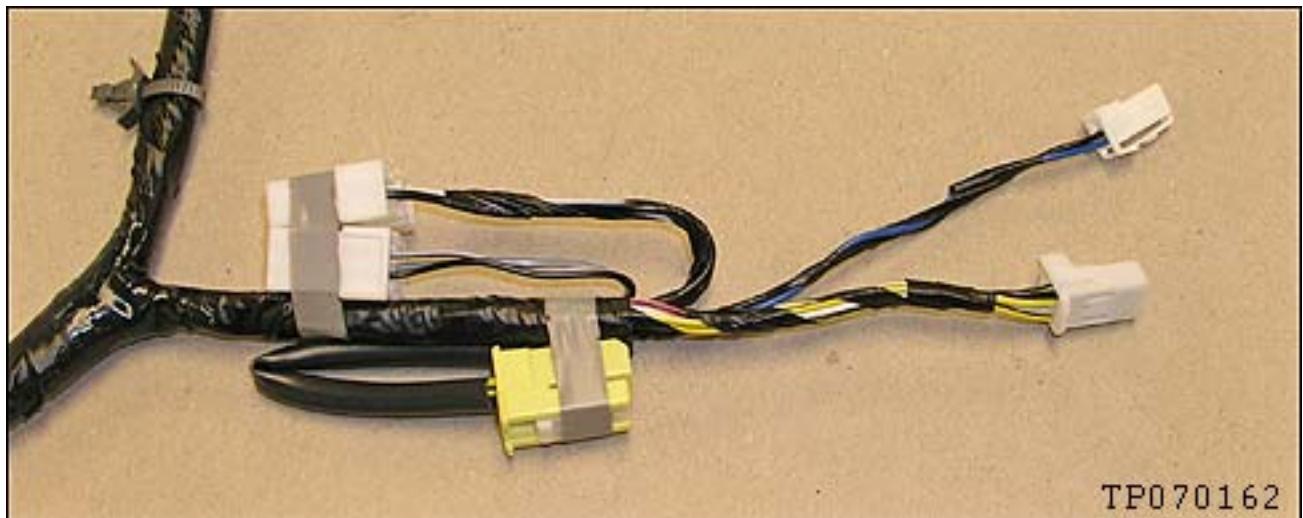
Figure D21

- During installation of the new harness you will find some connectors taped to the harness as shown.
- Some of the connectors will be for options that the vehicle you are working on does not have.
- Un-tape the connectors that are needed. Leave the connectors that are not needed taped to the harness.

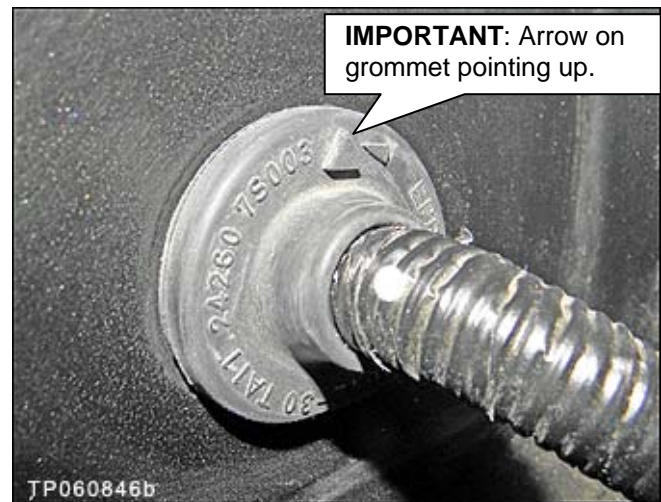
Figure D22

71. Make sure the arrow on the harness grommet, where it goes into the door, is pointing UP, as shown.

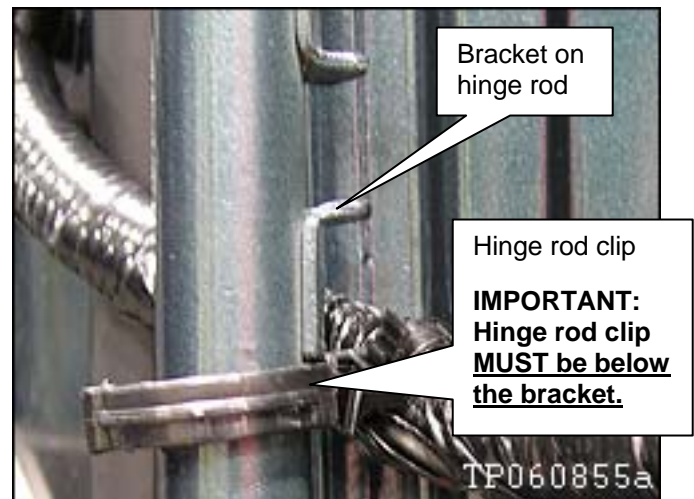
Figure D23

72. Make sure the hinge rod clip is below the bracket on the hinge rod as shown.
