SERVICE BULLETIN

EL13-016

June 3, 2013

2013 ALTIMA SEDAN; NAVIGATION HVAC AND BASE AUDIO DISPLAYS INTERMITTENTLY DO NOT ILLUMINATE

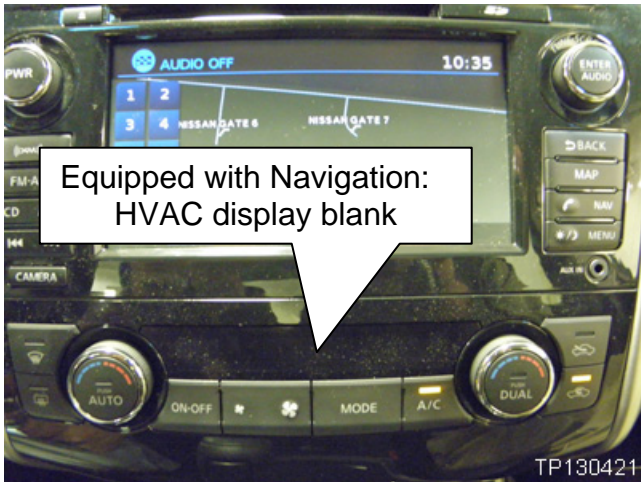
On vehicles equipped with Navigation or Base Audio, the HVAC Display Screen (Figure 1, page 2), Base Audio display (Figure 2, page 2) and overhead Lamp (located in overhead console) may shut off (black out) if the daytime or nighttime illumination controls are set to less than 1 bar.

- Figure 1 and Figure 2 show the display being blank due to illumination being adjusted to less than 1 bar.

- Under these conditions the operation of the HVAC display, Base Audio unit and the overhead lighting illumination are possibly operating correctly, simply need adjustment, and should not be replaced.

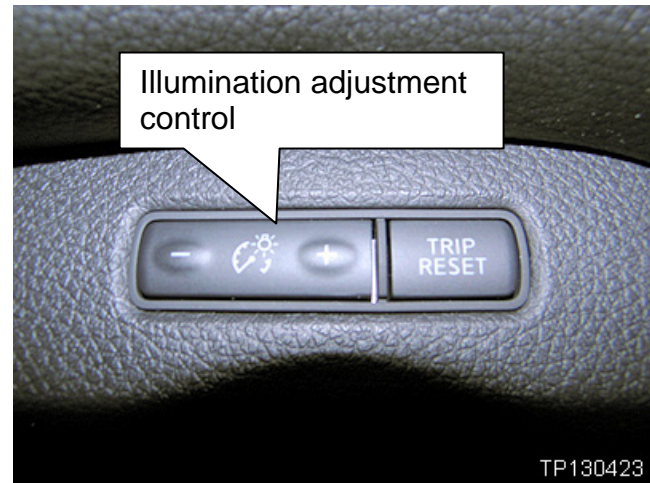
- The illumination control (Figure 3, page 2) is set to less than 1 bar.

- Figure 3 shows the illumination control located to the left of the steering wheel.

NOTE: Daytime and nighttime illumination can be set independently of each other through the same control located to the left of the steering wheel. If either daytime or nighttime illumination is set to less than 1 bar, these symptoms can occur.

- To set the daytime illumination the headlights must be off.
- To set the nighttime illumination the headlights must be on.

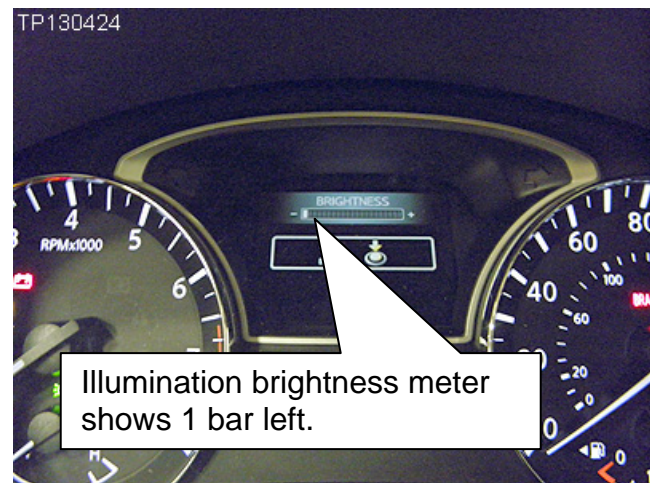
- Figure 4 shows the Meter with 1 bar of illumination adjustment left.
