Dealer Service Action

2014 Nissan Versa Note Rear Seat Latch Bolt

Subject: **2014 Nissan Versa Note
Rear Seat Latch Bolt Dealer Service Action**

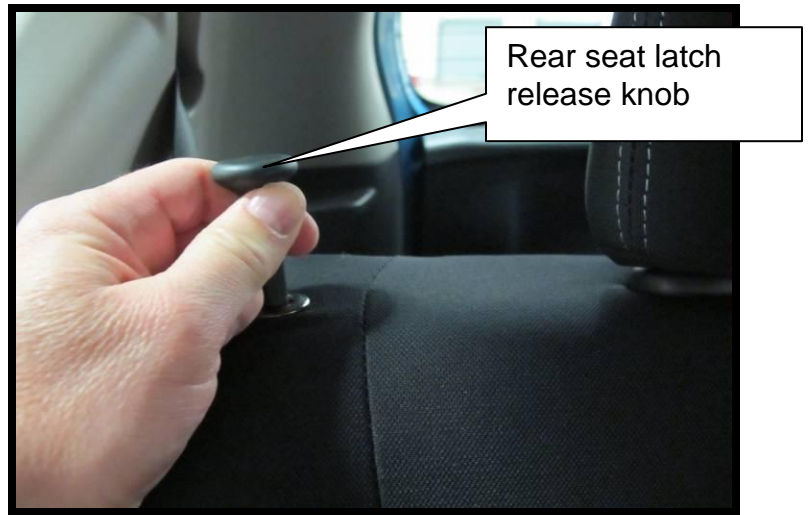
Figure 1

1. Open driver side rear door and fold rear seat back down using release knob as shown in Figure 1.

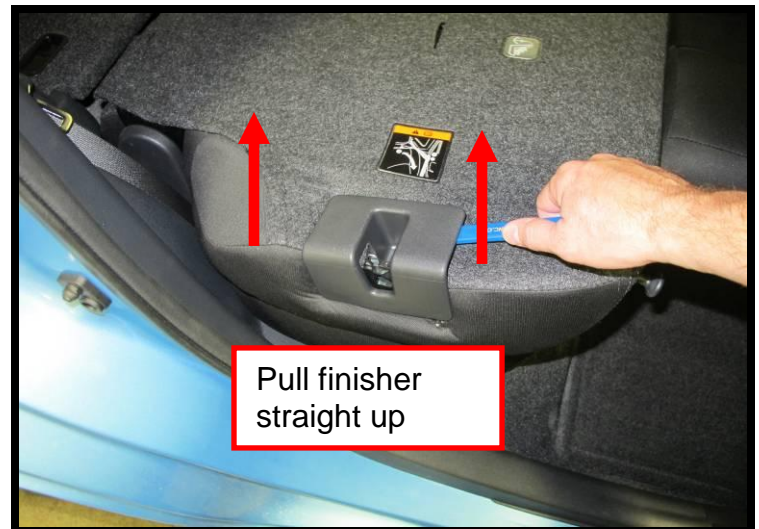
Figure 2

2. Remove rear seat back latch finisher using suitable trim tool.
 - Pull straight up away from seat back as shown in Figure 2.

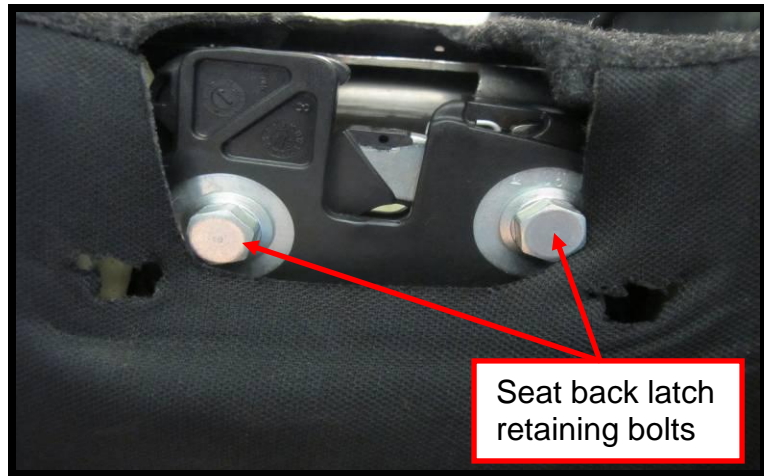
Figure 3

3. Remove the two 12 mm rear seat back latch retaining bolts from rear seat latch as shown in Figure 3, then discard.

4. Install two New 12 mm rear seat back latch retaining bolts on rear seat back latch and torque to 24 N•m (18 ft-lb).

Note: Verify seat back trim is not caught under retaining bolts when tightening.

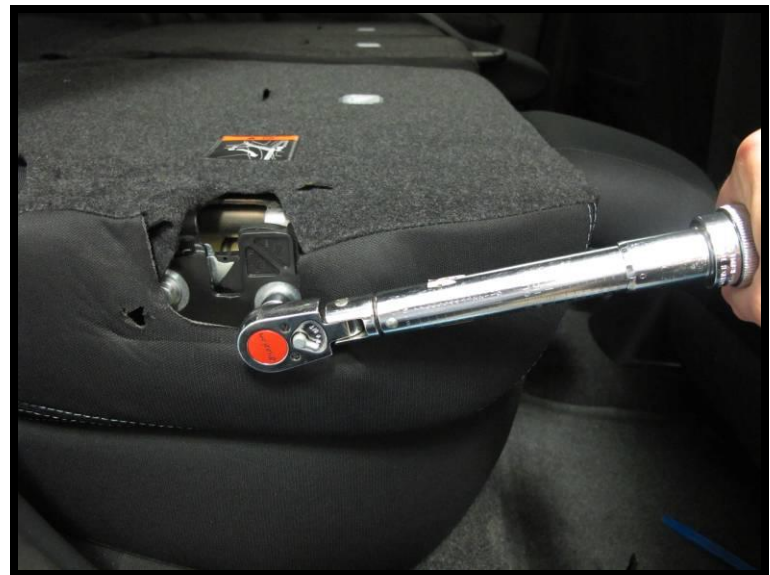
Figure 4

5. Replace rear seat back finisher on the rear seat back.
6. Verify rear seat back latch operation.
