ITB11-041g

## VOLUNTARY SERVICE CAMPAIGN 1997-2003 QX4 IN NON SALT STATES FRONT STRUT HOUSING CORROSION

CAMPAIGN ID #: R1110  
NHTSA #: 11V-244  
APPLIED VEHICLES: 1997- 2003 QX4 (JR50)

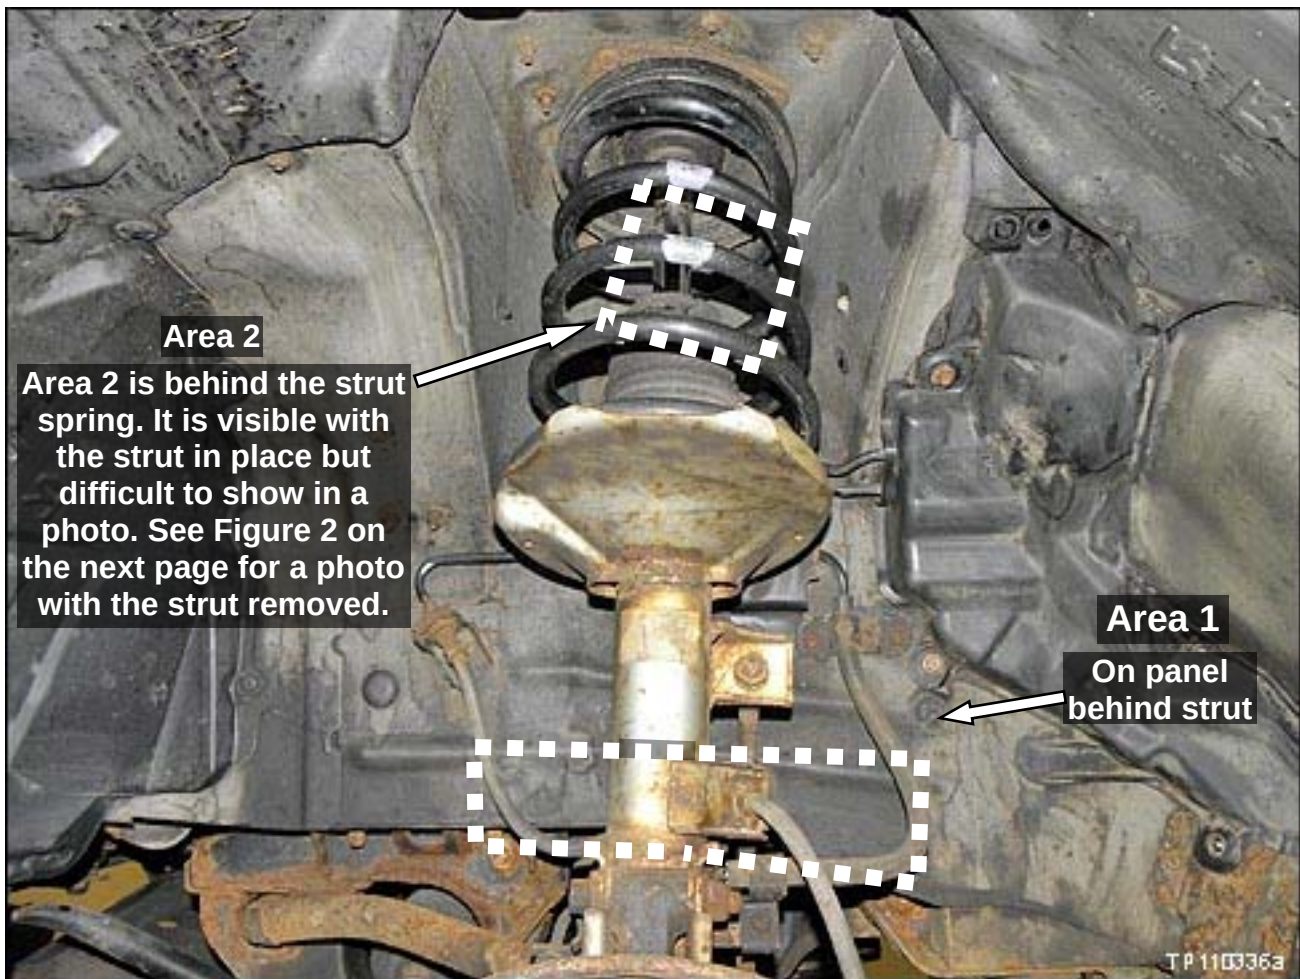
Figure 1

1. Lift the vehicle on a hoist.
2. Remove both front wheels.
3. Inspect for corrosion ON BOTH SIDES in the strut housing Area 1 and wheel house Area 2 (see Figures 1 through 6).

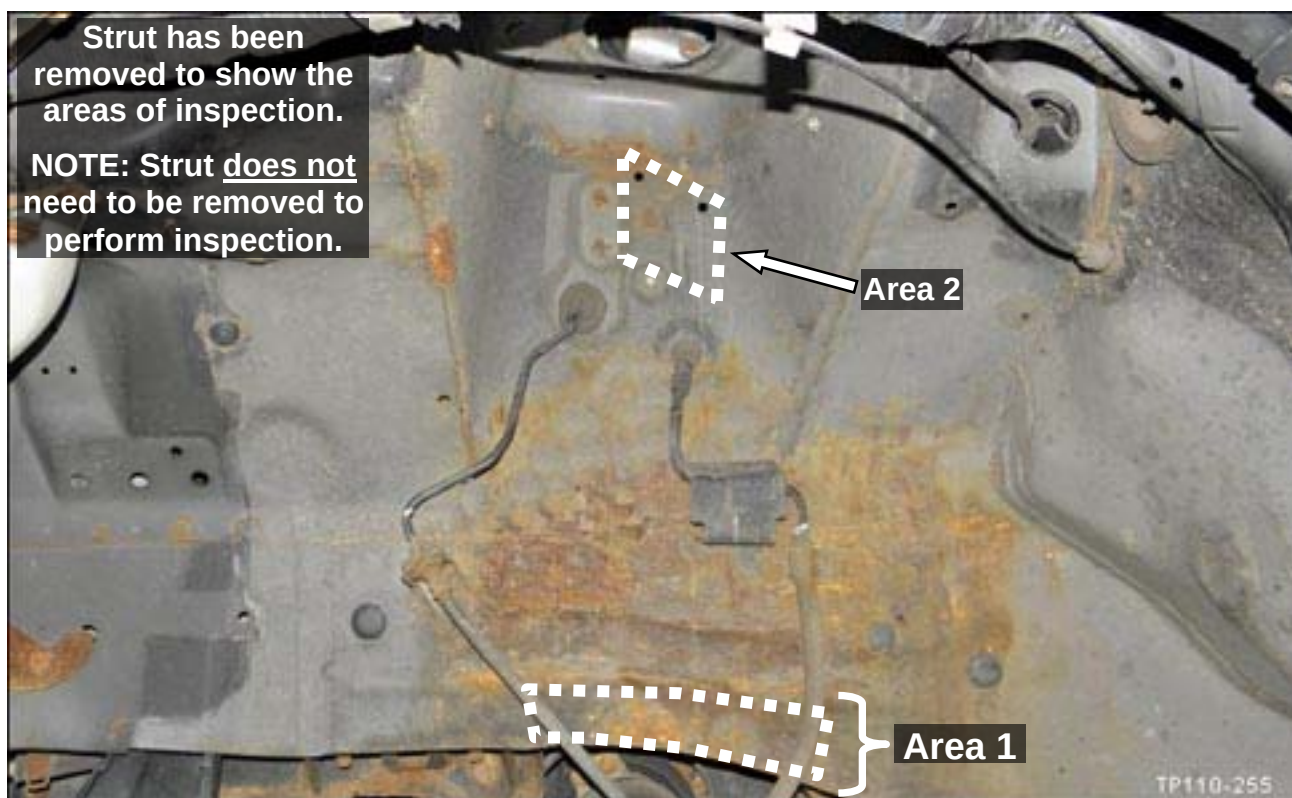
Figure 2

This example photo shows the inspection areas in relation to the repair bracket installation.

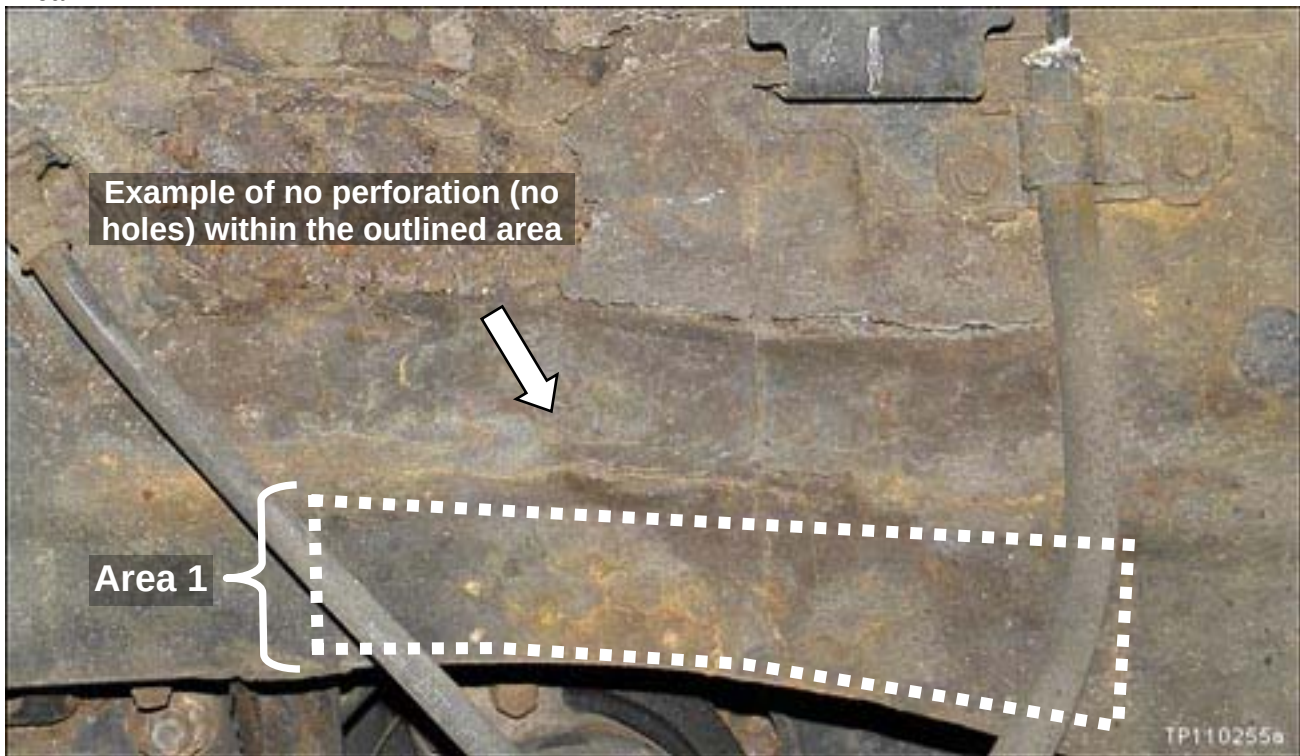
Figure 4

Area 1: Look for perforation (holes) in the metal only in the area outlined above.

- a. Retain the vehicle at the dealer. (The vehicle is not repairable.)
- b. Supply the customer with a rental car.
- c. Fax a completed Non-Repairable Report to Morley (see page 56).

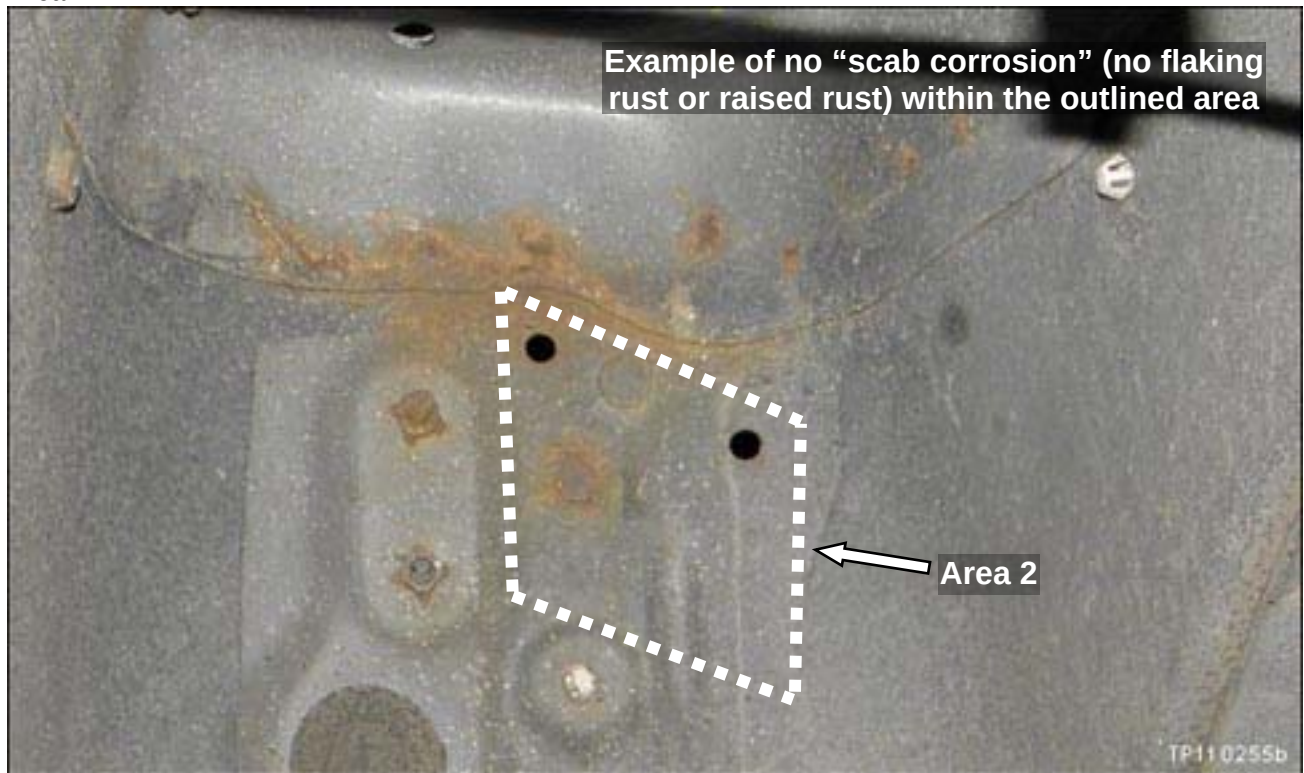
Figure 5

Area 2: Look for “scab corrosion” (flaking rust or raised rust) only in the area outlined above.

NOTE: If needed, refer to example (additional photo) of Area 2 scab corrosion inspection on page 48.

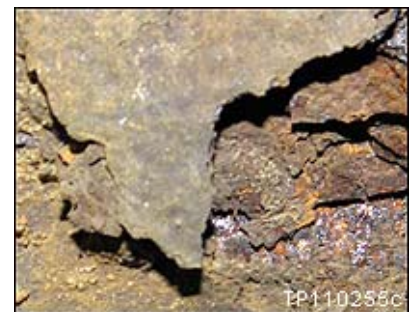
Figure 6 is an example of “scab corrosion” (flaking and raised rust).

If there is scab corrosion (flaking or raised rust) in Area 2 on the driver side OR passenger side:

- a. Retain the vehicle at the dealer. (The vehicle is not repairable.)
- b. Supply the customer with a rental car.
- c. Fax a completed Non-Repairable Report to Morley (see page 56).

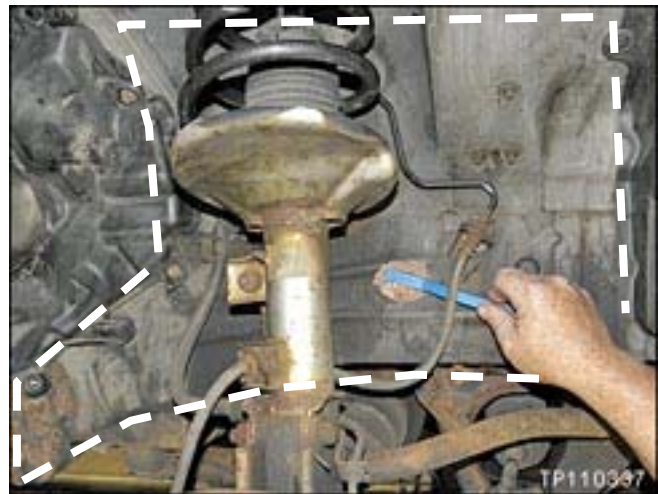
Figure 7

1. Use a wire brush to remove loose rust in the area shown with dashed line.

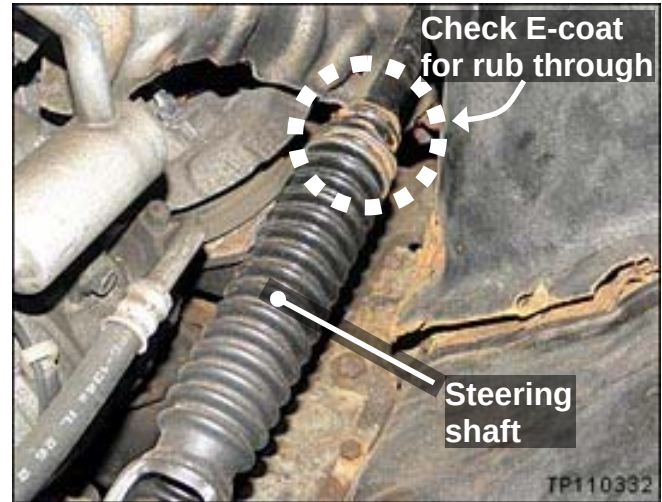
Figure RB5

- ONLY if the E-coat has been rubbed through to bare metal, the steering shaft will need to be replaced.
- If the steering shaft needs replacement, you will be instructed to replace it later in this procedure.

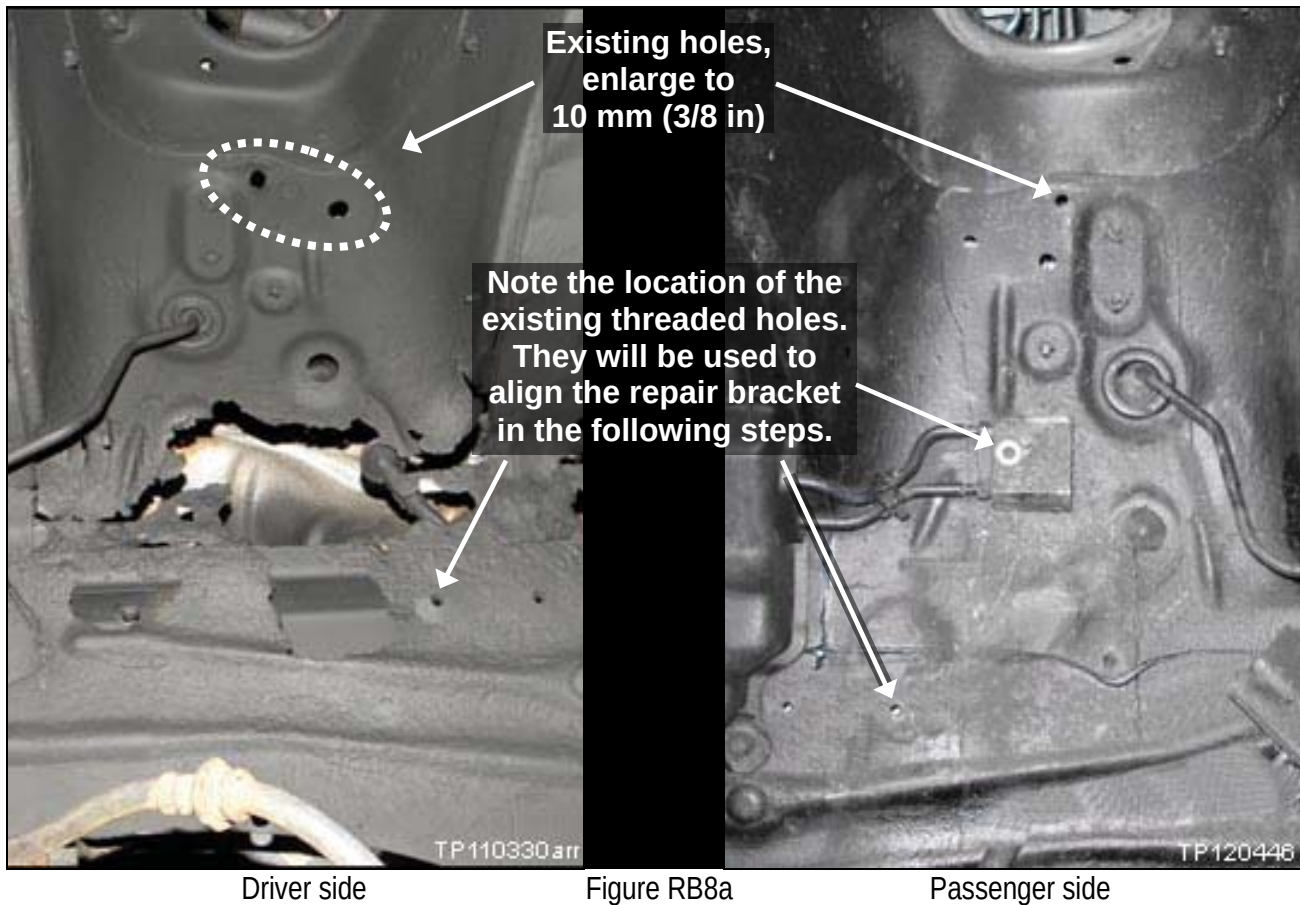
Figure RB8a

12. Driver side: Locate the 2 existing holes at the upper area of the strut housing panel (see Figure RB8a).

- With a drill bit, enlarge the one existing hole to 10 mm (3/8 in).

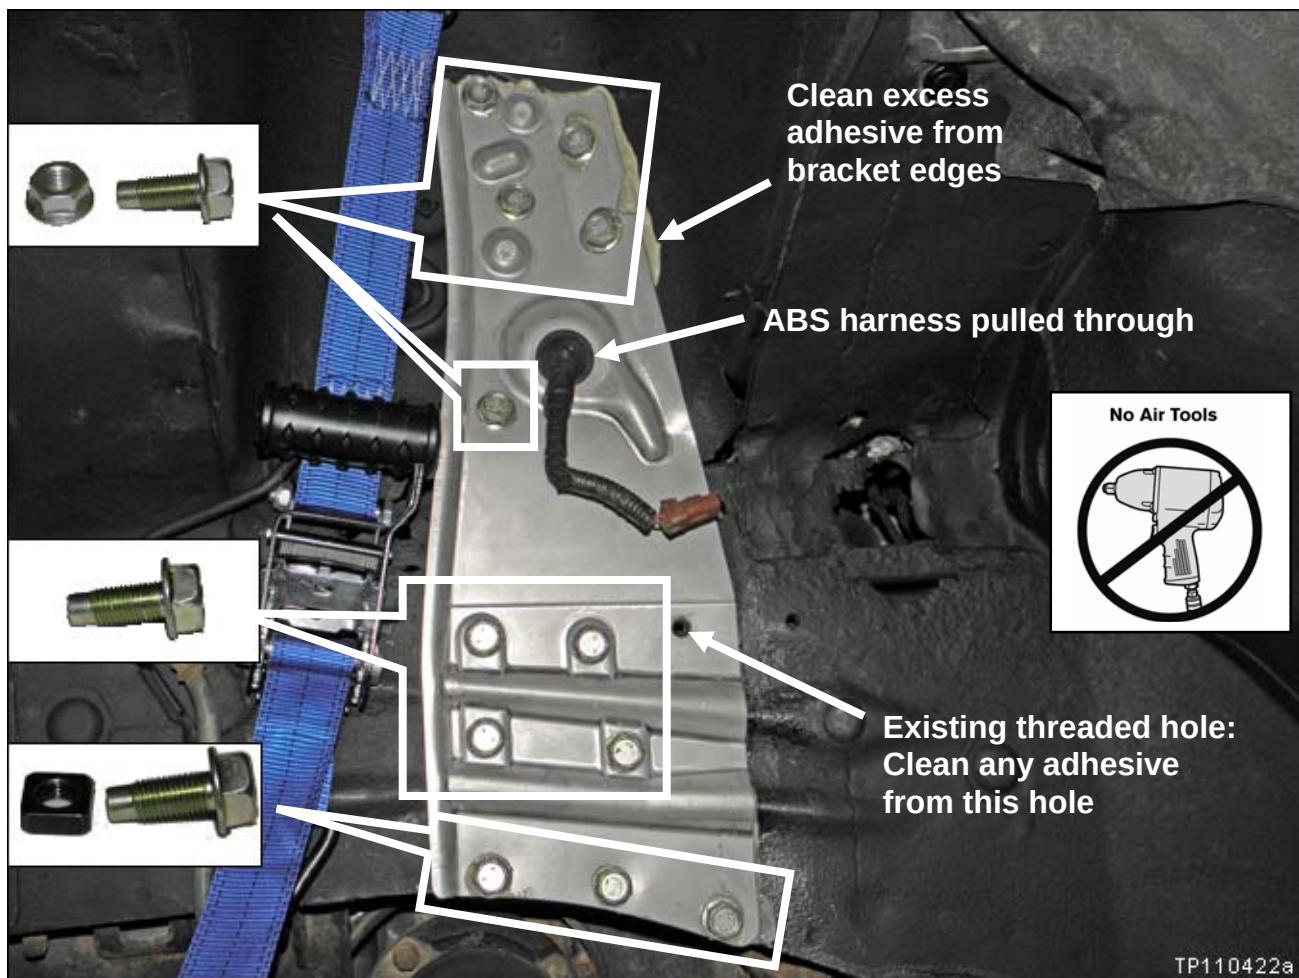
Figure RB25 – Driver side

- Driver side: make sure the ABS harness is pulled through its hole in the repair bracket.
- Use the correct nuts (see Figure RB25, or RB26 on next page, as it applies).
- Do not use air tools to tighten the bolts.
- Torque all new bolts/nuts to 50 N•m (5.1 kg-m, 37 ft-lb).
- Secure all existing bolts.
