Technical Service Bulletin

00 PDI inspection - IQS supplement

00 13 56 2035669/1 November 1, 2013.

Model(s)	Year	VIN Range	Vehicle-Specific Equipment
A6, A7, Q5, Q7	2014	All	Not Applicable

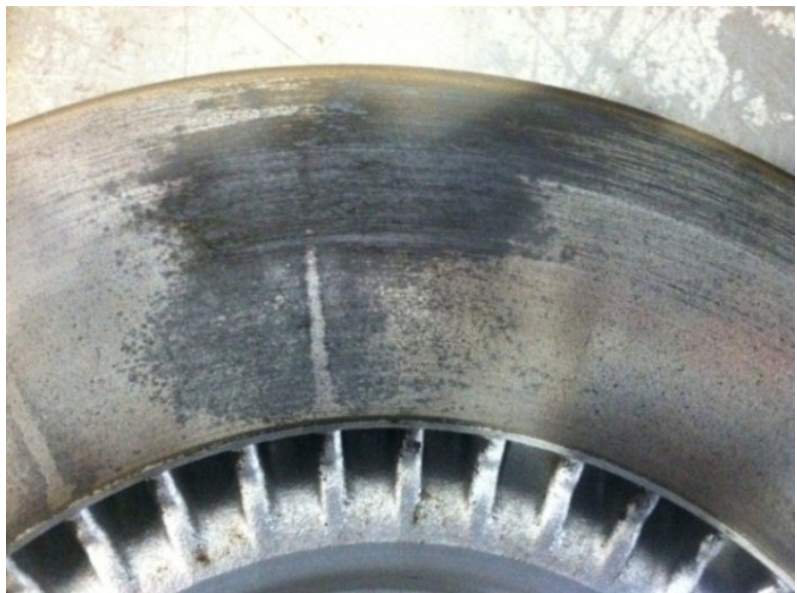
✓ Check Brakes for Pulsation/Vibration (3.0T engines only):

Figure 1. Brake pad marks on brake disc.

- If vibration or pulsation is felt while braking (in brake pedal or in entire vehicle) at speeds higher than 20 mph, put the vehicle on a lift and inspect the brake discs for pad marks (Figure 1).
- Replace only those brake discs that have pad marks (Figure 1). Use the following part numbers:
 - Front brake disc: **4G0615301A**
 - Rear brake disc: **4H0615601H**

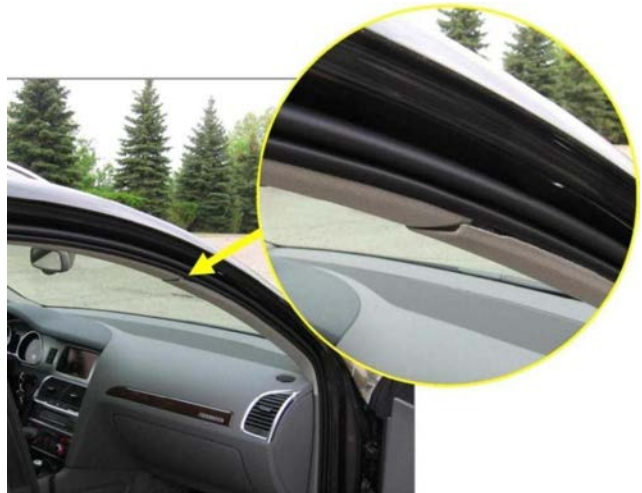
Figure 5. Loose A pillar trim.

- If the A pillar trim on either side of the vehicle is loose or ill-fitting as shown at right (Figure 5), replace the trim.

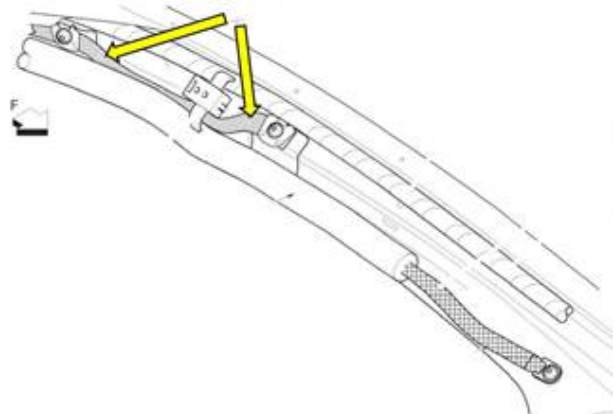
Figure 6. Location of the assembly support strap along A pillar trim bracket.

- When installing the new trim make certain that the assembly support strap is not trapped or pinched between the adapter and the A pillar structure (Figure 6).
