Technical Service Bulletin

58 Rear door seal in B pillar area loose / corrugated

58 13 05 2035796/1 November 14, 2013.

Model(s)	Year	VIN Range	Vehicle-Specific Equipment
A6	2012 - 2014	All	Not Applicable

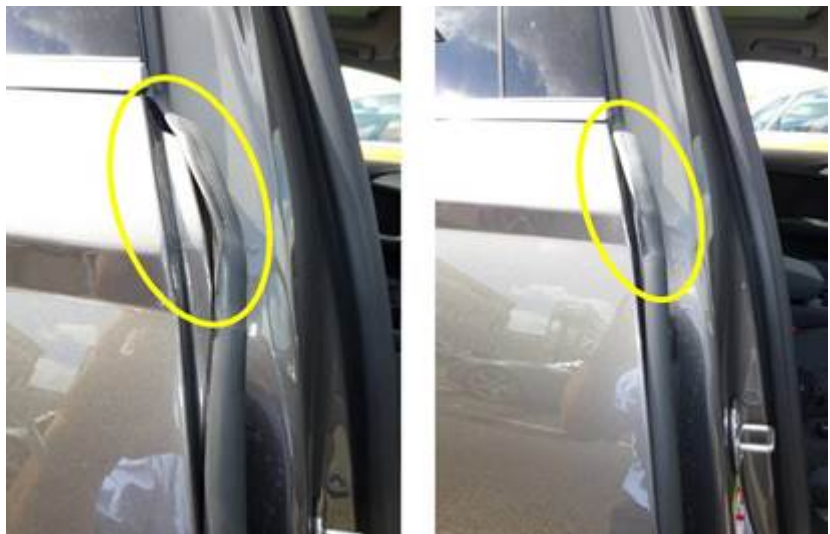
- The customer may report that the seal on the rear door is loose or deformed (Figure 1).
- The loose seal may cause noise when the vehicle is motion.

Figure 1. Example of deformed seal on rear door.

The seal is held onto the rear door by its own clamping force. As passengers enter and exit the vehicle, the seal may become dislodged due to friction created when their clothing comes in contact with the seal.

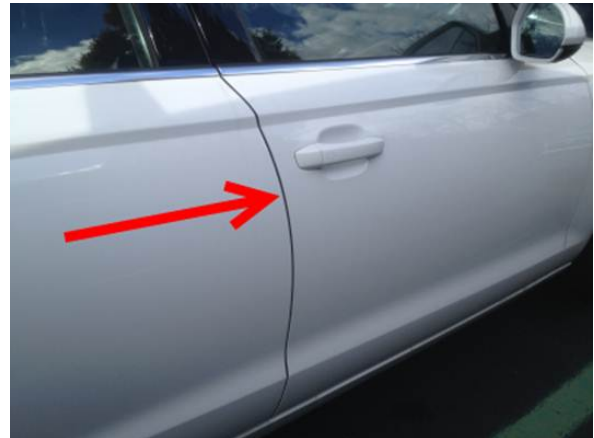
Figure 2. Location of seal on rear door.

1. Inspect the seals of both rear doors (Figure 2):
 - If the seal is found to be loose, but *not* damaged, continue with step 2.
 - If seal *is* damaged, do not continue with this bulletin. Replace the seal (confirm correct part number with Parts Department).

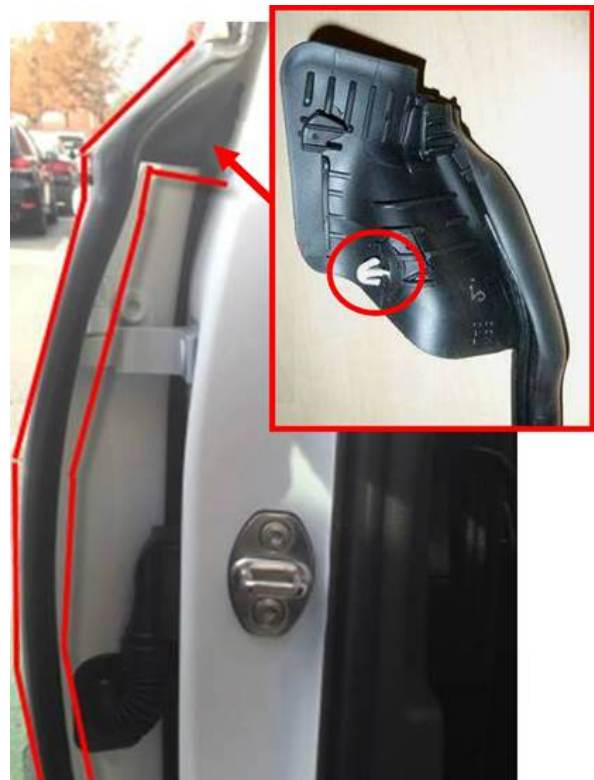
Figure 3. The section of seal to be removed (left) and clipped-in area (inset-right)

2. If seal is found to be loose, remove the section of the seal outlined in the image at right, using caution when removing the clipped-in area (Figure 3).

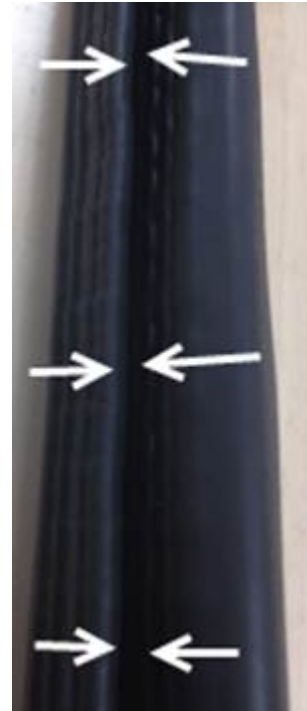
Figure 4. Seal clamping surface.

4. Clean seal clamping surface (Figure 4) with cleaning solution **D 00940104**. The seal will not bond properly if surfaces are dirty.

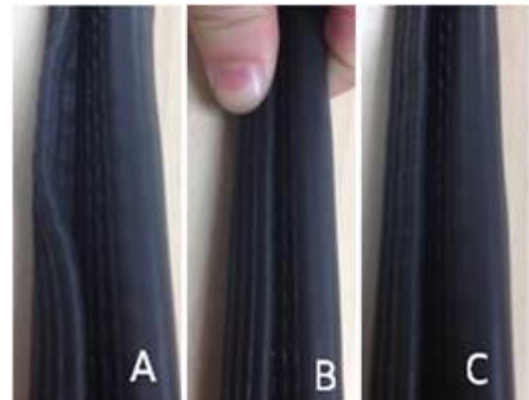
Figure 5. Deformed clamping surface (A), pressing clamping surface together by hand (B), and clamping surface with even force (C).

5. If the seal clamping surface is deformed after cleaning (Figure 5, A), press the clamping surface together by hand (Figure 5, B). This will result in even clamping force (Figure 5, C) when the seal is installed.

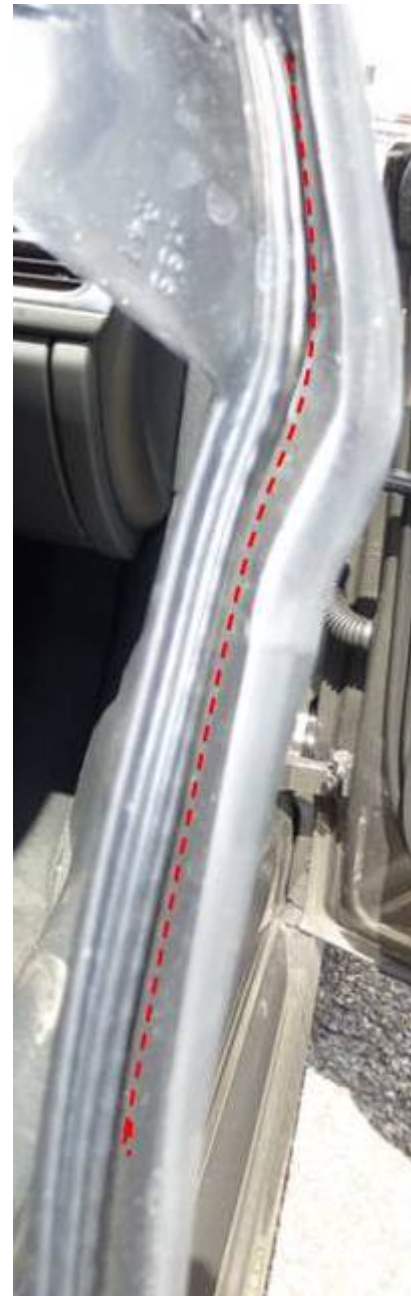
Figure 6. Seal clamping surface; red line indicates where to apply the bonding glue.

6. Apply a thin coat of bonding glue **D 002100** inside of the seal clamping surface, as indicated in the image at right (Figure 6).

7. Refit the seal on the door in reverse order of removal.
8. Do not close the front door for at least 2 hours after applying the bonding glue. Leaving the door open allows the bond to properly cure with the seal in the correct position.
