66 Wind noise from exterior rear view mirror

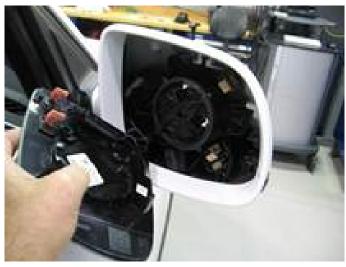
Figure 1. Exterior rear view mirror glass removed.

Begin by removing the exterior rear view mirror glass (Figure 1). Disconnect the electrical connectors carefully and set the glass aside.

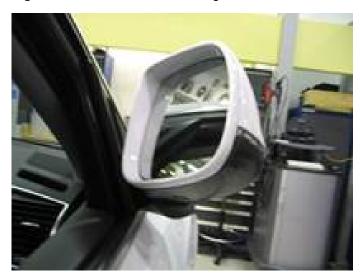
Figure 2. Exterior rear view mirror manually folded.

Remove the exterior rear view mirror cover.
Manually folding the mirror body up will aid in the removal process (Figure 2).

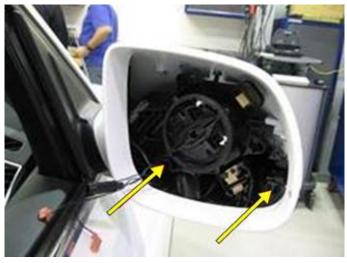
Figure 3. Location of the retaining clips.

3. Carefully pull the lower rim of the cover away from the mirror base. Release the two retaining clips for the cover inside the mirror base (Figure 3).

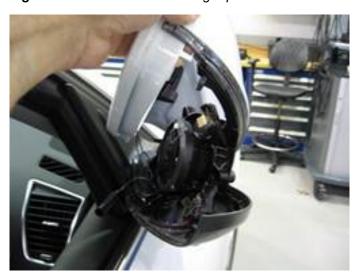
Figure 4. Removing the mirror cover.

4. Unsnap the cover and set it aside (Figure 4).

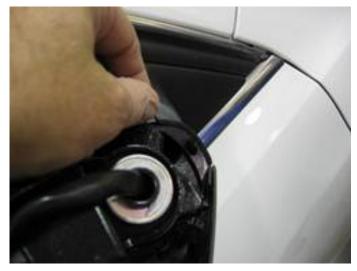
Figure 6. Application of felt tape.

6. Apply the felt tape strips to the exposed area of the mirror base, as shown at right (Figure 6 and Figure 7).

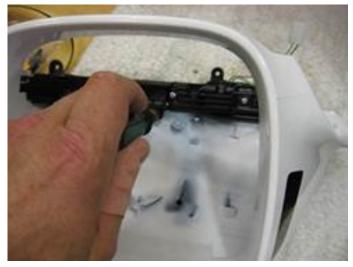
Figure 8. Removing the turn signal lamp.

7. Remove the turn signal lamp from the mirror cover (Figure 8).

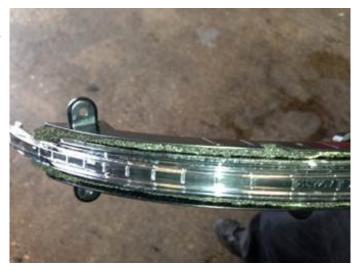
Figure 9. Turn signal lamp with sealing foam tape installed.

8. Apply strips of foam material (part number **8F0857869**) into the entire channel that surrounds the turn signal lamp, as shown at right (Figure 9 and Figure 10).

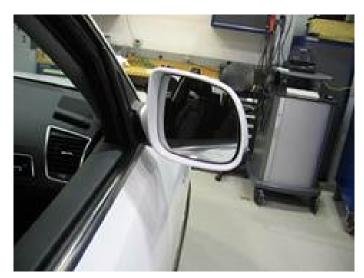
Figure 11. Mirror reassembled.

Reinstall the turn signal lamp into the mirror cover. Reinstall the mirror cover onto the mirror base (Figure 11).

Tip: Exercise care in the reassembly process. Incorrect or incomplete reassembly will cause recurrence or additional wind noise from the mirror assembly.
