Technical Service Bulletin

70 Noises from front doors when playing music tuned with heavy bass

70 13 35 2022773/5 November 26, 2013. Supersedes Technical Service Bulletin Group 57 number 12-70 dated September 5, 2012 for reasons listed below.

Model(s)	Year	VIN Range	Vehicle-Specific Equipment
A5 / S5	2008 - 2015	All	Not Applicable
A5 / S5 Cabriolet	2010 - 2015		
A4 / A4 allroad	2009 - 2015

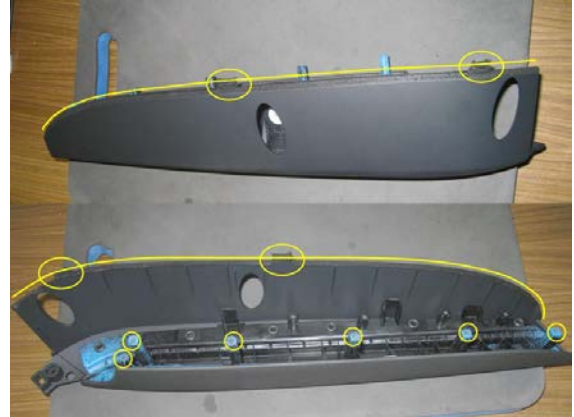
Figure 1. Areas to be isolated.

Vibration noises from the doors or the rear parcel shelf are heard, particularly when heavy bass audio is playing.

Components on the doors or the parcel shelf vibrate while heavy bass audio is played.

1. Apply fleece adhesive tape **D 373125A2** to the areas marked in yellow in the images at right (Figure 1, Figure 2, and Figure 3).

Cover the entire edge indicated by folding the fleece tape over the edge.

2. Apply special lubricating paste **G 052141A2** to the areas shown in blue in the images at right (Figure 1 and Figure 2).

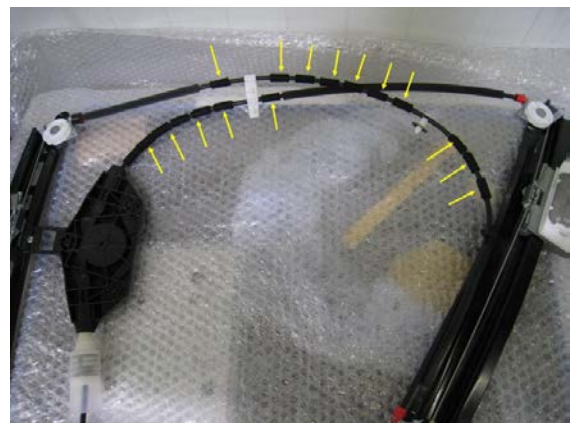
Figure 6. Window regulator cables, to be covered with felt strip.

4. Apply sections of self-adhesive felt strip **533863288A** to the window regulator cables in the areas shown (Figure 6).

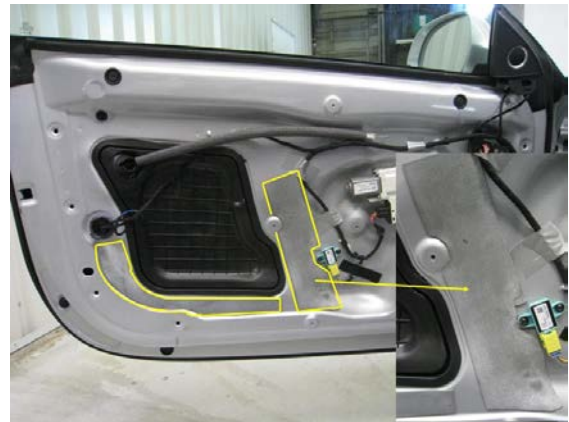
Figure 7. Areas to apply sound absorber.

5. Apply 2 pieces of sound absorber **4D0831539D** in the areas shown (Figure 7).

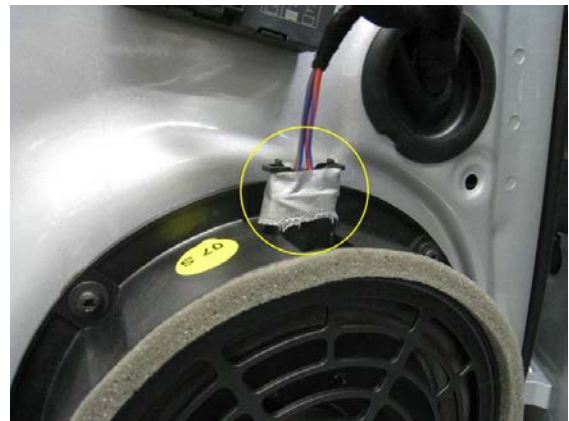
Figure 8. Duct tape surrounding the speaker connector.

6. Apply a piece of duct tape to the speaker connector as shown (Figure 8).
Apply the tape in such a way as to isolate any possible vibration from the connector, but not so tightly that the tape compresses the connector lock.

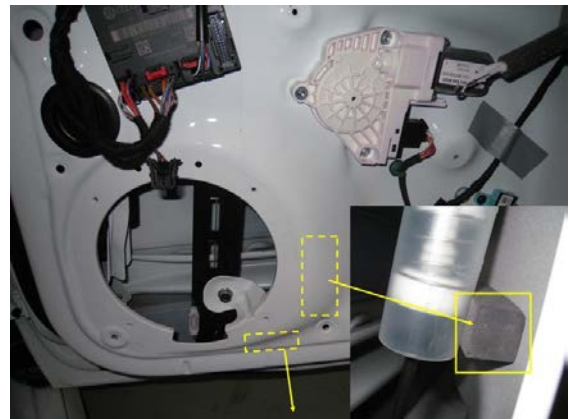
Figure 9. Application of insulation strip material.

7. Apply insulation strip material **8E0831575A** to the points of contact between the window regulator cables and the door shell as shown (Figure 9, Figure 10, and Figure 11).

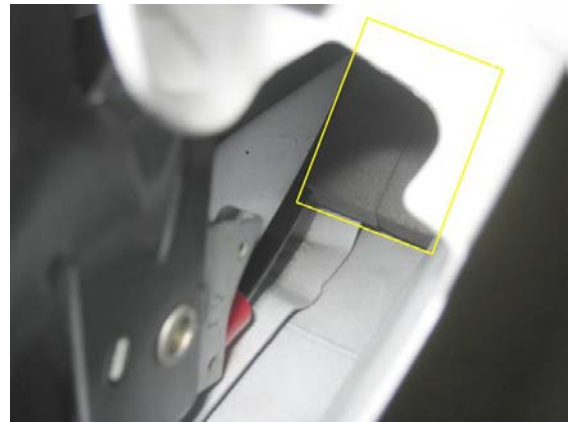
Figure 10. Application of insulation strip material.

In some cases (as in Figure 10), two pieces of insulation strip material may need to be bonded together to achieve the proper dampening.

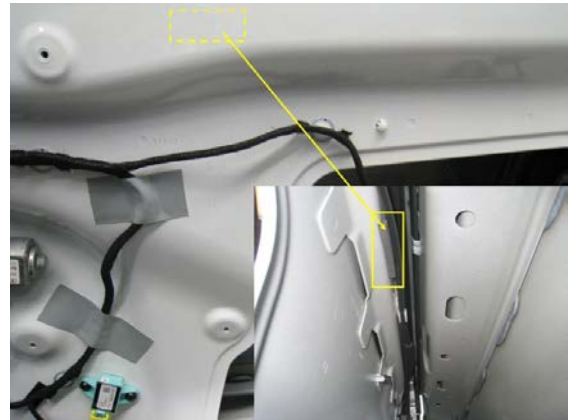
Figure 11. Application of insulation strip material.

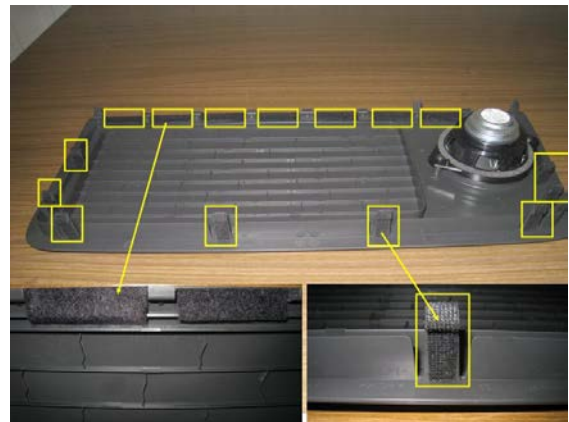
Figure 12. Areas to apply fleece adhesive tape.

8. Apply sections of fleece adhesive tape **D 373125A2** to the tabs of each rear loudspeaker trim (Figure 12).
