TECHNICAL BULLETIN

Q322NAS1
18 DEC 2013

Service Action: Air Suspension Thermistor Wiring Short Circuit

Range Rover (LG)
Model Year: 2013
VIN: DA100000-DA107500

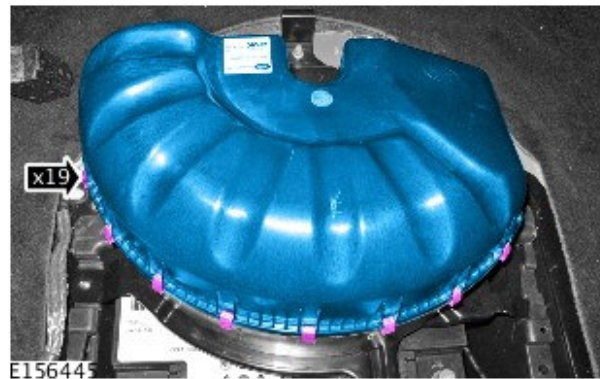
3.

Gain access to the air supply housing (two parts [upper and lower] which surrounds the suspension air supply unit).

- Separate the upper and lower parts of the air supply housing and remove the upper part.

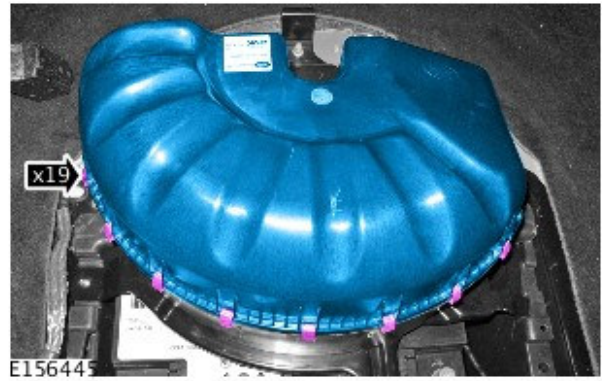
- 10.** Install the upper section of the air supply housing, making sure of the accuracy of the fit:
- Secure the two sections with the 19 metal clips.
