Reference	SSM63857
Models	Range Rover (All New) / L405
Title	All New Range Rover Drivers Door Lock Covers not fitted correctly
Category	Body
Last modified	07-Mar-2013 00:00:00
Symptom	112000 Latches/Locks & Security
Content	<p><b>Concern</b>                      A number of Dealers have reported that the Drivers Door Lock cover on the 'All New Range Rover' has either come adrift after fitment or has shown signs of cracking again after fitment by the Dealer</p> <p><b>Action</b>                      It is important that the Dealer fit Driver's Door lock Cover is fitted correctly in order to prevent it coming adrift or cracking at a later date. Please refer to the attached file which details the fitting instructions.</p>

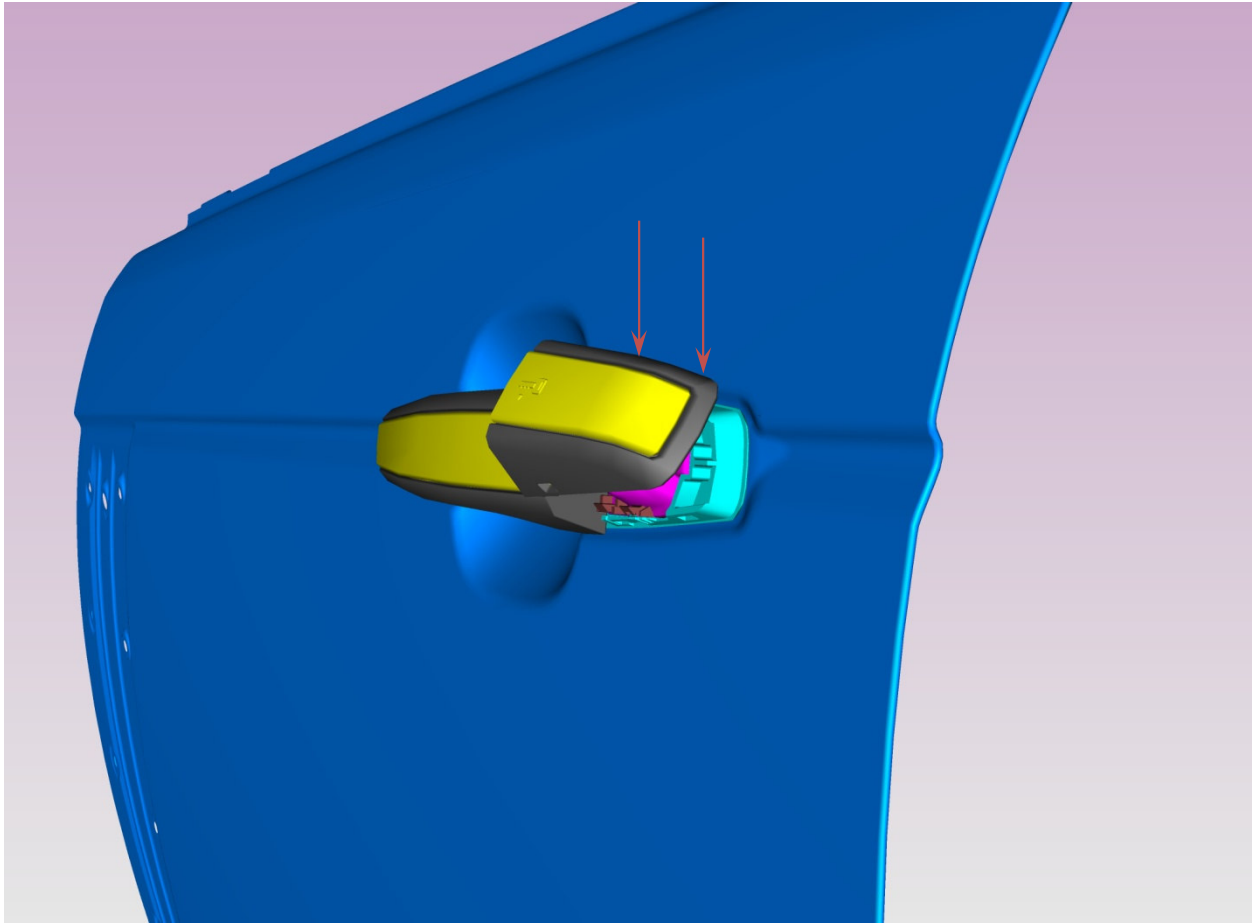
Approach the vehicle with the Door Lock Cover tilted upwards. There is a pair of clipping features that need to be carefully located into the gasket behind.

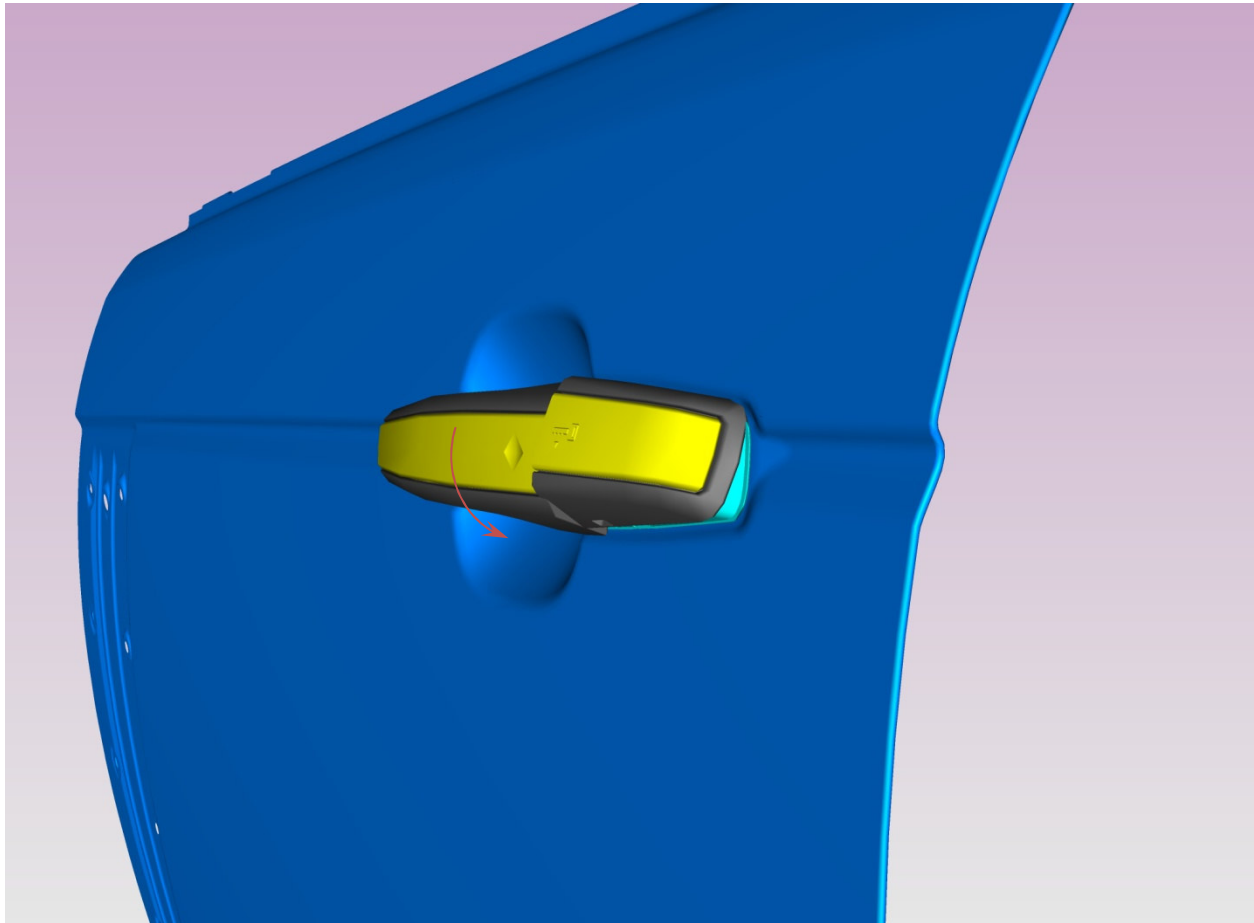
Located both of the clipping features into the gasket in a downwards motion. Once the upper retention lugs are located, rotated the Door Lock Cover downwards to engage the clip on the underside

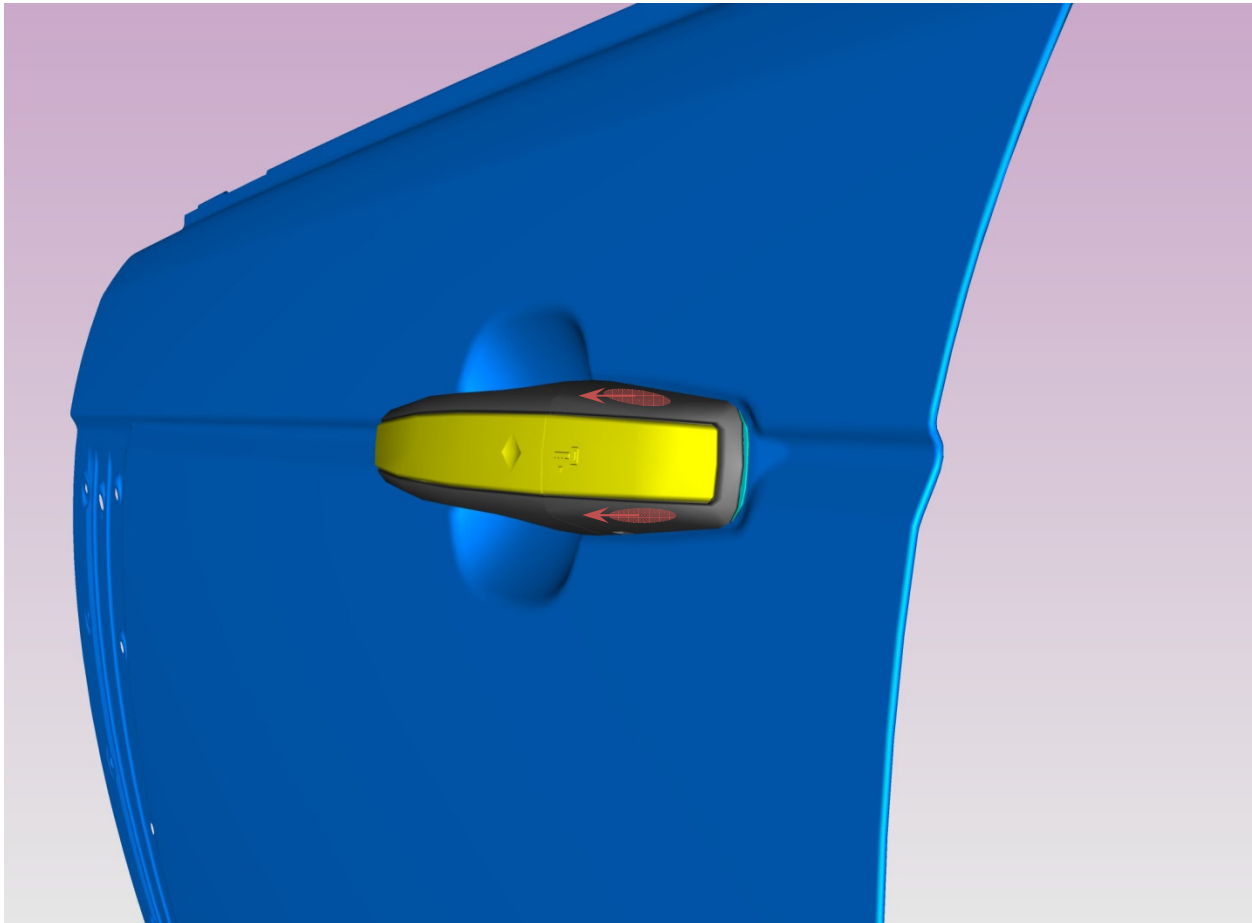
Rotate the Door Lock Cover downwards until a positive click is felt / heard, as the lower retention lug snaps into place in the gasket. Check the Door Lock Cover is secure by gently pulling it, it should remain securely in position on the vehicle.
