Reference SSM62297

Title L359 Freelander & Range Rover Sport front carpet mat fit

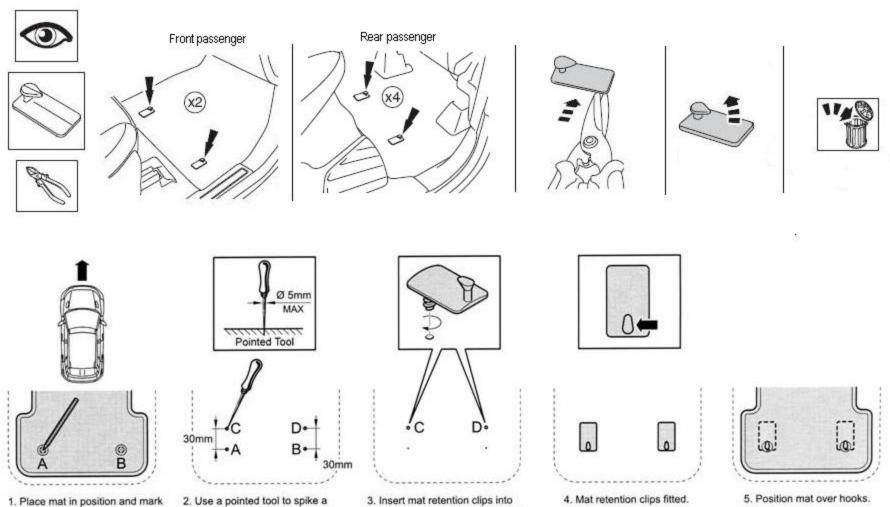
## **Mats Retention Clips**

points C and D and turn clockwise

until they turn freely.

small hole in the carpet at points C and D, 30mm forward of marks

A and B.

centre of hole positions.

4. Mat retention clips fitted. 5. Position mat over hooks.

If it is seen that the front carpet mat does not fit correctly

follow the attached instruction
