TECHNICAL BULLETIN LTB00542NAS1 05 JUL 2013

SECTION: 204-04

Tire Pressure Monitoring System - Improved Diagnostics and Service Information

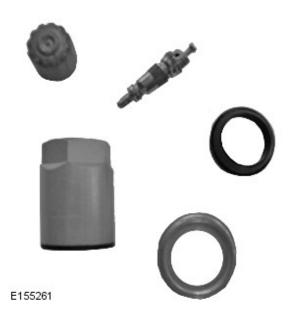
- TG1B Service kit hardware and seals only; no valve stem
 - Part number LR032879; currently fits:
 - LR4 (L319)
 - Range Rover Evoque (L538)
 - Range Rover Sport (L494)
 - Range Rover (L405)
 - Range Rover Sport (L320, 2010-2013MY)
 - Range Rover (L322, 2010-2012MY)

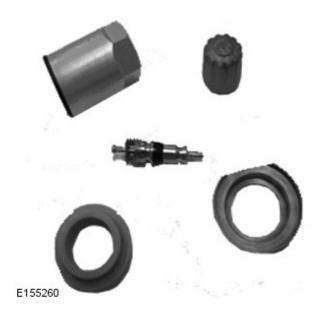
11. TG1C Service kit - hardware and seals only; no valve stem

- Part number LR032865; currently fits:
 - LR2 (L359, 2010MY+)

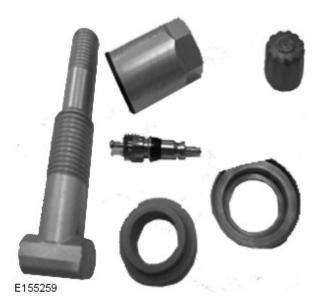
- 12. TG1C Service kit hardware, seals, and valve stem
 - Part number LR032834; currently fits:
 - LR2 (L359, 2010MY+)
