# Technical Service Bulletin

## 21 Rattling/jarring noise from engine - 2.0 TFSI EA888 transverse

21 13 15 2027585/4 June 24, 2013. Supersedes Technical Service Bulletin Group 21 number 12-09 dated May 16, 2012 for reasons listed below.

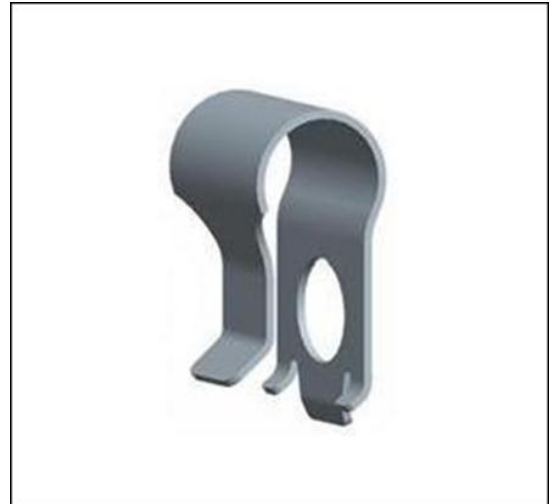
**Figure 1.** Spring clip

A spring clip (**06J145220A**) must be fitted on the wastegate adjustment (Figure 1).

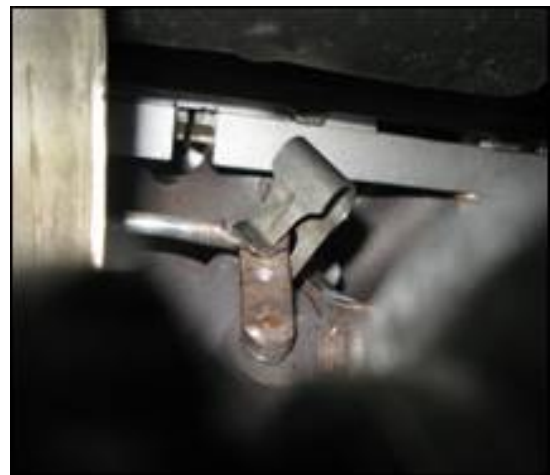
**Figure 2.** Wastegate linkage with clip fitted from the side.

1. Remove the noise damping according to the instructions in Elsa: *Repair Manual >> Body >> Body Exterior >> 50 Body Front >> Removal and Installation >> Noise Insulation.*
2. Remove the drive shaft protection.
3. Fit the clip from the side (Figure 2).

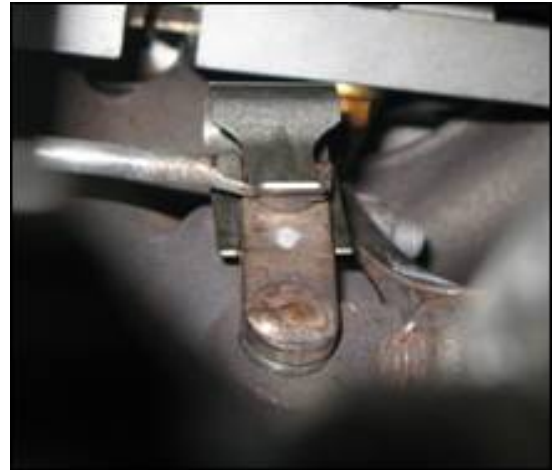
**Figure 3.** Wastegate linkage with clip in final position.

4. Turn the clip to the left until the lugs slot in (Figure 3).

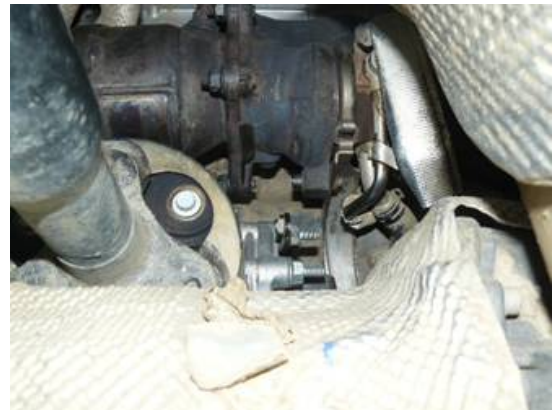
**Figure 4.** Reach through and position clip.

1. Remove the propshaft heat shield according to the instructions in Elsa: *Repair Manual >> Body >> 66 Exterior Equipment >> Removal and Installation >> Underbody Trim Panels >> Heat Shields, Driveshaft*
2. Reach through from behind to position the clip (Figure 4).

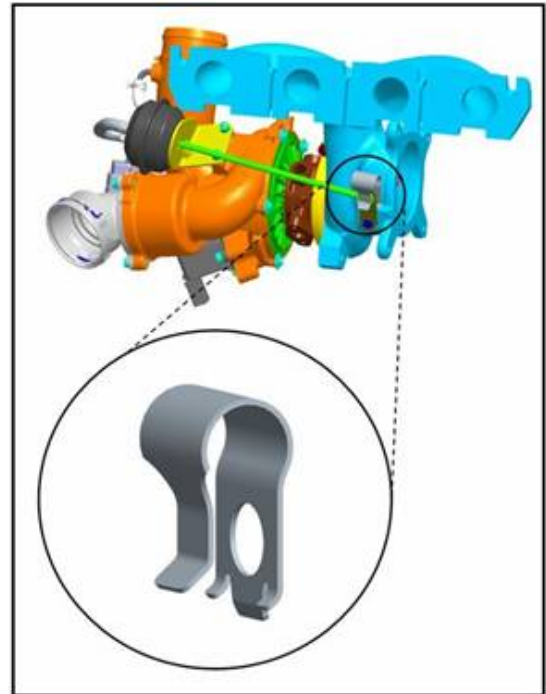
**Figure 5.** Fit the spring clip on the wastegate adjustment.

3. Fit the spring clip on the wastegate adjustment (Figure 5).

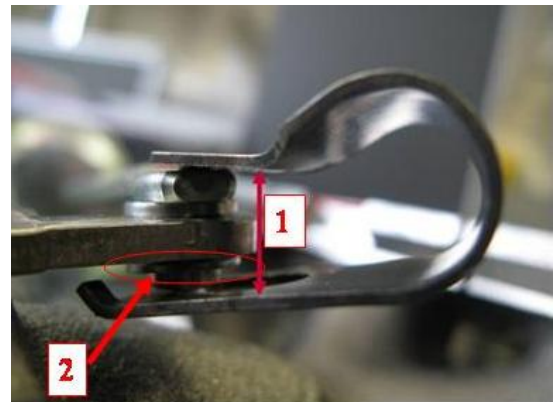
**Figure 6.** (1) Maximum opening of spring clip.

**Tip:** The spring tip must not be overstretched. The maximum opening of the spring clip is 14 mm. In the example in the image, the opening is approximately 10.5 mm (Figure 6).

The spring clip must be replaced after every removal.

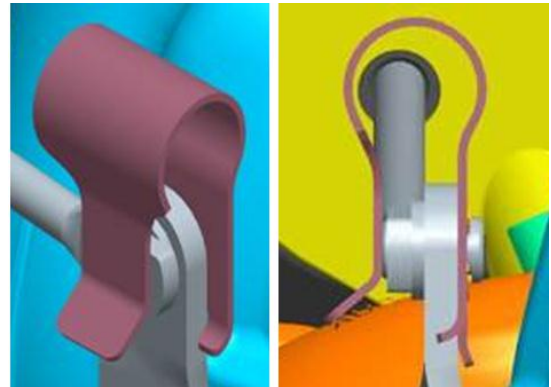
**Figure 7.** Spring clip correct fitting.

4. After fitting the spring clip, check for correct fit (Figure 7).

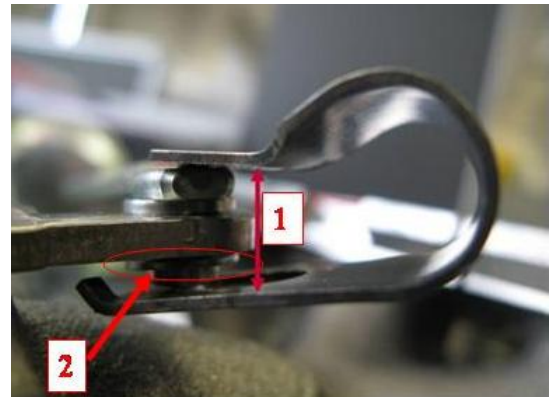
**Figure 8.** (2) Position of the original circlip.

5. Check the position of the original circlip (Figure 8), and correct if necessary.
