TECHNICAL BULLETIN
LTB00526NAS1
12 APR 2013

SECTION: 501-00

Discolored Quarter Glass / Waist Seals

Range Rover Sport (LS)	Model Year:	2005-2013
	VIN:	900129 Onwards

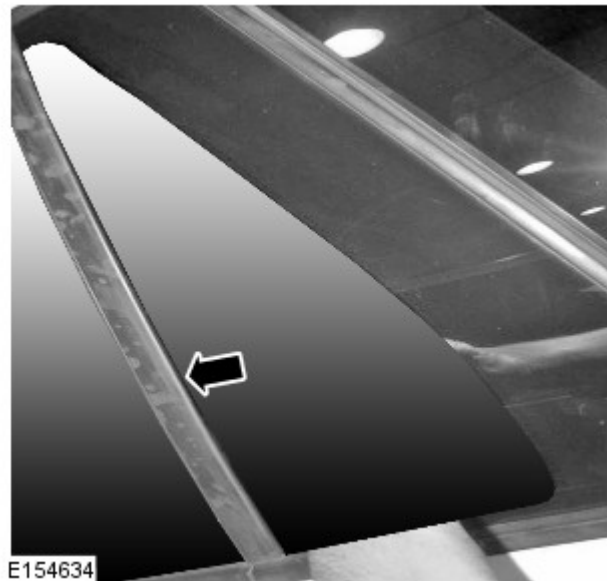
Situation: The quarter glass / waist seals may become discolored.

Cause: This may be caused by the seals becoming contaminated from external sources.

- Rinse affected area down with fresh water to remove grit and dust.

- Spray affected parts with dilution and then gently wipe with soft cotton cloth to remove staining.
- Rinse off with fresh water and dry with a **clean** soft cotton cloth.
- Make sure that the quarter glass / waist seal is aesthetically pleasing on the eye.
- If required, repeat procedure to the other quarter glass / waist seals as necessary.
