SERVICE BULLETIN

APPLICABILITY: Legacy and Outback 2000-2009MY w/ 5MT
 Forester 1999MY and Later w/ 5MT
 Impreza (Including WRX) 1999MY and Later w/ 5MT

NUMBER: 03-70-12R
DATE: 12/13/12
REVISED: 05/22/13

SUBJECT: Repair Procedure for High-Pitched Sound from Extension Housing Area Using Latest Generation Production Parts

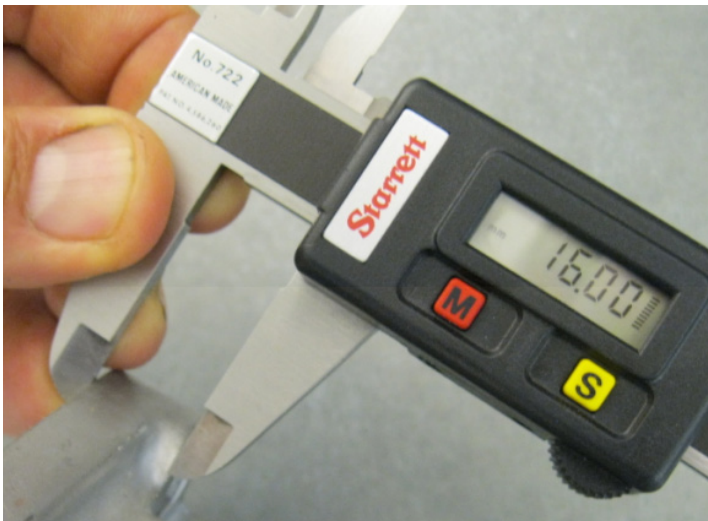
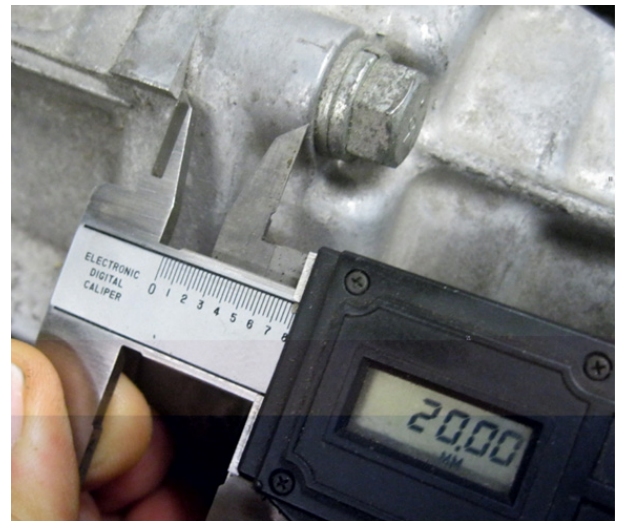
NOTE: When replacing the extension case, the output oil seal, p.n. 806735210 must be replaced. If the transmission number is prior to 5588478, and you are replacing the extension case, shorter case bolts, p.n. 800610940, (quantity 9) must also be installed due to the thinner retaining bolt boss areas of the replacement extension case (16mm vs. 20mm) as shown in the photos below.

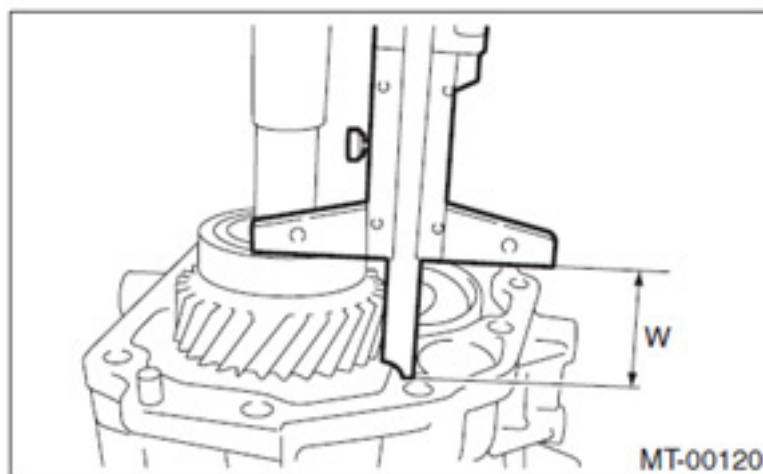
W Measured value

- Measure height “W” between transfer case sealing surface and taper roller bearing outer race on the transfer driven gear.

- Calculate the required thrust washer thickness “T” using the revised formula below:

$$T = X - W - (1.715 \text{ to } 1.765 \text{ mm (0.0686 to 0.0706)})$$

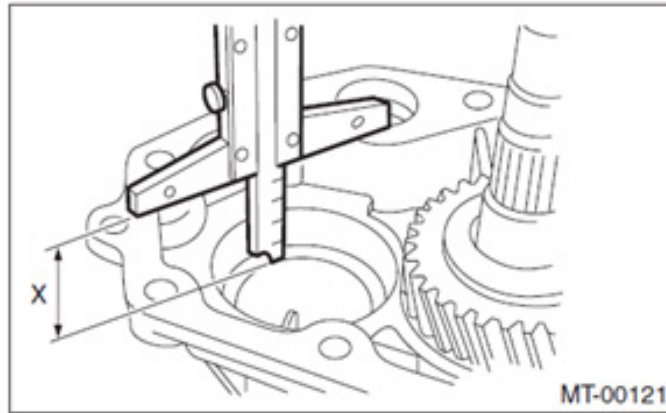
X Measured value

- With the bearing outer race, dish plate and thrust washer removed, measure depth “X” of the bearing bore of the extension case.

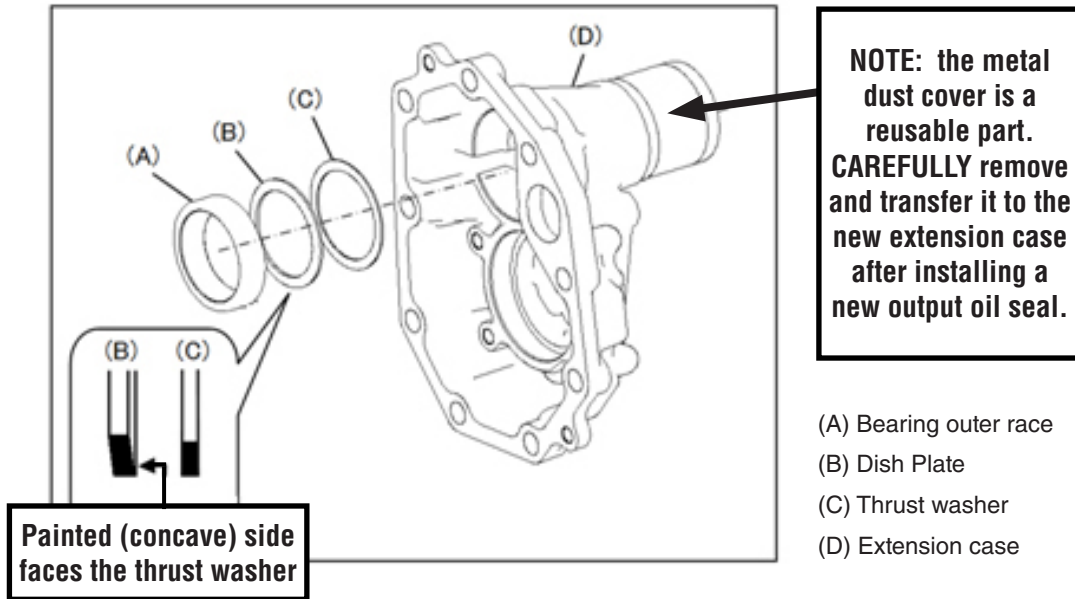
- Once the proper thrust washer has been selected, assemble the new extension case as shown in the illustration below.

- Install a new output oil seal before transferring the original metal dust cover over to the new extension case.
- Follow the procedure in the applicable Service Manual for re-installation of the new extension case assembly to the transfer case.
