SERVICE BULLETIN

APPLICABILITY: 2013 MY Outback with seat back protector

NUMBER: 15-160-13R

SUBJECT: Poor Fit of Seat Back Protector

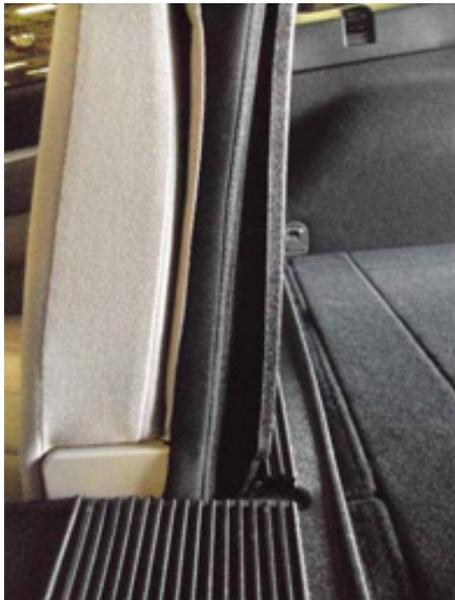
Typical seat back protector fit

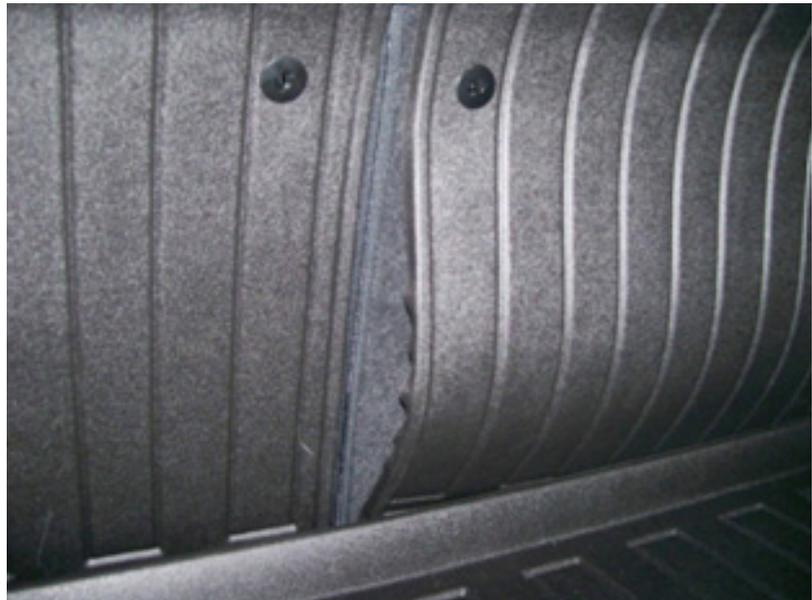
If the seat back protector buckles outward from the rear seat back excessively, please make sure the seat back protector is installed properly. A seat back protector that is installed too low on the rear seat back will interfere with a bracket in between the cargo area floor and the rear seats. This interference causes the seat back protector to buckle when the seats are folded upright.

Poor appearance of seat back protector due to improper installation

Check the distance from the top edge of the seat back protector to the point of transition between the rear seat back material and the seat fabric. If the top edge of the seat back protector is not at the right distance from the transition between seat back and seat materials, remove the clips from the seat back protector and reinstall.

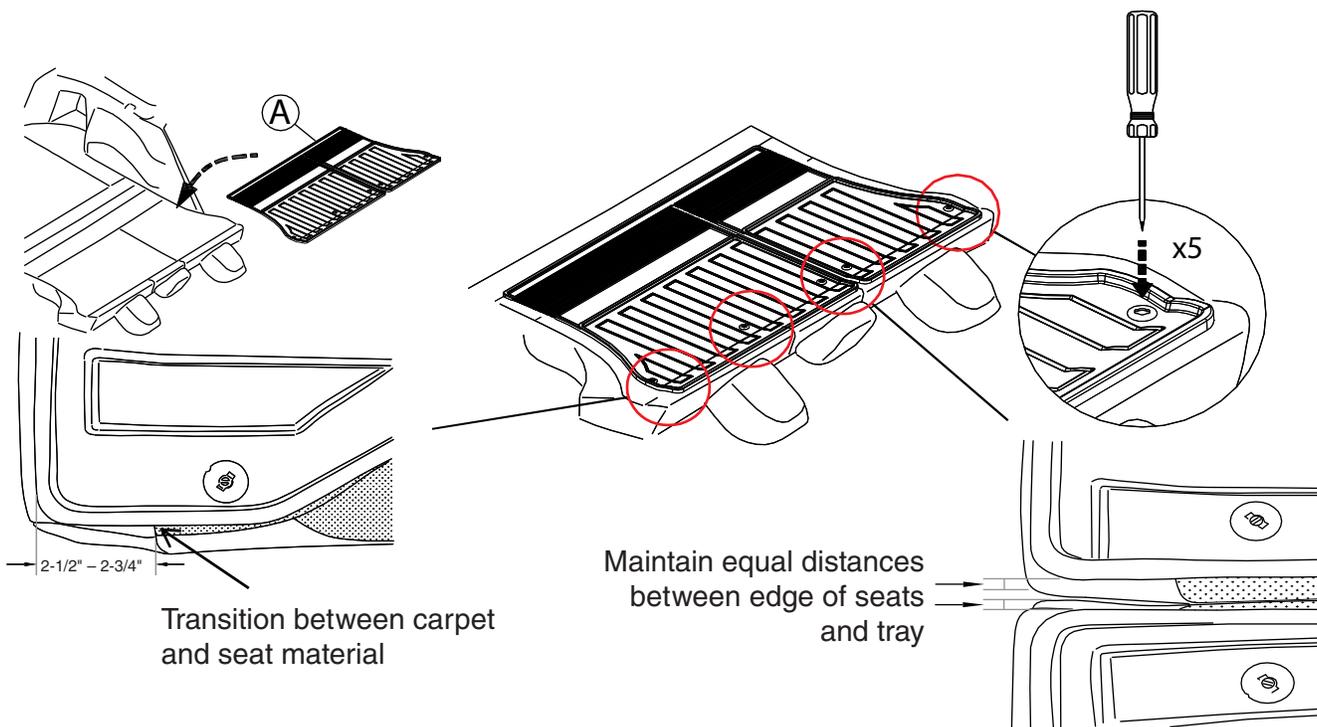
Place tray in position and use awl to make holes in the seat back material in all 5 grommet locations.
