Technical Bulletin

40 13 01 March 20, 2013 **2033347**

CV Boot Replacement

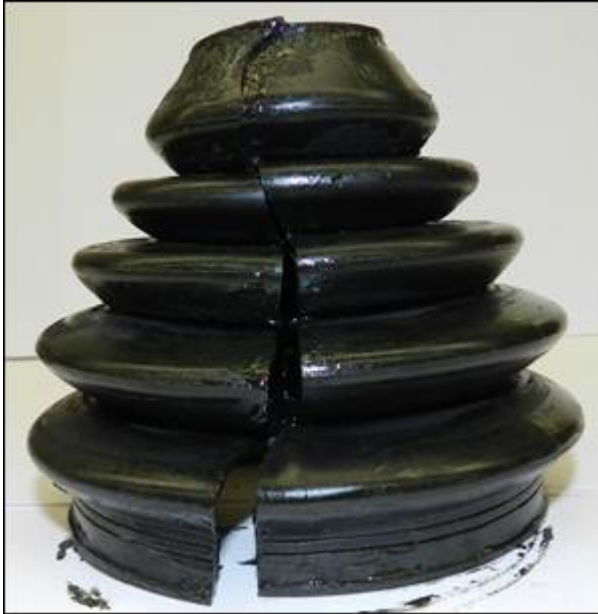
CV Boots should not be cut or sliced upon removal.

If it is determined that a CV boot needs to be replaced, the boot should be removed and replaced without cutting or slicing the boot open. Once the CV Joint is removed the boot will slide off the axle shaft. Refer to repair manual group 40, removal procedure for drive axle disassembly, in ElsaWeb.

Claims will not be accepted if the CV Boot is cut or sliced.

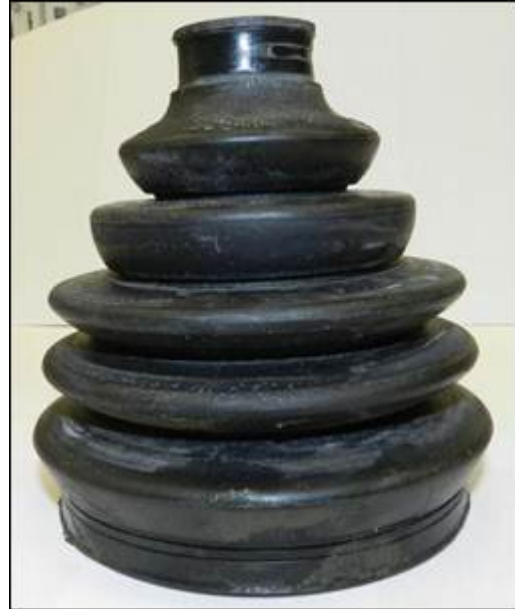
CV Boots should slide off the driveshaft after the removal of the CV Joint.
