Tech Tips

TT 13-13-01

2008-2013 Vehicles with CCTA or CBFA 2.0T TSI Engine – Crank Gear/Timing Chain Service Tip

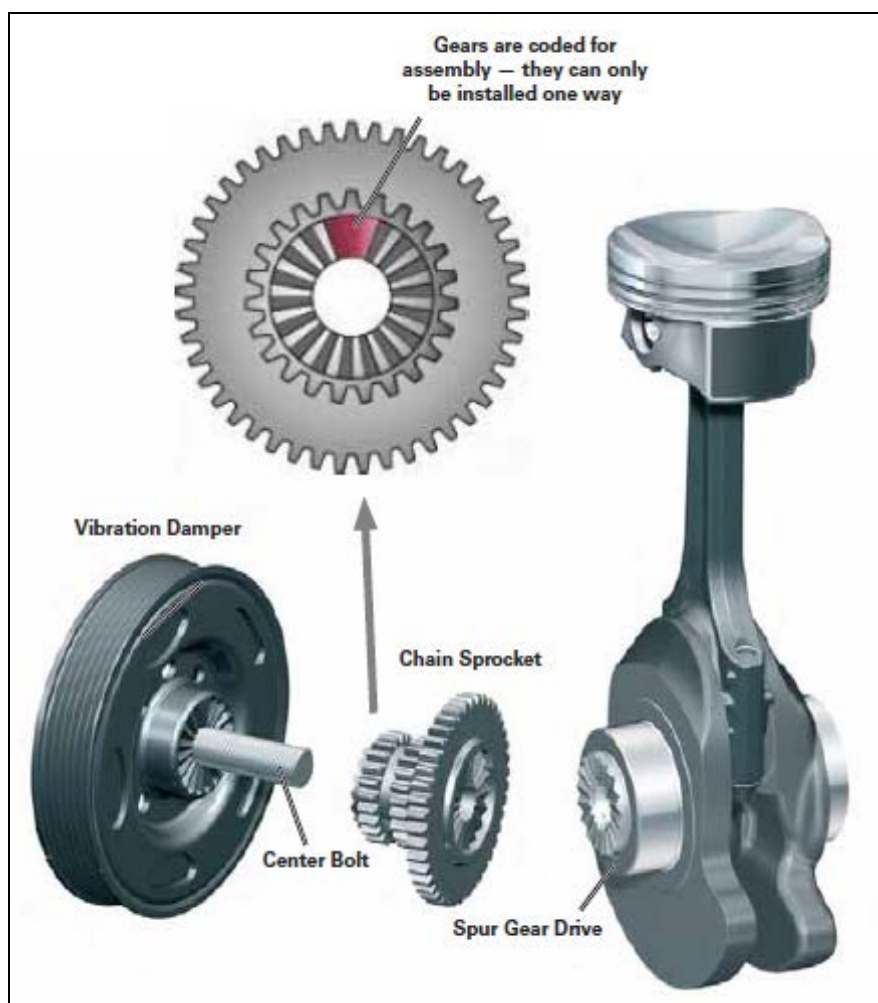
When servicing the timing chain sprocket or removing the vibration damper, be aware that one bolt holds both the vibration damper (harmonic balancer) and the crankshaft timing chain sprocket to the crankshaft. Once the damper is removed, the crankshaft should not be rotated unless special tool spacer T10368 has been installed. The crankshaft timing chain sprocket and spur gear drive on the crankshaft have a coupling that must be seated correctly during assembly. Failure to install special tool spacer T10368 before rotating engine will cause the engine to skip time and bend valves.
