# Tech Tips

TT 61-08-05

## 2007-2013 Eos – Convertible Top Repair Tip

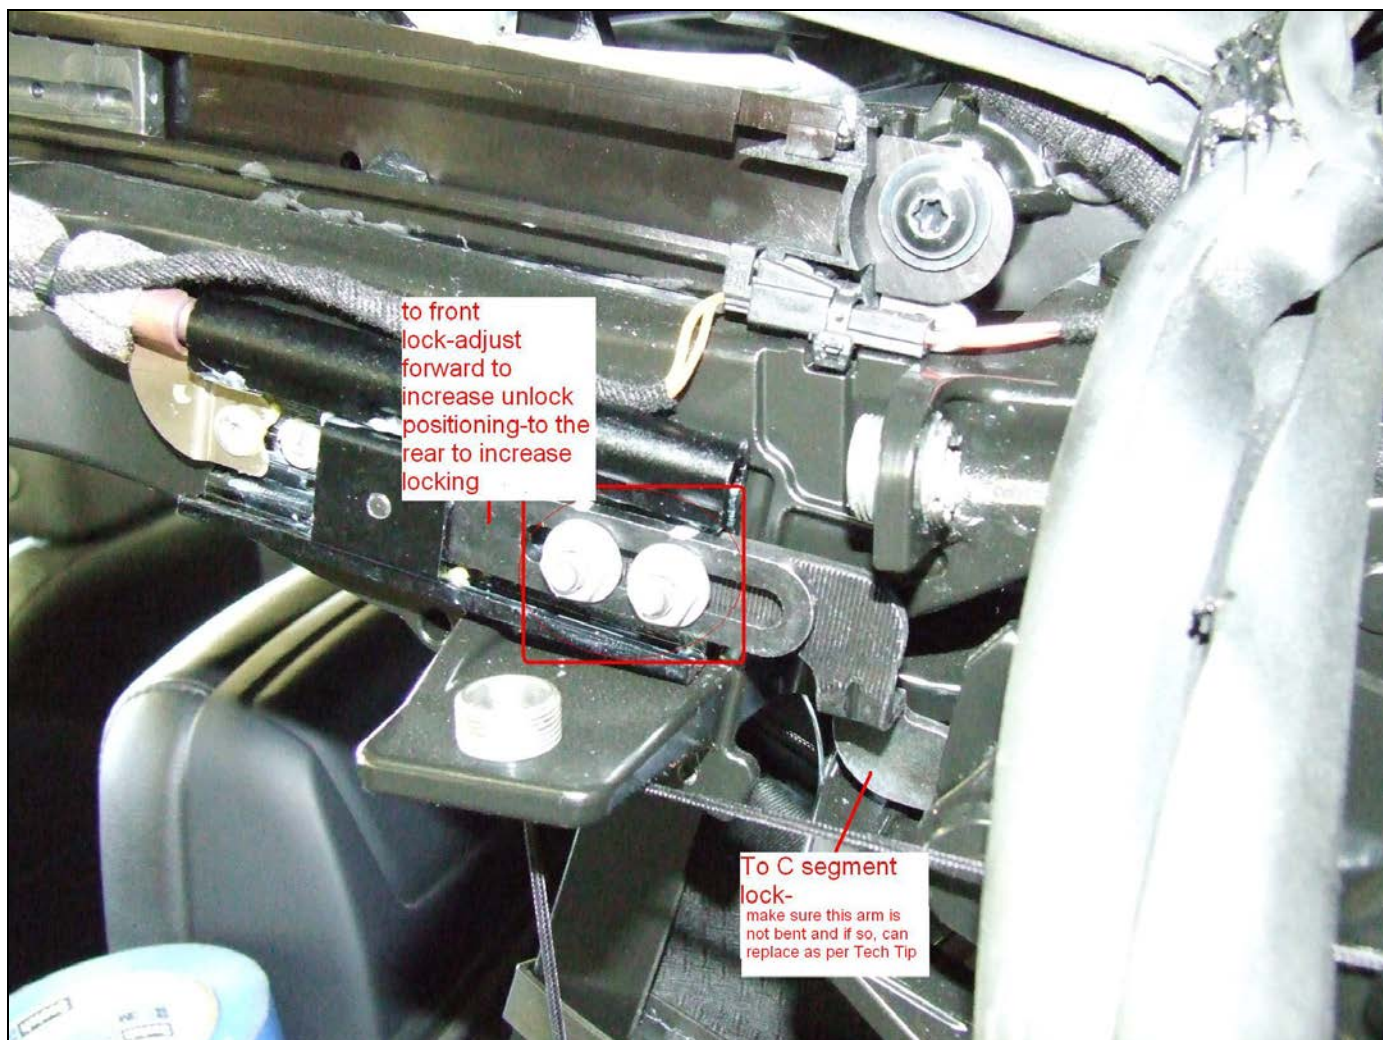
If, during diagnosis of the convertible top, the adjuster arm for the front lock is found damaged, **order part number 1Q0898499 or latest supersession.** This one part number will include both sides in the package. **Adjuster arm location is shown below with painted roof pillar panel removed.**
