Technical Service Bulletin

19i9 UPDATE - Coolant Expansion Tank (NVLW)

March 5, 2013

Model(s)	Year	VIN Range	Vehicle-Specific Equipment
A8/S8	2013	009820 - 015495	None

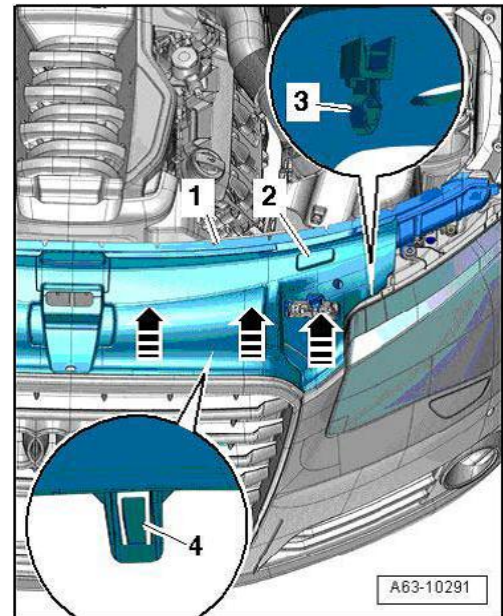
Figure 1. Removing cover.

1. Detach cover (Figure 1, 2) from lock carrier (Figure 1, arrows). Retainers (Figure 1, 3 and Figure 1, 4) must be released when cover is pulled off. Pull cover out of slot on lock carrier (Figure 1, 1) and remove.

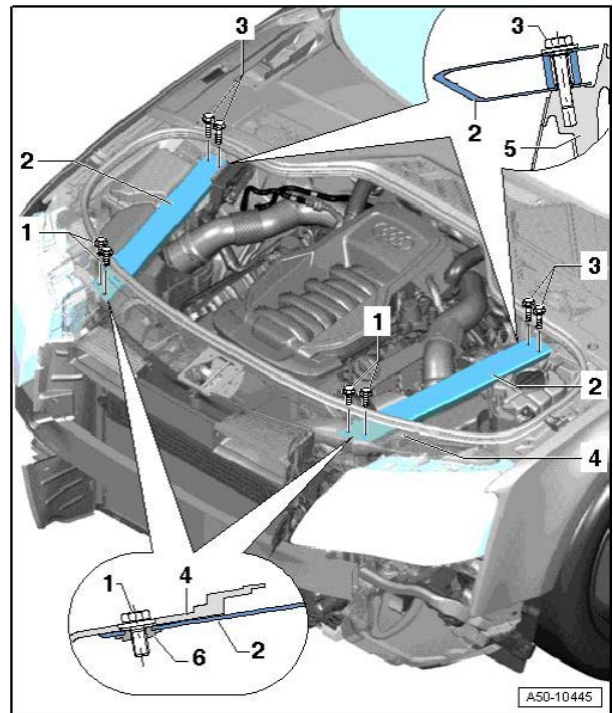
Figure 2. Longitudinal member removal

2. Remove longitudinal member (left side) by unscrewing bolts at front and rear (Figure 2) and lifting it out. (Tightening torque: 24 Nm) Then, remove bolts (Figure 3).

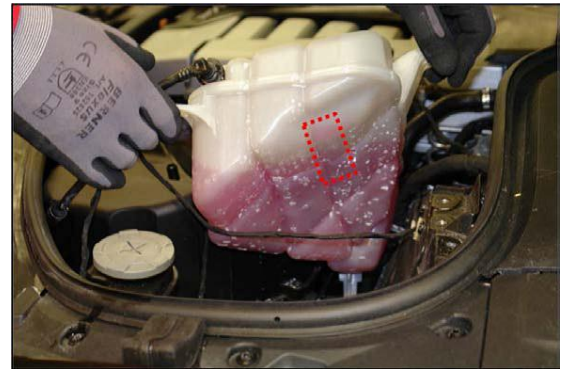
Figure 4. Lifting up coolant expansion tank

3. Lift up coolant expansion tank to find the manufacturing date (Figure 4).

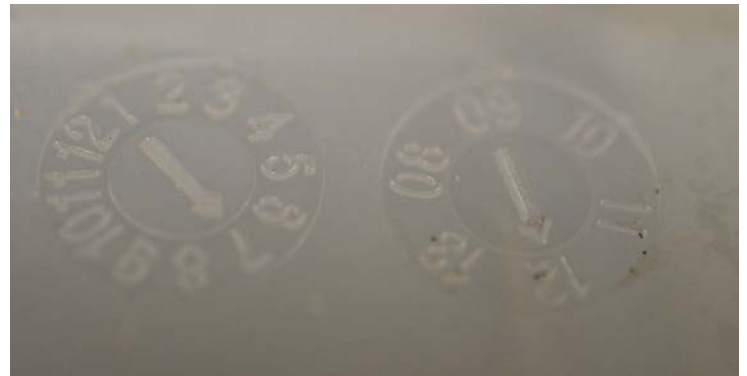
Figure 5. Manufacturing date.

4. Observe the manufacturing date. The dial on the left represents the month, and the dial on the right represents the year (Figure 5). In Figure 5, the dial on the left shows “7”, and the dial on the right shows “12”, which means that this example was made in July, 2012.

If the manufacturing date shows either of the following dates, it must be replaced:

- July, 2012
- August, 2012

If the manufacturing date shows any other date, it is okay and can be re-installed.

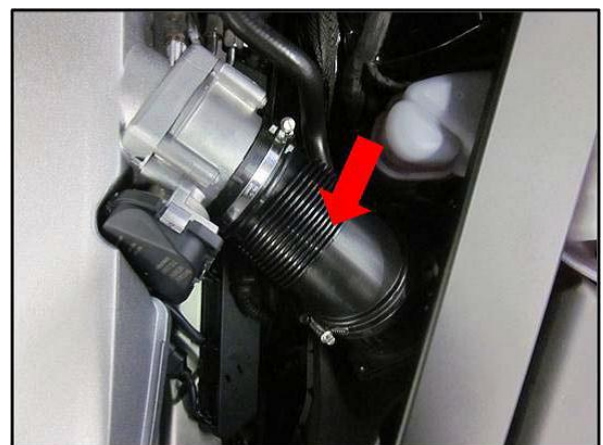
Figure 6. W12 air duct

1. Remove the air duct from the engine:
 - W12 engine (Figure 6)
 - S8 engine (Figure 7)

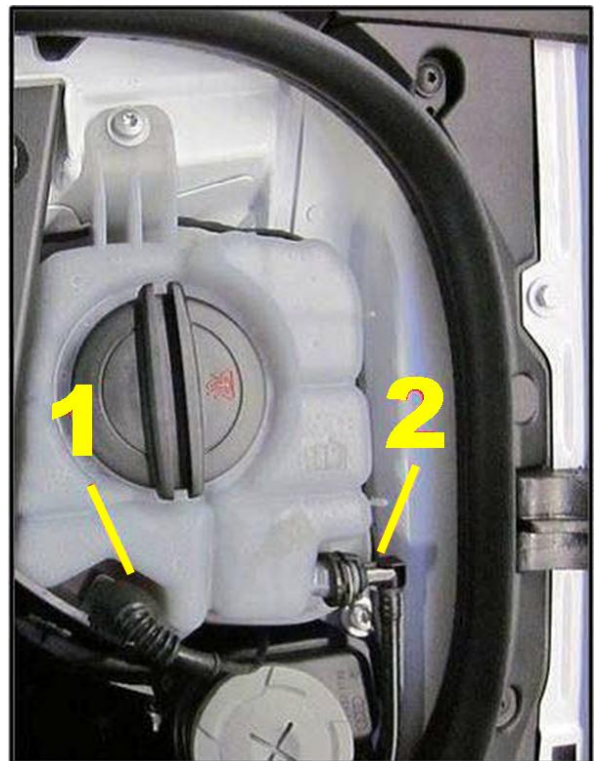
2. Unplug connector (Figure 8, 1) and disconnect breather line (Figure 8, 2)

Figure 8. Connector (1) and breather line (2)

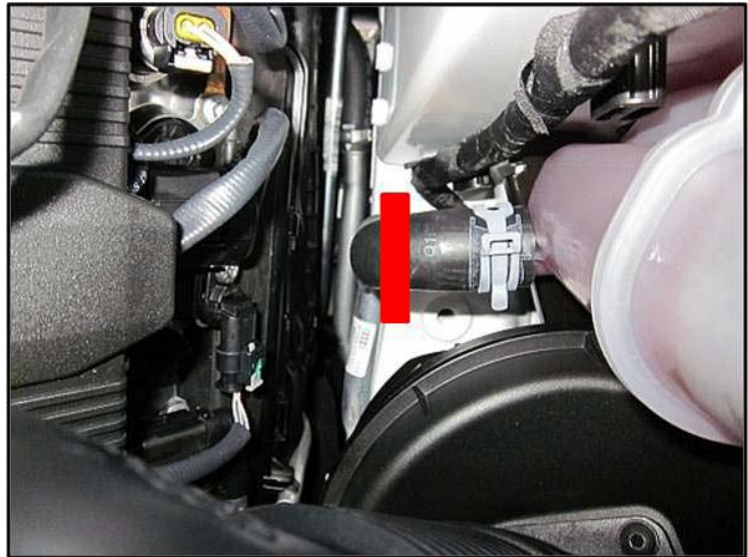
Figure 9. Expansion tank filler hose

4. Release hose clip, disconnect filler hose, and seal off opening on expansion tank immediately with your finger (Figure 9).
