# Service Bulletin

Bulletin No.: PIT4551F

**Subject:** Back Up Alarm Inoperative And Needs To Be Connected During PDI

**Models:** 2008-2013 Chevrolet Silverado  
2014 Chevrolet Silverado 2500 / 3500  
2008-2013 GMC Sierra  
2014 GMC Sierra 2500 / 3500  
Equipped with Back Up Alarm (RPO 8S3)

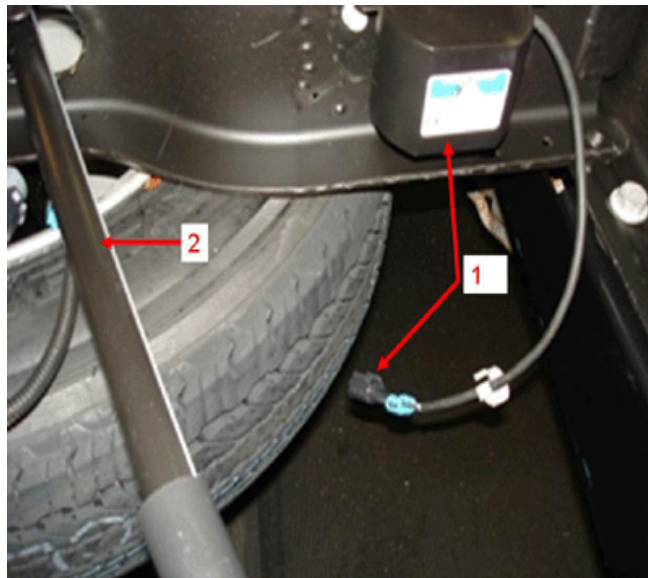
2044179

During the PDI it may be noticed that the backup alarm is inoperative. On trucks equipped with the Back Up Alarm option RPO 8S3, the alarm will be intentionally left disconnected from the assembly plant.

1. Back Up Alarm/Connector
2. Spare Tire Hoist Tube

The alarm is located on the right rear of the frame, and the chassis harness alarm connector is located on the left rear of the frame. Route the harness up and over the spare tire hoist tube and connect to the backup alarm.
