Service Bulletin

Bulletin No.: PIT5222

Subject: Center Seat Accessory Power Outlet Inoperative (Inspect Fuse F1DR 15 amp)

Models: 2014 Chevrolet Silverado 1500
2014 GMC Sierra 1500

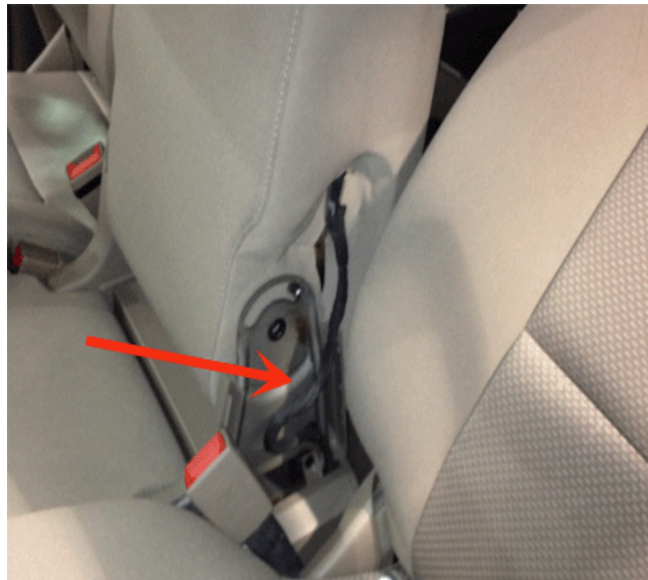
3395361

Some owners may comment the Center Seat (Armrest) Accessory Power Outlet (X80E) is inoperative. This power outlet is operational when the ignition is turned to either the run or the accessory positions. If the power outlet is inoperative in the run or accessory positions inspect the F1DR fuse (15 amp), located in the right I/P fuse block, for being blown.

If the fuse is blown inspect for a short to ground on circuit 850 near the left pivot for the center seat armrest, as shown below. If the circuit is shorted repair as necessary and protect the harness so it does not reoccur.

For wiring repairs covered under warranty, please refer to latest version of bulletin 10-00-89-005 for warranty information on wire/connector repairs.
