Technical Service Bulletin

19J1 UPDATE – 4.0 I Quality Package (NVLW)

October 24, 2013

Model(s)	Year	VIN Range	Vehicle-Specific Equipment
S6, S7, A8, and S8	2013 - 2014	See Campaign/Action screen in ElsaWeb	None

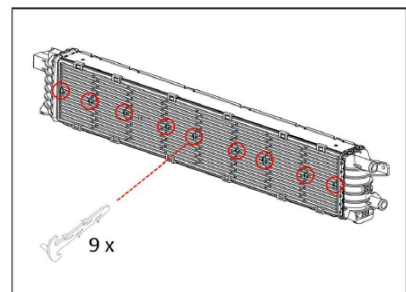
Figure 5. Secure grille with nine retaining clips.

2. Fit protective grille onto radiator (Figure 4) and secure with nine retaining clips (Figure 5).

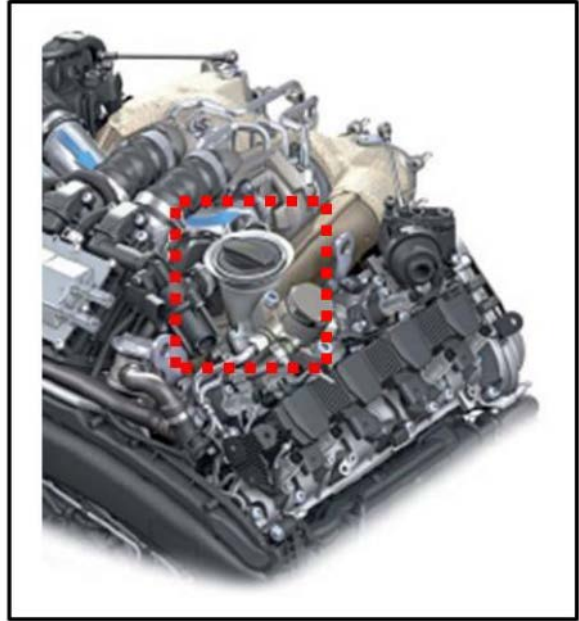
Figure 9. Oil filler neck.

Replace oil filler neck (Figure 9).

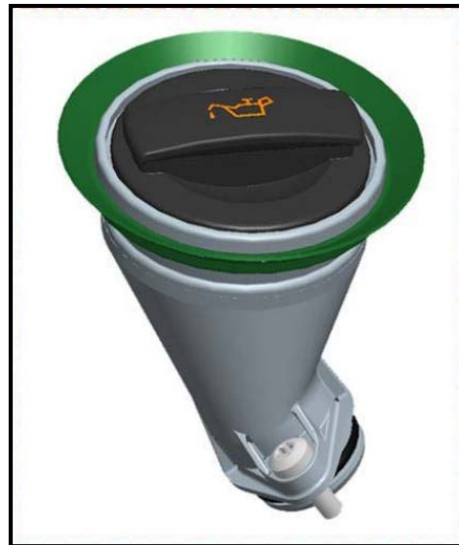
Figure 10. Torque bolt to 9 Nm.

Torque bolt to 9 Nm (Figure 10).
