Technical Service Bulletin

19J1 UPDATE – 4.0 I Quality Package (NVLW)

October 25, 2013

Model(s)	Year	VIN Range	Vehicle-Specific Equipment
S6, S7, A8, and S8	2013 - 2014	See Campaign/Action screen in ElsaWeb	None

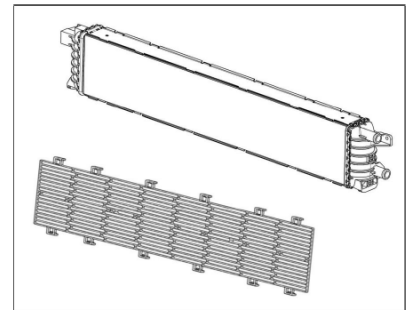
Figure 4. Fit protective grille onto radiator.

2. Fit protective grille onto radiator (Figure 4) and secure with nine retaining clips (Figure 5).

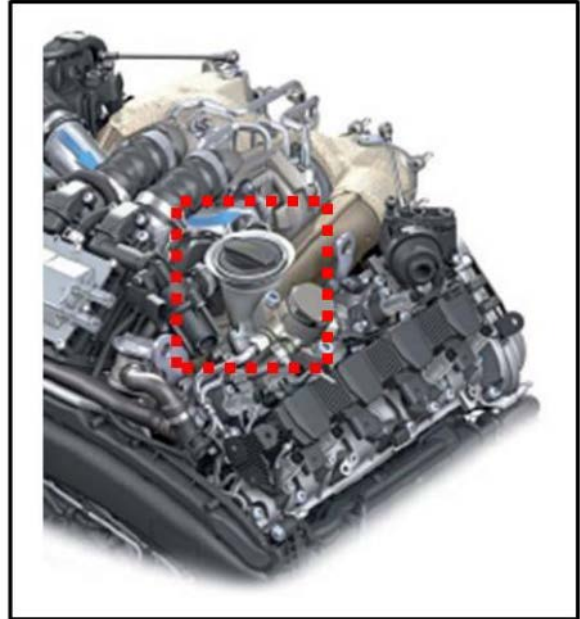
Figure 9. Oil filler neck.

Replace oil filler neck (Figure 9).
