# Technical Service Bulletin

## 19J1 UPDATE – 4.0 I Quality Package (NVLW)

July 23, 2013

A quality package has been defined for Audi vehicles with 4.0L TFSI engine manufactured within a specific period. This Update is in effect until removed.

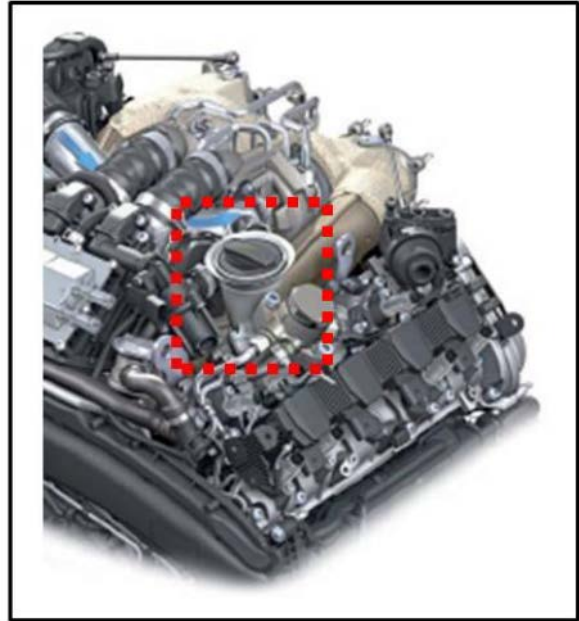
**Figure 9.** Oil filler neck.

Replace oil filler neck (Figure 9).

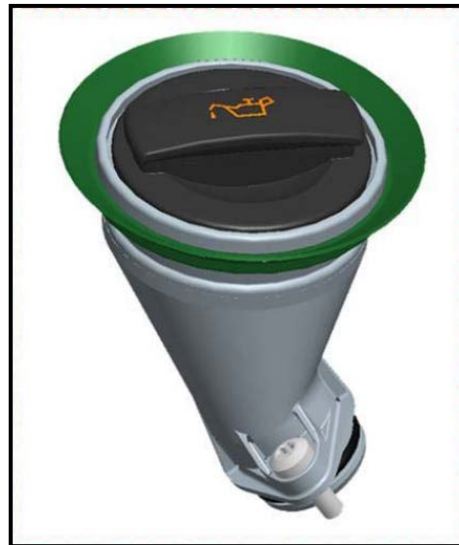
**Figure 10.** Torque bolt to 9 Nm.

Torque bolt to 9 Nm (Figure 10).
