Bulletin No.: PI0703B

Subject: Service Rear Axle Message Displayed on Driver Information Center (DIC), DTC C0407 with Symptom Code 64 or C0403 Symptom Code 62 Set

Models: 2010-2012 Buick LaCrosse
2010-2012 Cadillac SRX
Equipped with All-Wheel Drive (AWD)

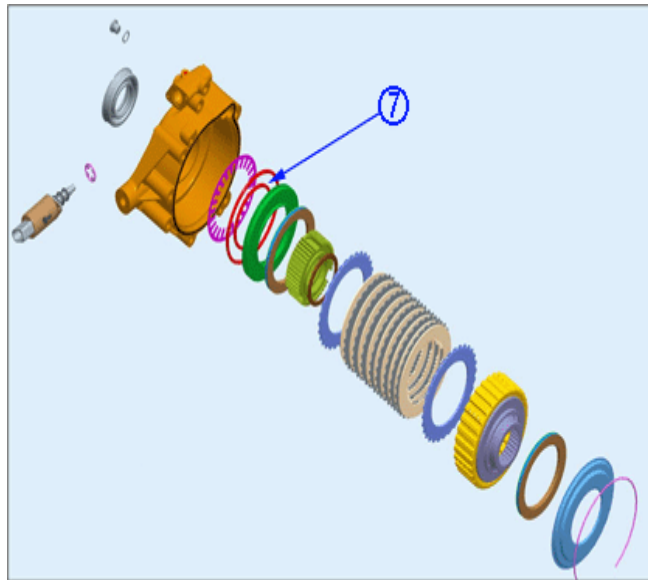
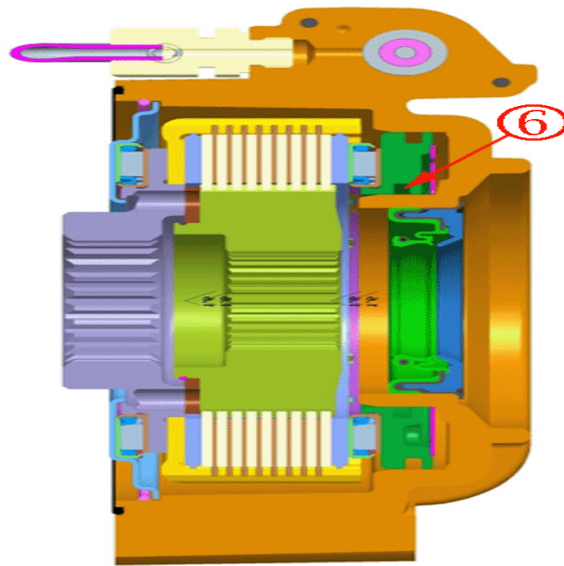
2549356

3. If the rear differential fluid level is too high and either a or b exists, then the eLSD clutch oil is leaking past the eLSD clutch internal piston seals (6 or 7) into the rear differential. The service fix is to replace the eLSD clutch piston only using the following procedure.

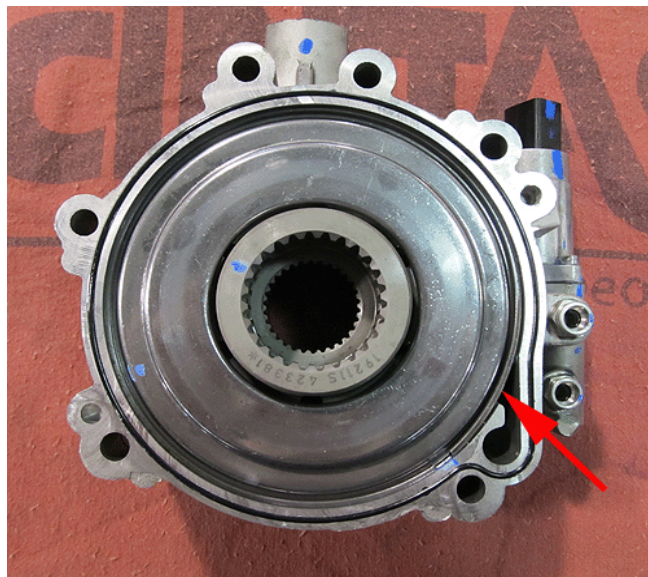
2789536

5. Remove the limited slip differential clutch low and high pressure pipes from the differential clutch.
6. Remove the electrical connector from the limited slip differential valve and remove the harness from the clip.
7. Remove the limited slip differential clutch bolts (Qty: 6).
8. Remove the limited slip differential clutch from the differential carrier assembly.

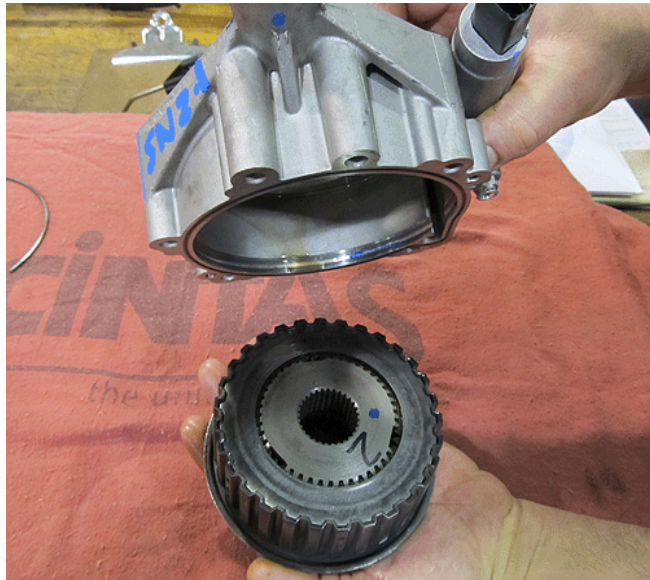
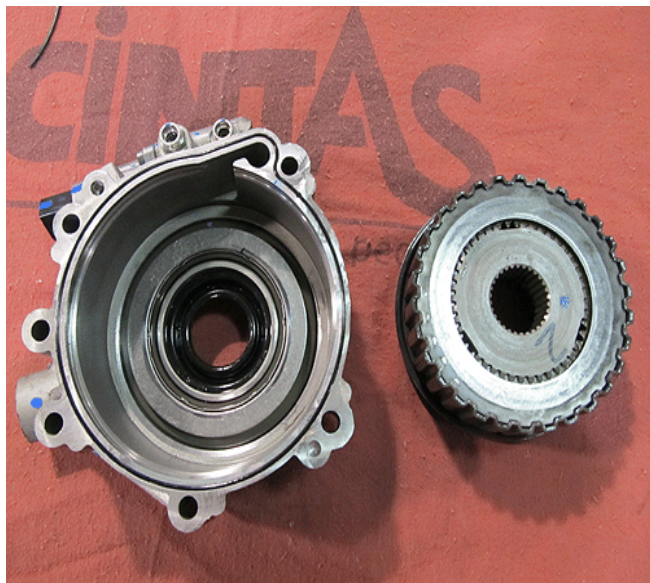
2789542

9. Remove the retaining ring that secures the differential clutch pack to the clutch housing.

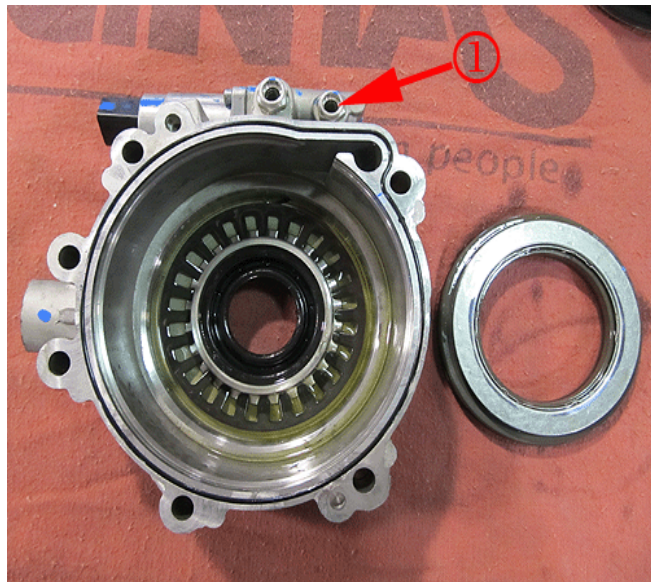
2789545

10. Remove the differential clutch pack from the clutch housing. Hold the housing in one hand and flip over to allow the clutch pack to fall into the other hand.

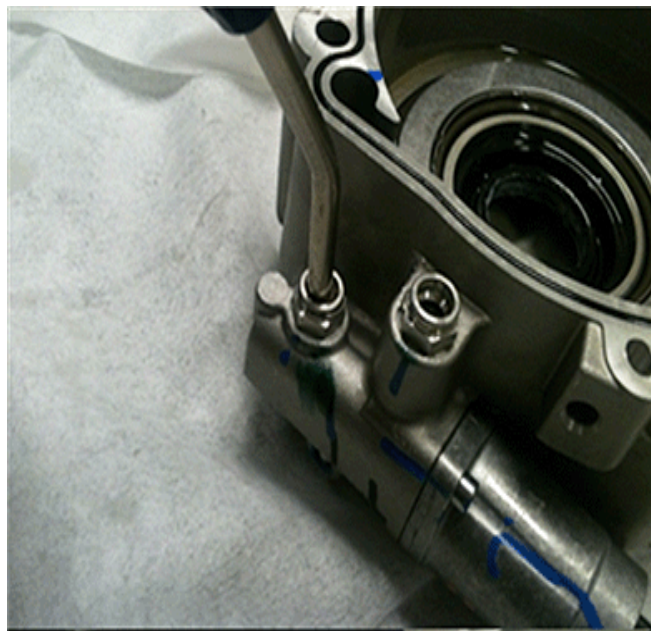
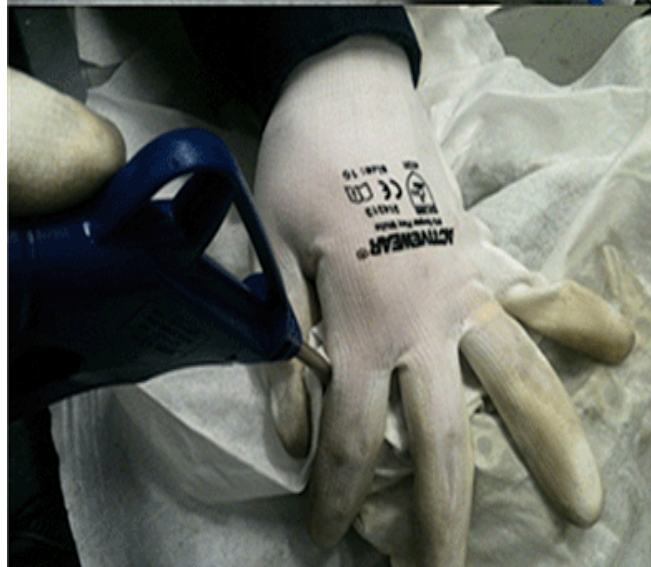
2806109

11. Apply compressed air to the low pressure pipe connector port to release the piston from the differential clutch housing.
12. Remove the eLSD clutch piston from the housing.

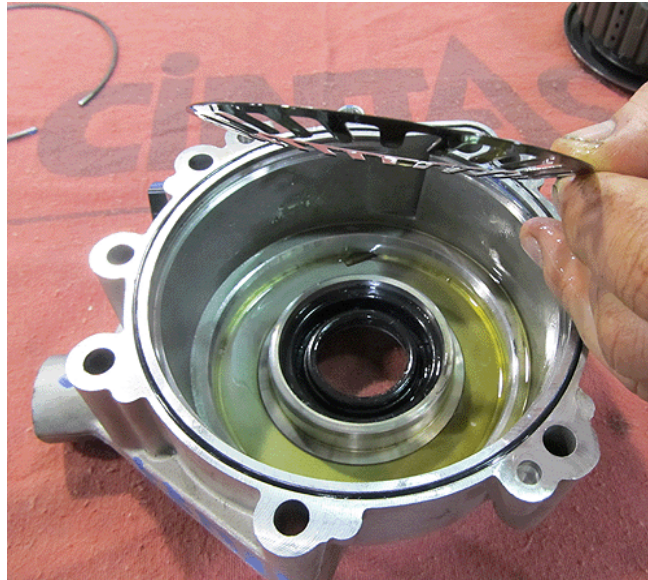
2789546

Note: If the piston spring is removed, ensure proper orientation when reinstalling. Spring fingers must be positioned as shown above.

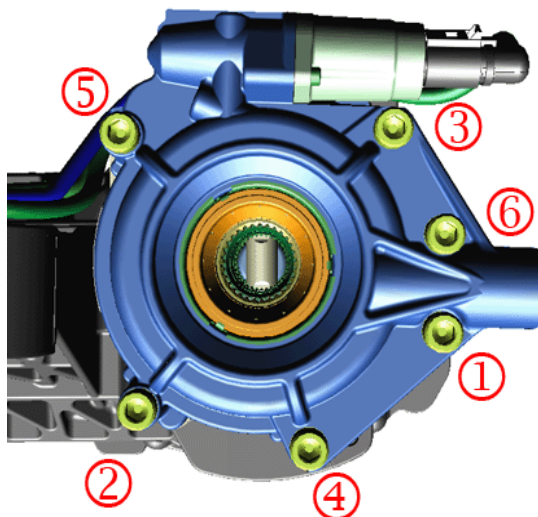
2806114

19. Reinstall the limited slip differential clutch bolts (Qty: 6).

Tighten the bolts in proper sequence to 30 N•m (22 lb ft).

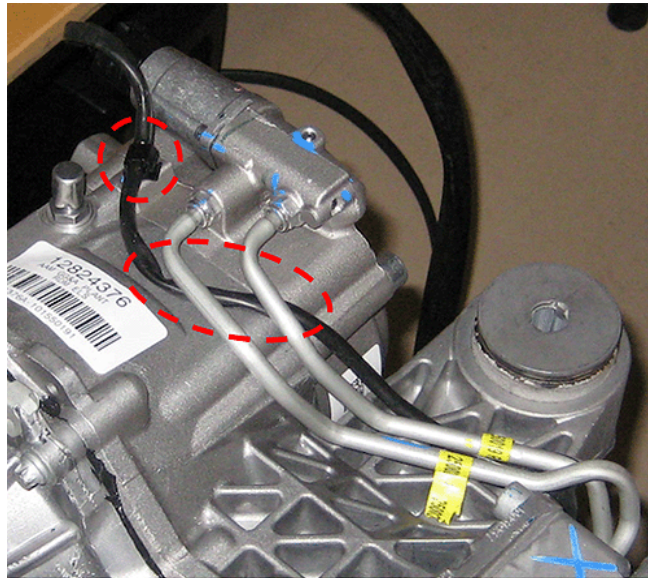
2806112

21. Reinstall the electrical connector to the limited slip differential valve and harness to the clip. Route the electrical harness under the pressure lines as shown.

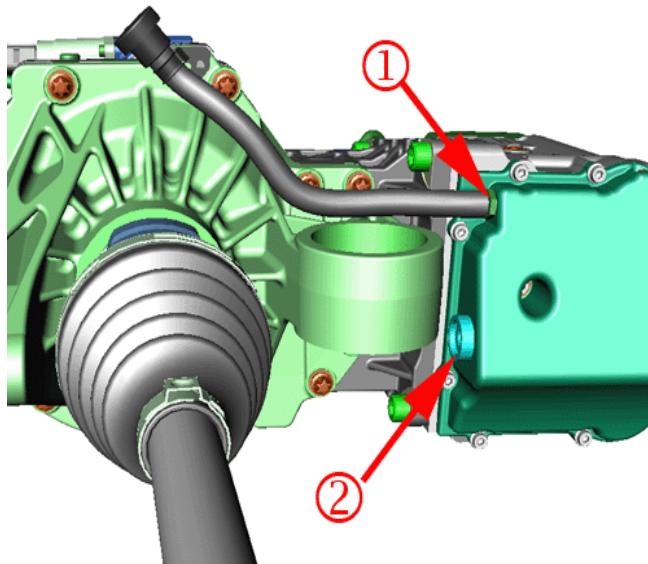
2806115

22. Remove the TTD clutch cover fill plug (2) and add 140 ml (0.15 qts) of eLSD clutch fluid. Install the fill plug and tighten to 14 N•m (10 lb ft).

Note: 140 ml (0.15 qts) if only the piston was replaced and 300 ml (0.32 qts) if the piston and filter were replaced. May be easier to get the required fluid into the unit if the assembly is tilted up on the pinion nose.

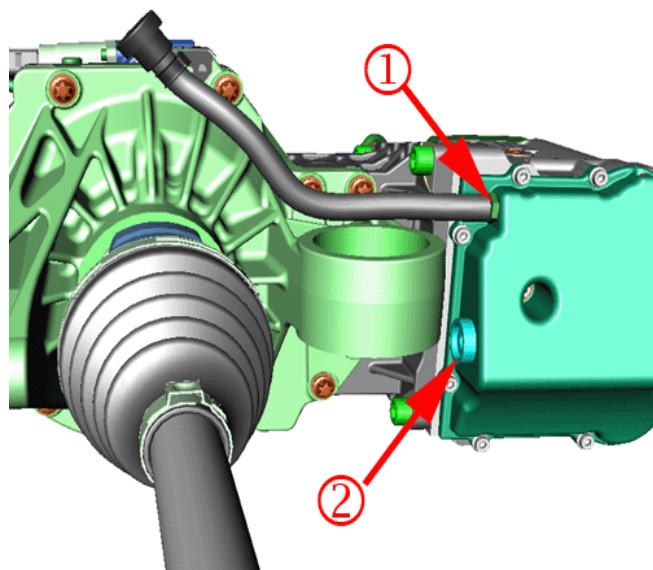
2806115

Important: When filling the eLSD clutch housing after repairs, the fluid must be able to flow over the top of the internal wall of the pump cavity (3 and 4), making it imperative that the fluid is filled through the vent opening (1) with the cover plug (2) installed. The bottom of the cover plug opening (2) and the internal wall (3) are at the same level. If the cover plug (2) is not installed, the fluid will fill the eLSD clutch oil sump (5) and run out of that opening (2) before it can flow over the wall (3) into the pump cavity (4).

3. Remove the vent hose (1) from the fitting.
4. Attach the fill hose to the vent fitting and fill the TTD clutch through the vent opening on the cover. Ensure that the fill plug (2) is installed prior to adding fluid through the vent fitting.
